**200 Cattle Dr. Lot# 81
Fredericksburg, TX 78624**

Prepared For: Jesse & Susan Gonzalez

Date: 10/11/2023

Inspection Address: 200 Cattle Dr. Lot# 81, Fredericksburg, TX 78624

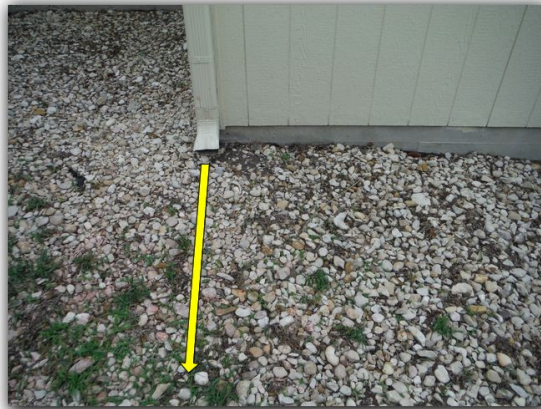
Gutter downspout is loose or damaged - noted at the right side of the home

Gutters draining to close to the structure - recommended to have 6' extensions to help get water away from the foundation

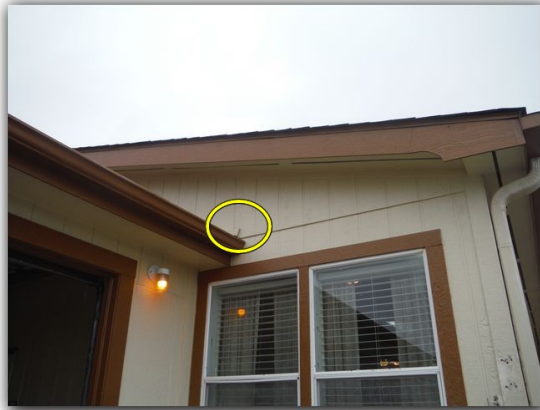
- A kick-out flashing is missing - recommended when the drip edge of a roof line terminates against the wall of the home - noted in the front of the home where the garage roof meets the home - a gutter is present here

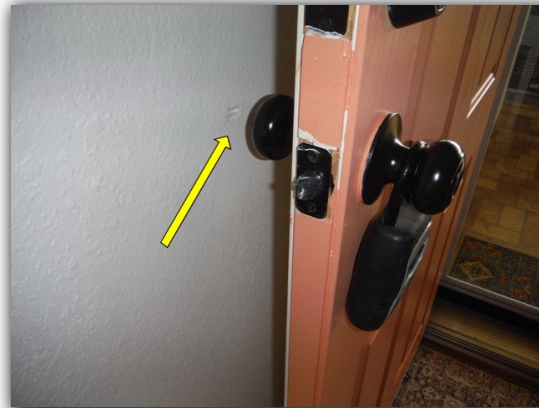
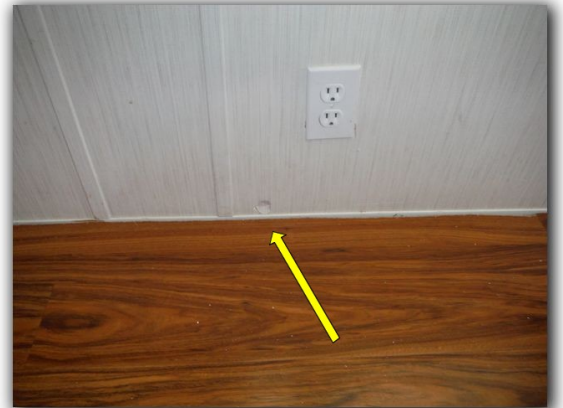
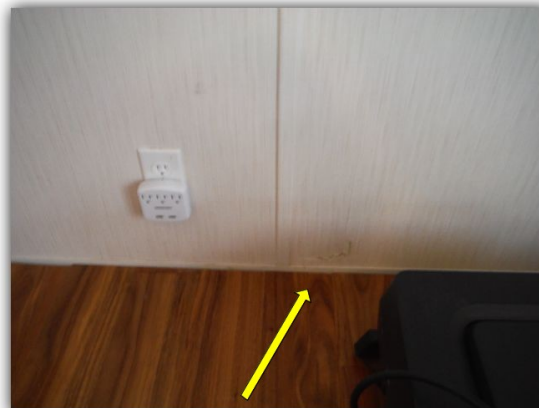
- Sheet rock wall is dented or damaged - noted behind the front door handle, below the front plug in the family room, below the front wall plug in the breakfast area, and at the right wall in the front right bedroom

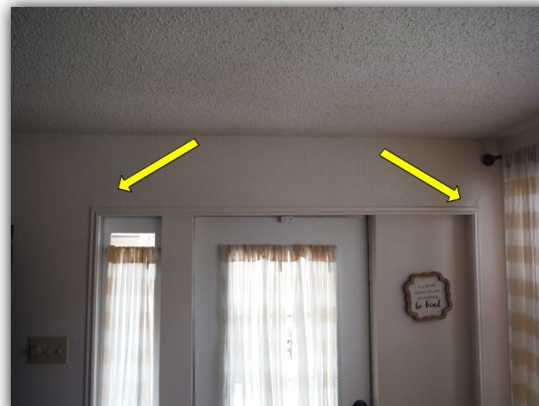
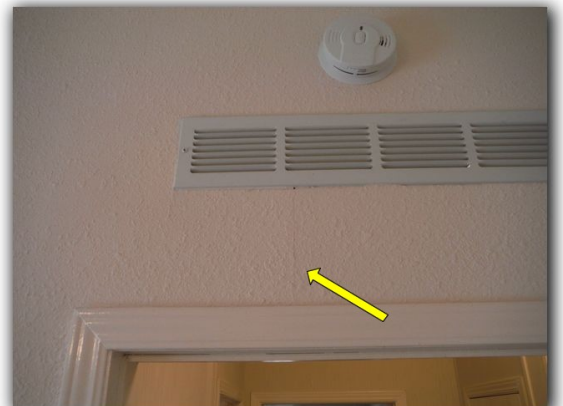
Cracks in the sheet rock wall covering - noted over the rear family room exterior door and left rear window in the family room, and above the right rear bedroom door opening

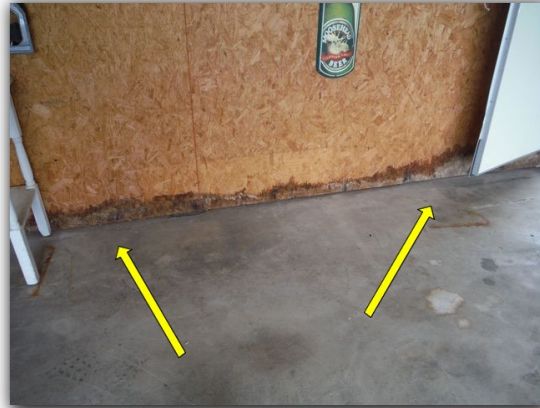
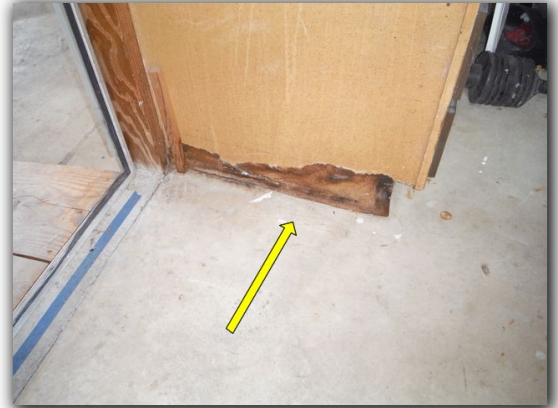
Signs of moisture staining are present in the garage along the rear wall and at the bottom of the cabinets inside the rear garage storage room - evidence indicates water has pooled and entered the garage area along the left side of the rear porch at some point

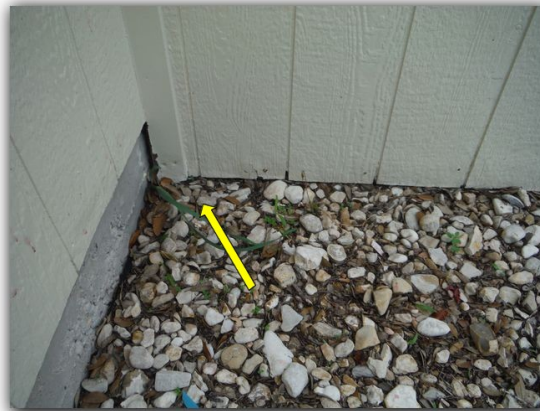
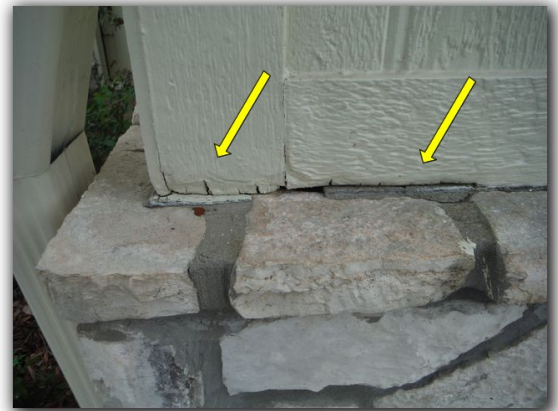
Trim boards are soft or damaged - noted at the left rear inside corner in the rear of the garage, front right corner of the home at the trim over the rock skirt, rear right side below the window unit, and also at the bottom corners of the rear garage man door

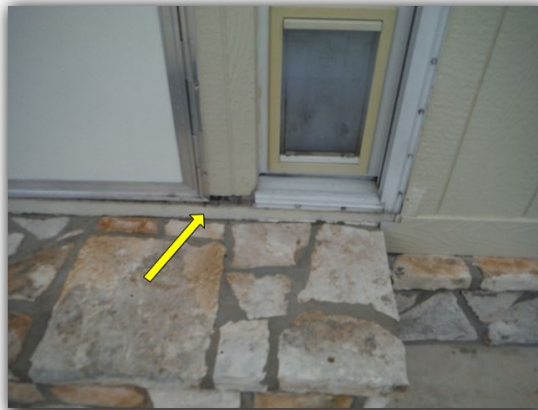
Trim piece is missing - noted near the rear dog door

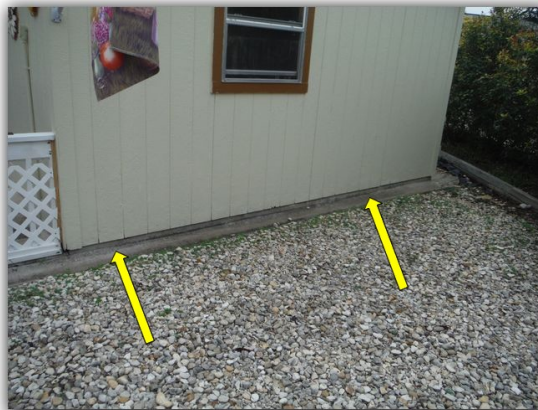
Wood siding is soft or damaged in some areas - noted along the bottom of the rear walls of the garage

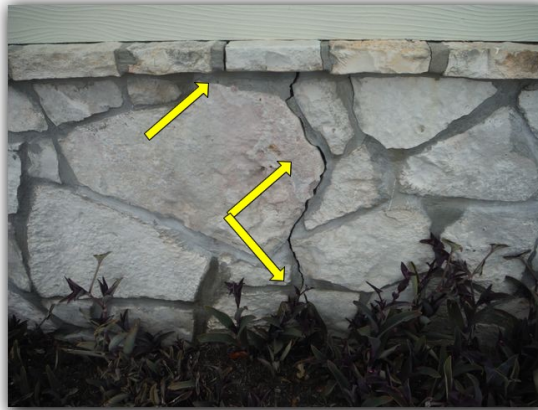
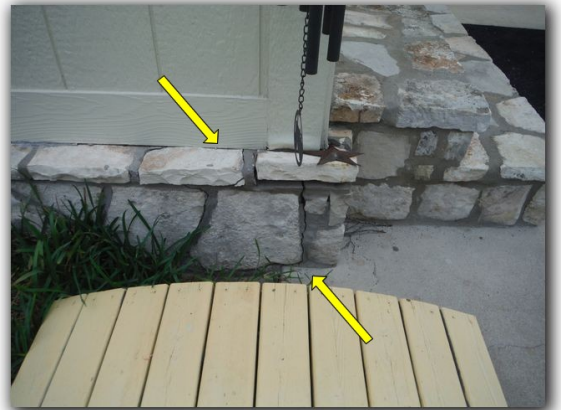
Some cracks noted in the stone skirting material - noted in the front of the home near the hose bib and at the right outside corner of the rear porch

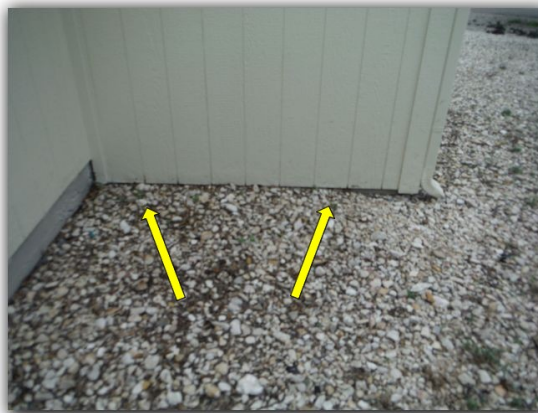
Inadequate clearance between siding and grade - recommended to have 4" - 6" of clearance - noted in the rear of the garage

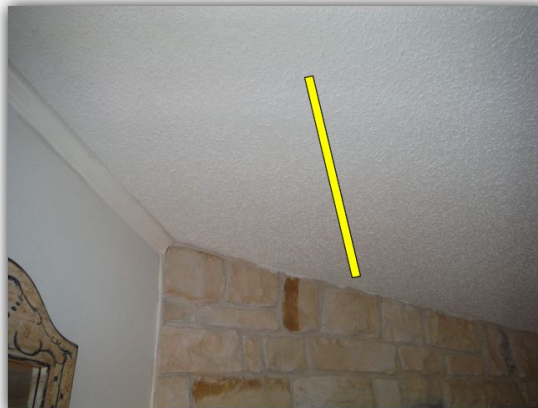
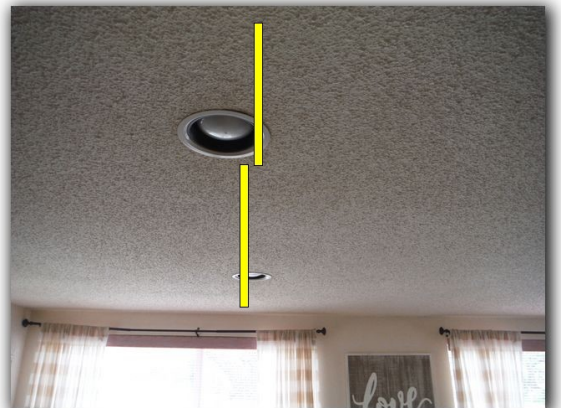
Cracks in the ceiling sheet rock - noted in the living room at the left side of the chimney and in the rear family room along the left side near the recessed light cans

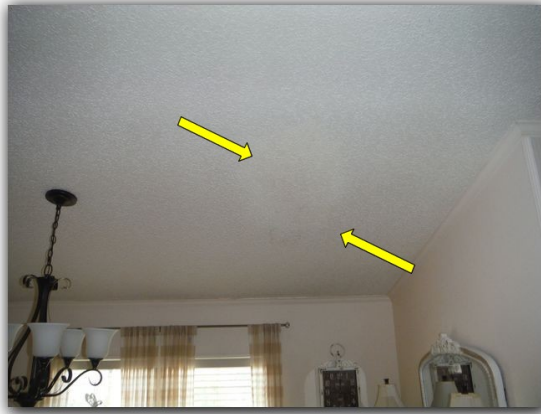
Evidence of a patch or repair to the ceiling sheet rock - noted near the light fixture in the dining

room

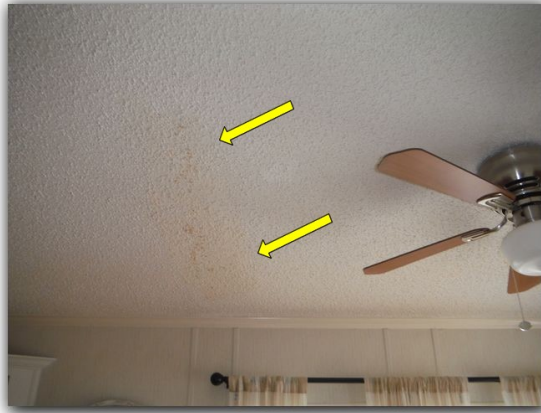
Staining on the ceiling sheet rock - noted near the fan in the breakfast area

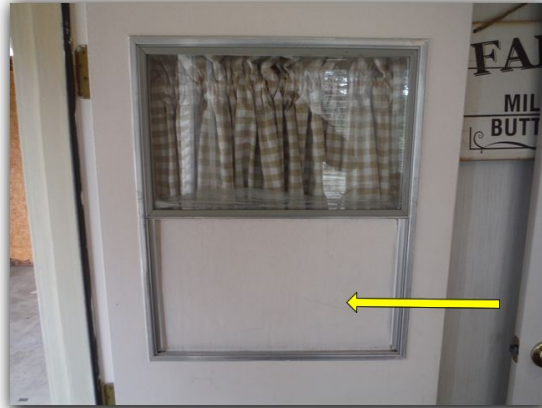
- Door drags on the wooden ramp - noted at the rear garage store room door

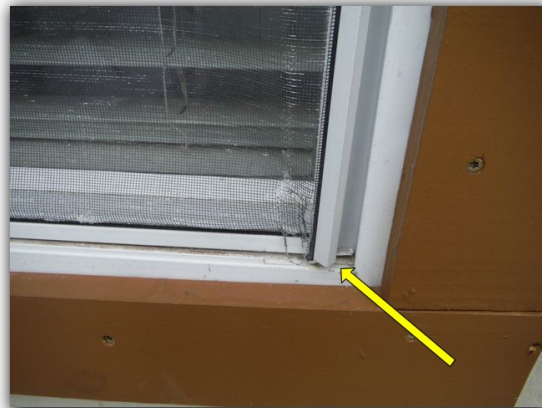
- Window screens are missing or removed at the front porch
- Some window screens are damaged or torn - noted torn at multiple screens and noted as a damaged frame at the right rear bedroom window

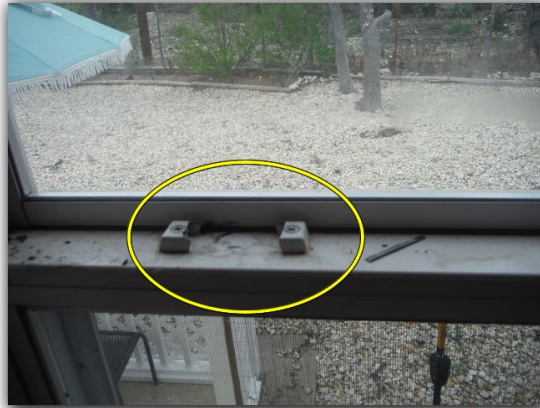
- Window lock is damaged or missing - noted at the left rear window in the rear family room

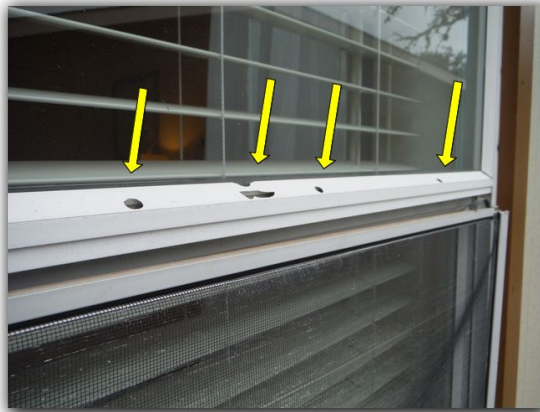
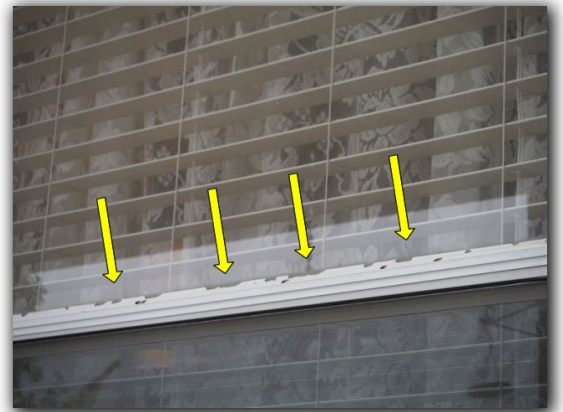
- Window is tight or difficult to open - noted at the breakfast area beside the garage door, front left dining room window, master bath commode, and also in the right rear bedroom (in bedrooms this restricts emergency egress which is also a known safety hazard)
- Some window trim / plastic , etc. damaged and / or chipped

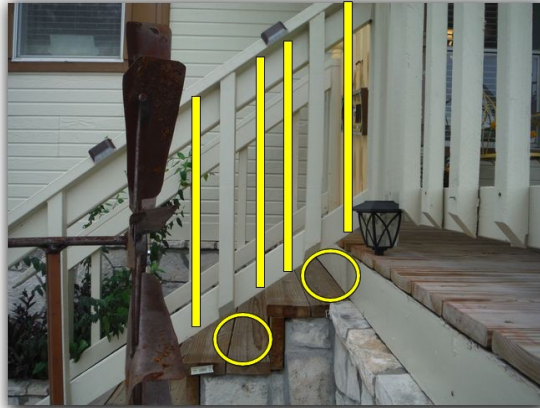
- Baluster spacing on steps exceed 4 3/8" - noted at the front porch

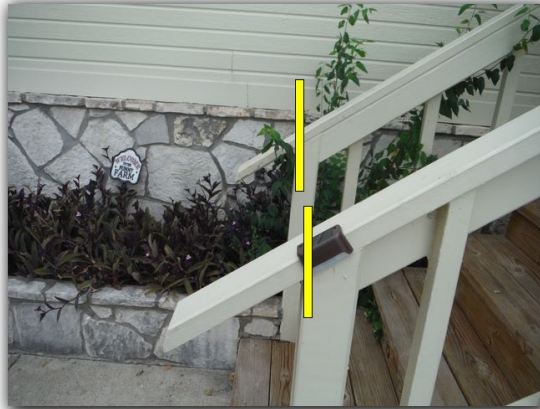
Hand railing is not terminated properly - recommended to be terminated at the last post to prevent snagging clothing or accessories and causing a fall - noted at the front porch steps

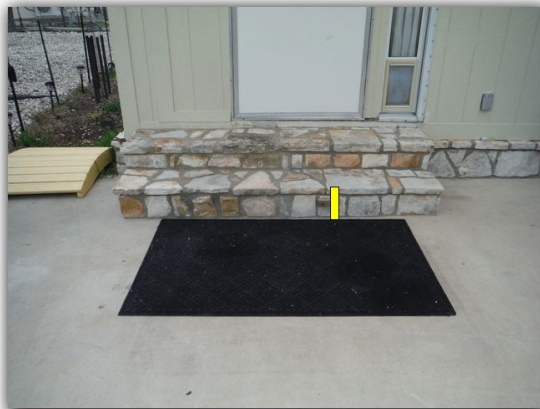
Improper dimensions of stair raisers - steps are not recommended to be taller than 7 3/4" - noted at the bottom of the rear stone steps

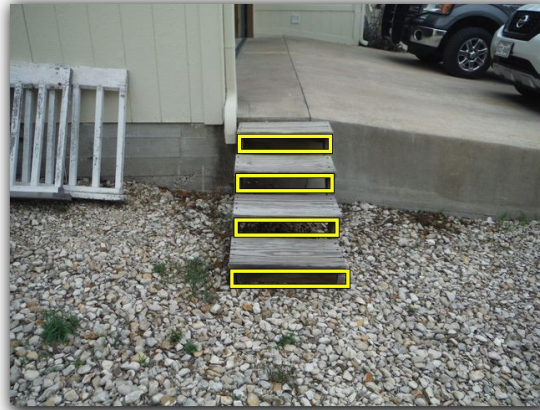
Steps are missing toe kicks - noted at the left side driveway steps

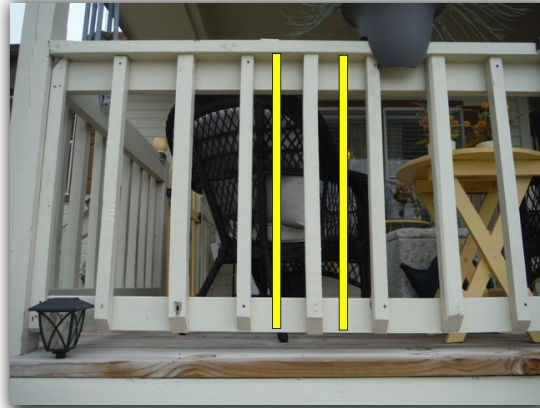
Balusters are greater than 4" spacing - noted at the front porch

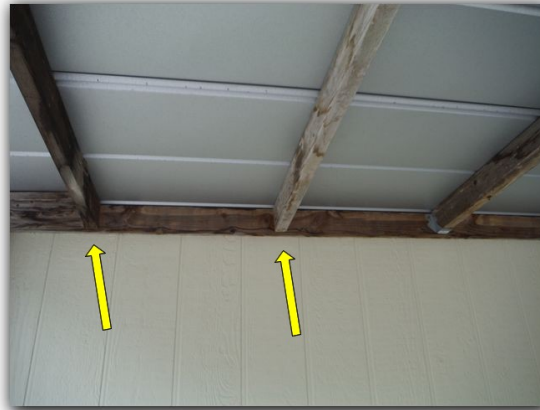
Hanger braces are missing - noted at the outside of right rear lean to roof

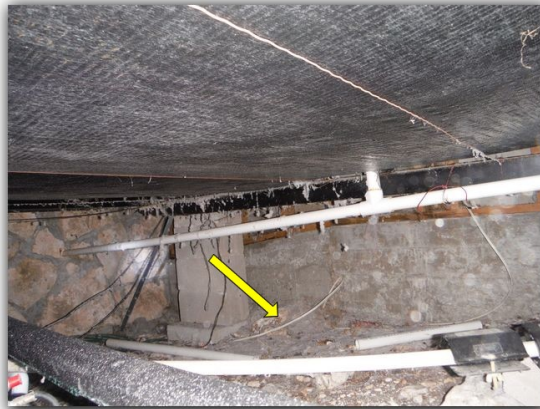
- Test indicates an open or weak ground wire - noted at the living room plug left of the fireplace and at multiple plugs in the master bedroom
- Wiring is unsupported beneath the structure - noted at one wire on the ground below the front left corner of the home

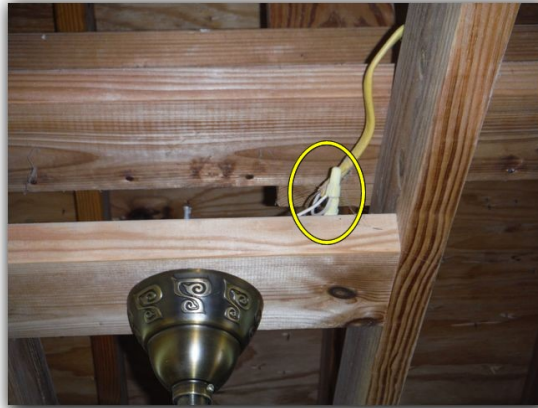
- One or more connections are not in junction boxes - noted above the fan in the rear garage storage room

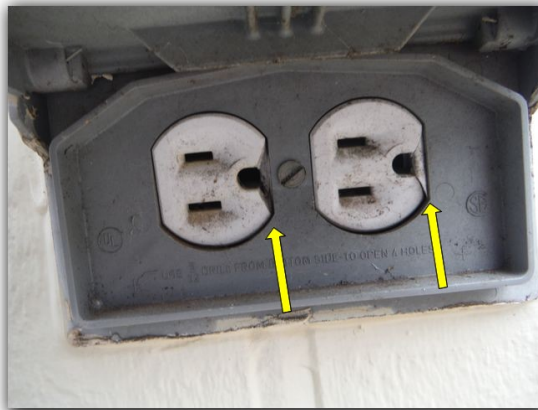
- Switch is loose at the wall mounting - noted in the master bathroom left of the vanity
- Plug is loose at the wall mounting - noted at the front wall in the front right bedroom
- Some wall plugs are chipped near the ground hole

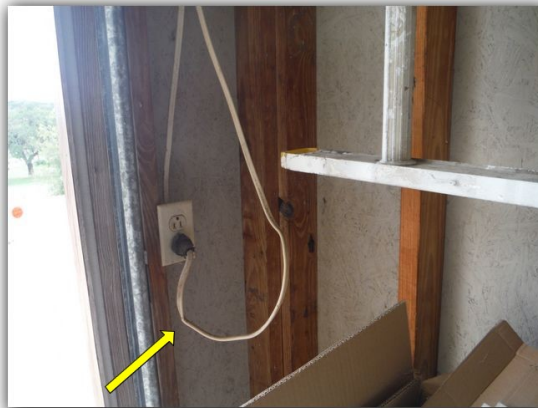
- Extension cords are not recommended for use as permanent wiring - noted at the left side of the garage

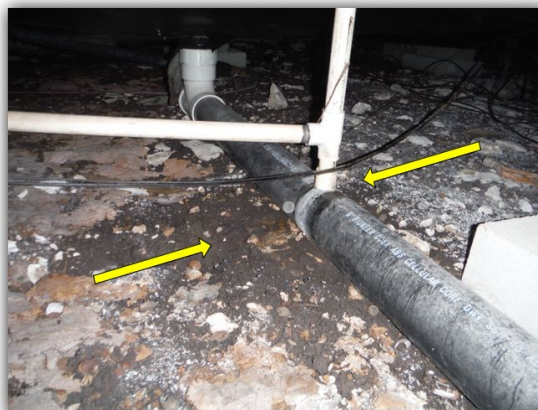
- An electrical disconnect is recommended near the unit for technicians
- The primary drain line is terminated into the home's drain system below the home and the connection appears to leak some

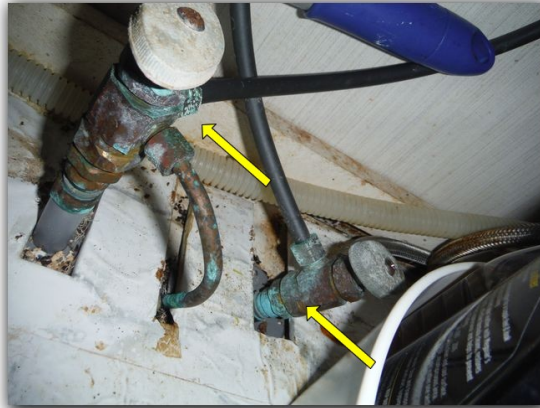
Kitchen sink - some corrosion noted at supply valves - no moisture was present here during testing today

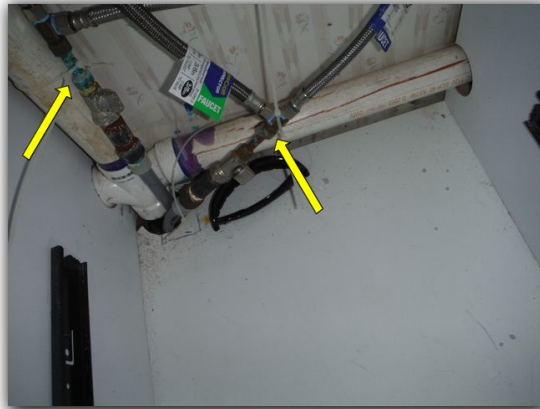
- Master lavatory - both lavatories - drain stops are loose or inoperable
- Master lavatory - some corrosion noted at supply valves - no moisture was present here during testing today

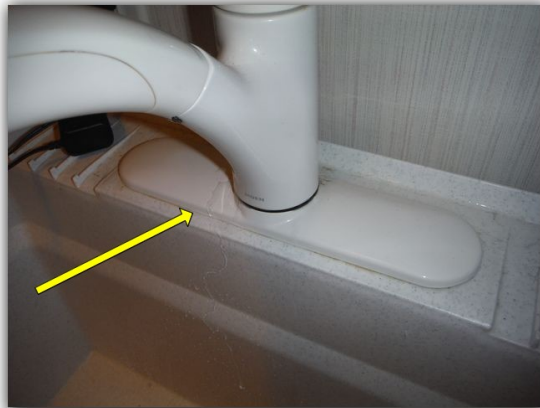
- Utility lavatory - faucet leaks at the base when turned on

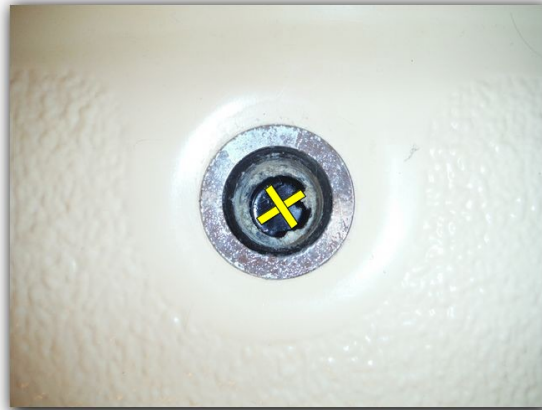
- Master bathroom - tub drain grate is missing the cross section or divider

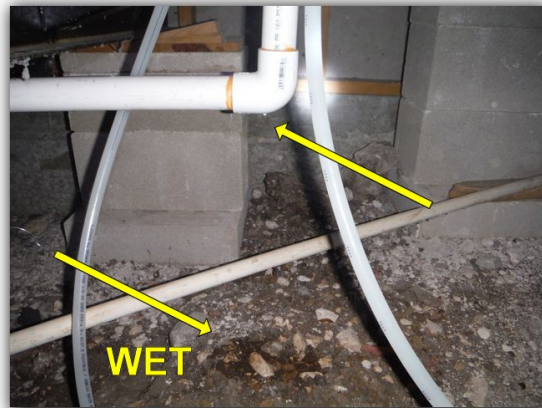
- Exterior hose bibs do not have back-flow prevention
- Pipe below the left side of the home was found dripping - below the utility lavatory

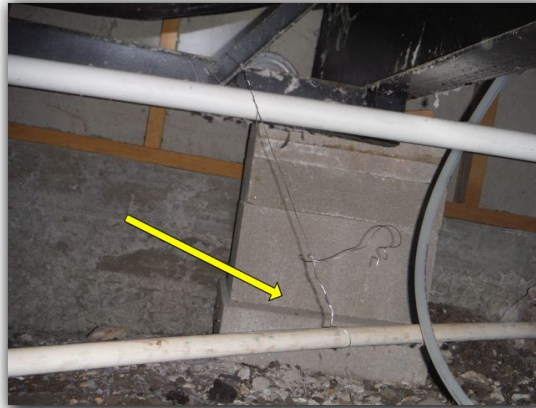
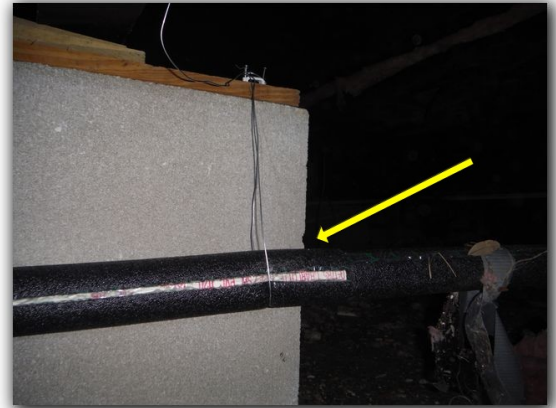
- Water pipes are not recommended to be supported with bare wire - noted below the utility room

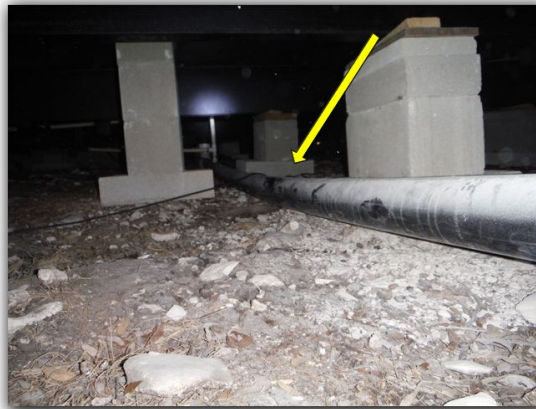
- Drain below the middle of the home sags some

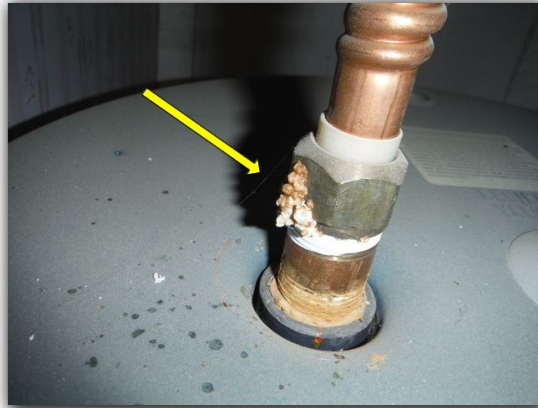
- An electrical disconnect is not within close proximity to the unit for technicians
- Corrosion or dissimilar metal reaction at plumbing connections - noted at the top of the unit - no moisture was present here during the inspection today

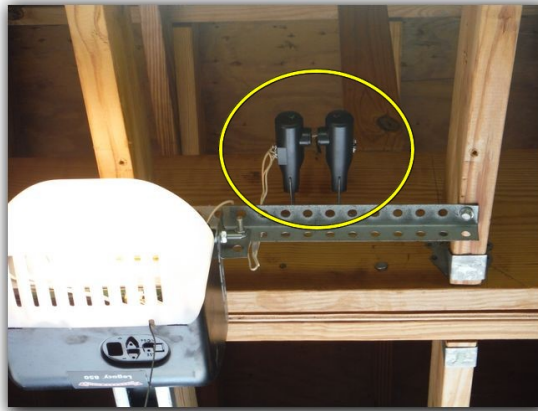
Electronic safety sensors are not installed properly - recommended to be installed within 6" up from the floor at the sides of the door - these are mounted together in the attic area
