HOME INSPECTION REPORT

600 Smith Creek
Christiansburg, VA 24073

JUNE 13, 2024

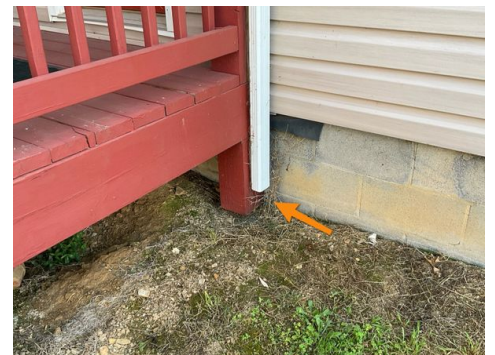
DISCHARGES TO FOUNDATION-QC

One or more downspouts discharged roof drainage next to the foundation. This condition can effect the ability of the soil to support the weight of the structure above and can cause damage related to soil/foundation movement. The Inspector recommends the installation of downspout extensions to discharge roof drainage a minimum of 6 feet from the foundation. This is causing large amounts of water to be deposited into crawlspace.

Contact a qualified gutter contractor

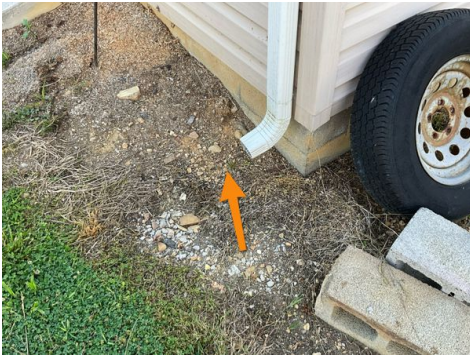
DOWNSPOUT NEEDS EXTENSION

Gutter downspouts need to be extended 5 to 6 with solid corrugated piping to get water away from the foundation. This pipe should be buried and away from foundation. Recommend licensed contractor to evaluate

Contact a qualified general contractor.

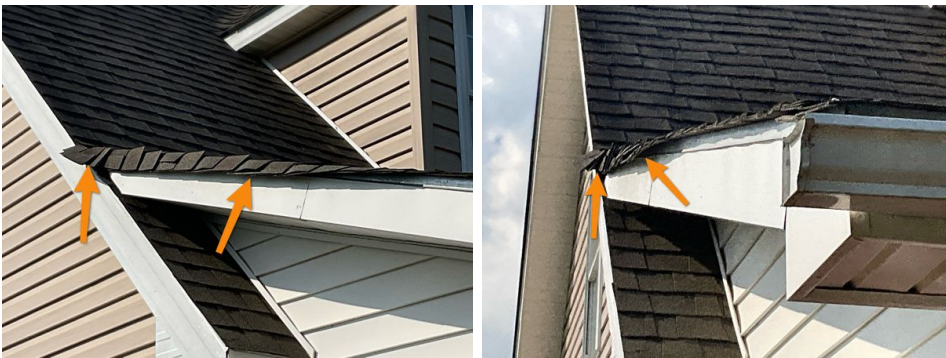
Garage

CUTS NOT STRAIGHT

Shingles were not cut in a straight line at eave on east side. This condition is primarily a cosmetic concern but could cause breakage of shingles.

Contact a qualified roofing professional.

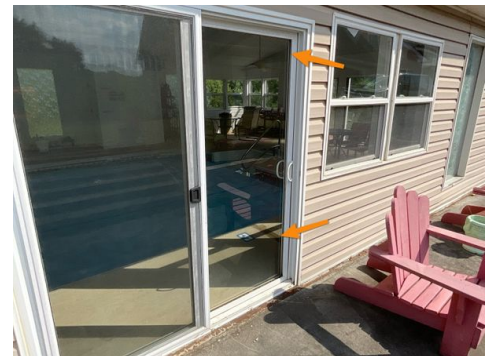
Pool house

BROKEN PANE

An exterior door had a broken window panes. Recommend repairing

Contact a qualified door repair/installation contractor.

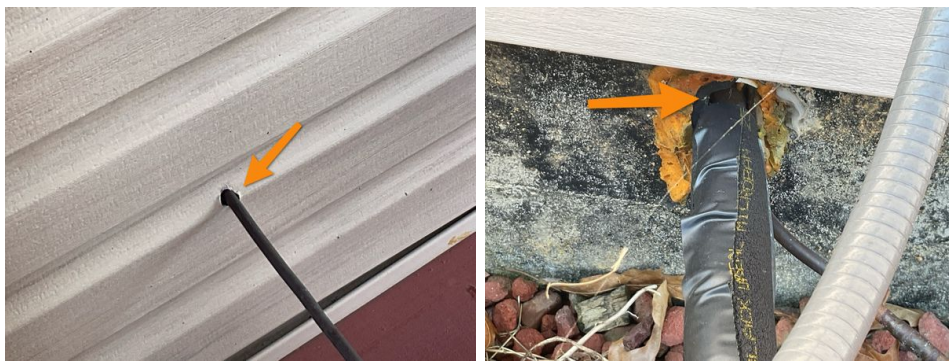
East

SEAL PENETRATIONS- QC

Exterior wall penetrations had gaps that should be sealed with an appropriate sealant to prevent moisture and insect entry. All work should be performed by a qualified contractor.

Contact a qualified general contractor.

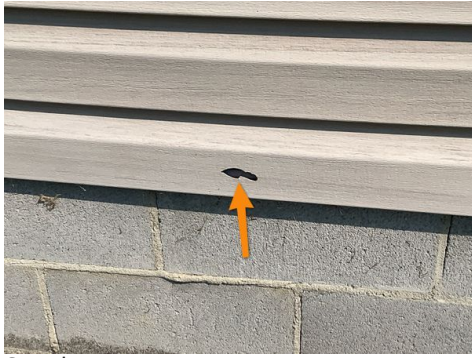
South

HOLE IN SIDING

Holes in siding. Recommend licensed contractor to evaluate and correct

Contact a qualified siding specialist.

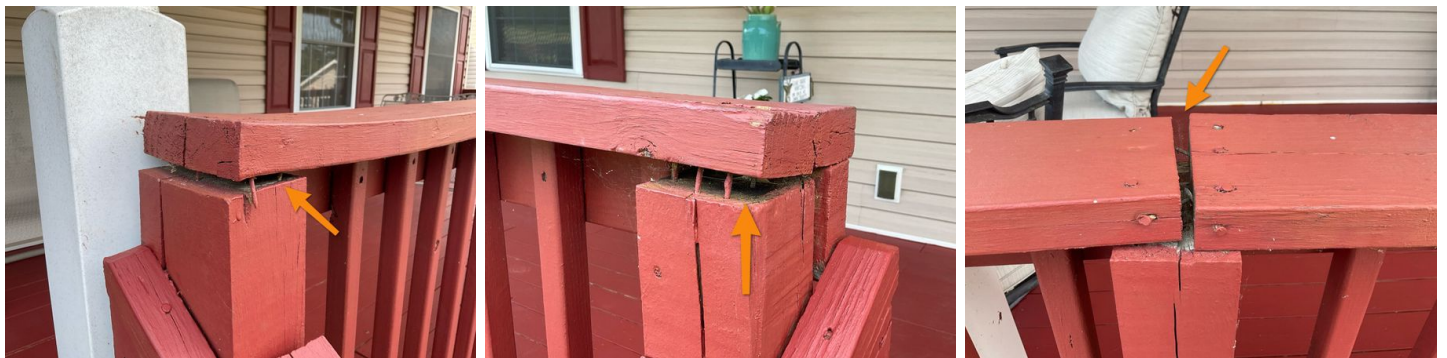
LOOSE HANDRAIL- QC

The handrail was loose and should be made secure by a qualified contractor.

Contact a qualified professional.

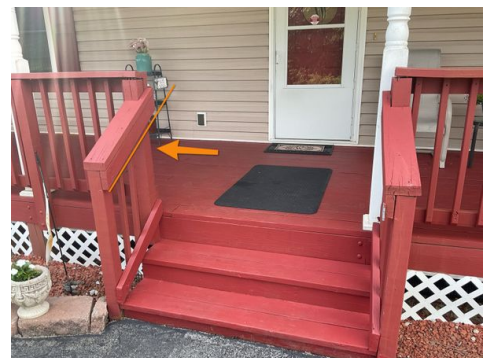
NON GRIPPABLE HANDRAIL

This staircase did not meet generally-accepted modern safety standards that specify the proper the size and dimensions of a grippable handrail. Recommend licensed contractor to correct

Contact a qualified general contractor.

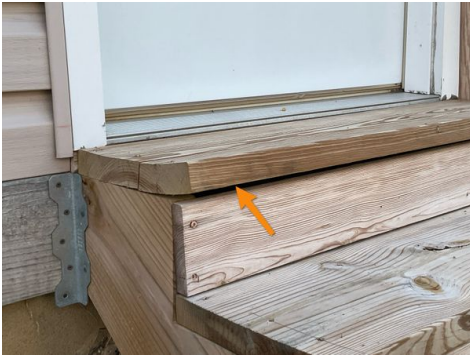
Garage

STAIR TREAD

The deck stairs have some areas of bowing. This could be a tripping hazard. Recommend repairing by a licensed contractor

Contact a qualified deck contractor.

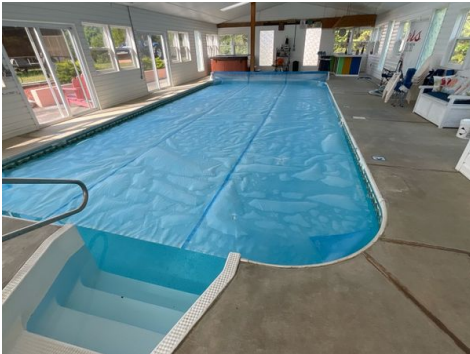
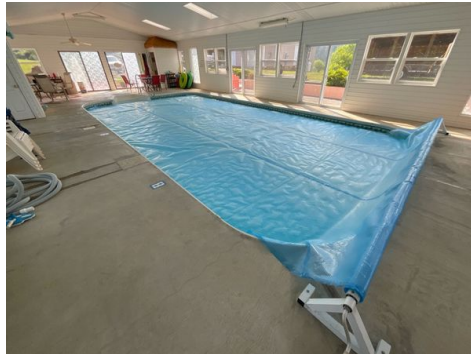
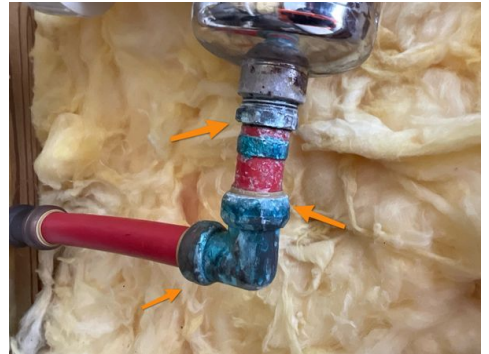
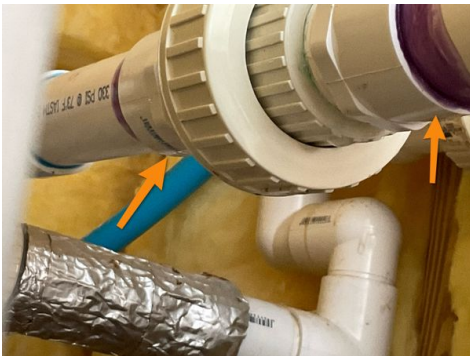
POOL

Pool inspections are not part of the home inspection per ASHI and InterNACHI Standards. Inspector recommends getting pool evaluated by a licensed pool company and licensed electrician. Found no issues with grounding, visual only. There were a few leaks at fittings near pump.

Contact a qualified swimming pool contractor

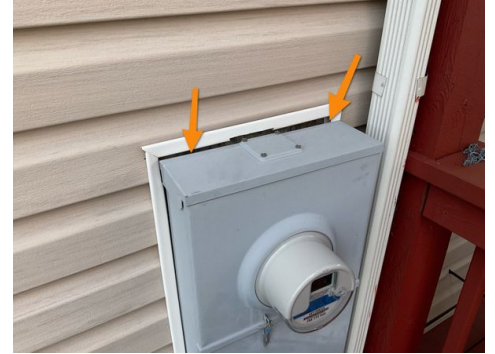
LOOSE METER- POCO

The electric meter was loose and should be securely fastened. The Inspector recommends correction by the electric utility provider.

Contact a qualified electrical contractor.

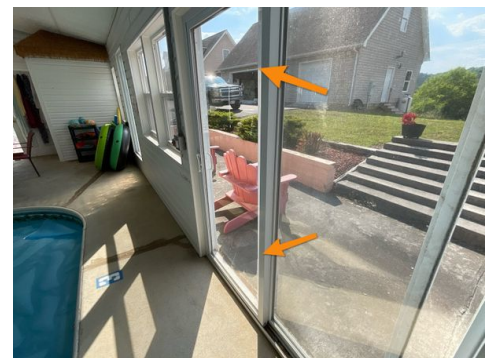
Pool house

Minor Deficiency**DIFFICULT TO OPERATE, ROLLERS- QC**

Difficulty in operating the sliding glass door in home, appeared to be caused by worn or out-of-adjustment rollers. Door does not lock. The Inspector recommends service or replacement by a qualified contractor.

Contact a qualified door repair/installation contractor.

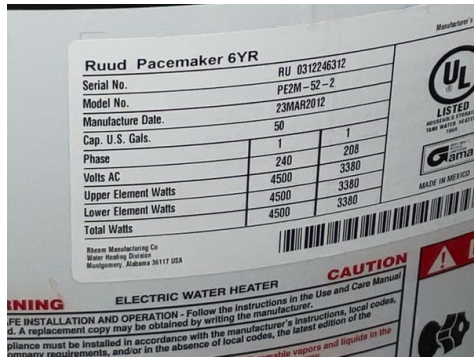
PAST WARRANTY

Water heaters can be expected to last as long as the listed warranty. The water heater was past warranty and may need to be replaced soon. Budget for replacement. MFG date of 2012

Recommendation
Recommend monitoring.

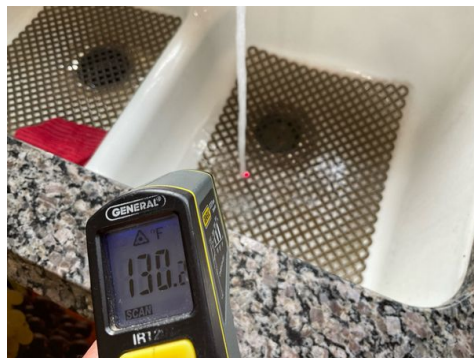
WATER TEMPERATURE

The water heater is producing hot water and temperature is in picture. Normal range is 92-135 degrees.

Recommendation
Recommend monitoring.

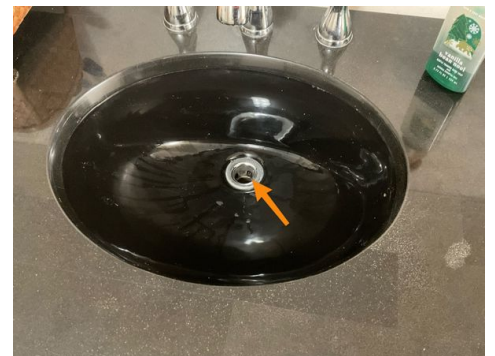
2nd Floor Bathroom

INOPERABLE STOPPER

The sink in the bath had an inoperable stopper.

Recommended DIY Project

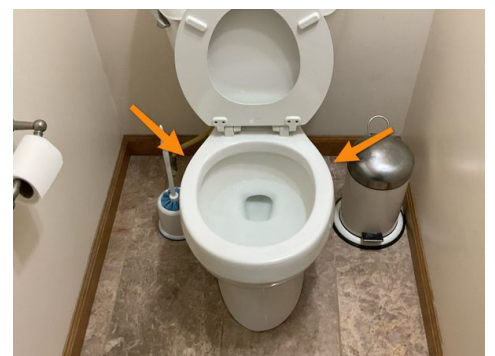
2nd Floor Bathroom

LOOSE AT FLOOR

In the bathroom, the toilet was loose at the floor and should be lifted, wax environmental seal replaced and re-attached by a qualified plumbing contractor.

Contact a qualified plumbing contractor.

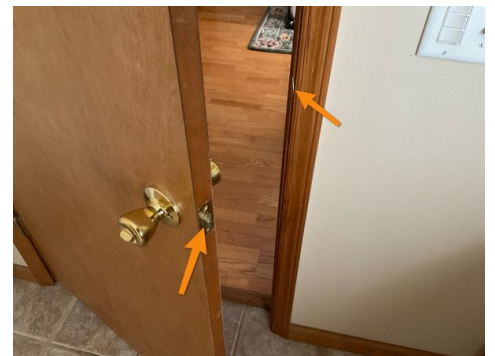
1st Floor Master Bathroom

INOPERABLE LATCH- QC

The door in the bathroom isn't catching strike plate. The Inspector recommends service by a qualified contractor.

Contact a qualified door repair/installation contractor.

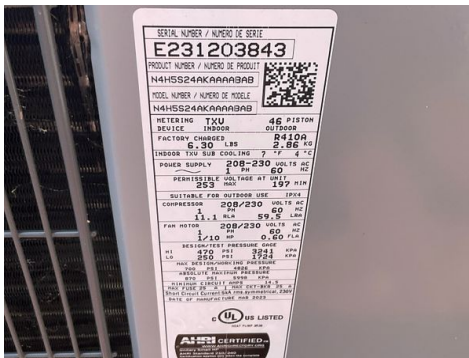
Outside unit 1 East

Information from the air-conditioner label/data plate is shown in the photo. Outside unit 1 MFG 2023, unit 2 MFG 2020
