To: Board of Directors
Spanish Galleon Condominium Assoc., Inc.
300 Sombrero Blvd.
Marathon, FL 33050

Re: Building Damage Survey Report

Spanish Galleon
 11150 Sombrero Boulevard
 Marathon, Florida 33050

Structural Survey

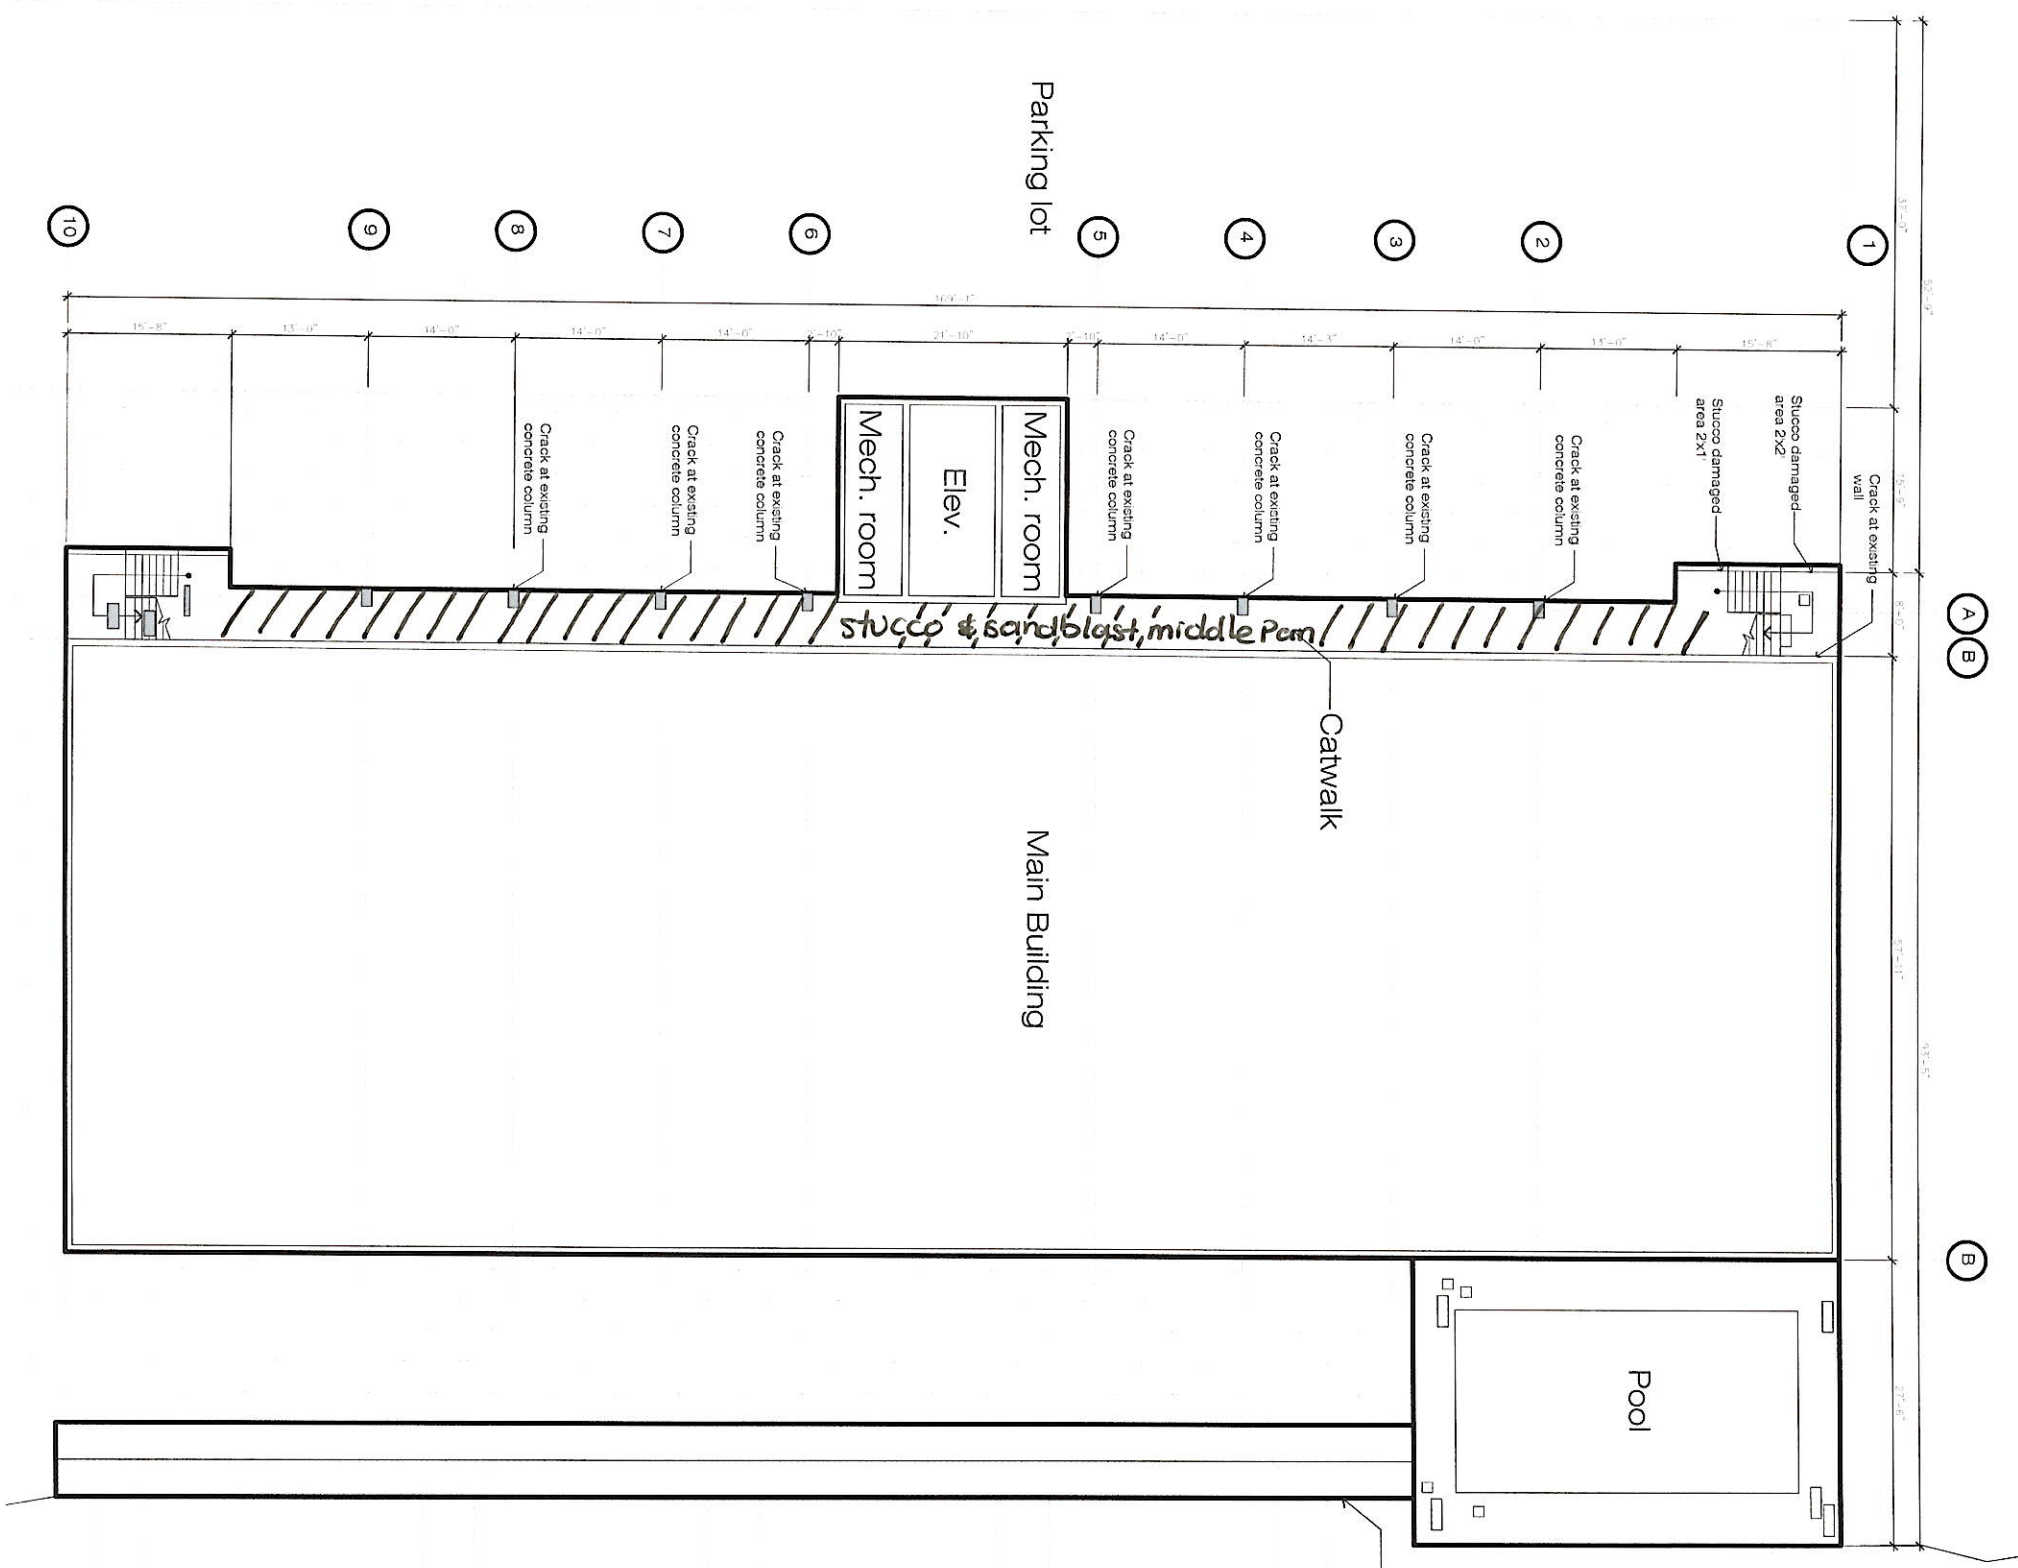
S-1

stucco & sandblast, middle part

Crack at existing concrete column

Crack at existing wall

Stucco damaged area 2x1

Stucco damaged area 2x2
