PROPERTY INSPECTION REPORT

Concerning: 6224 FM 344, Tyler, TX
(Address or Other Identification of Inspected Property)

By: Shane Miller, Lic #7898 01/06/2021
(Name and License Number of Inspector) (Date)

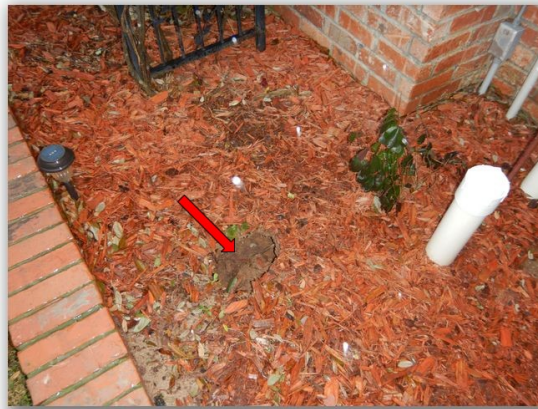
- Recommend backfilling areas of washout observed in the flowerbed near the septic system on the left side of the house.

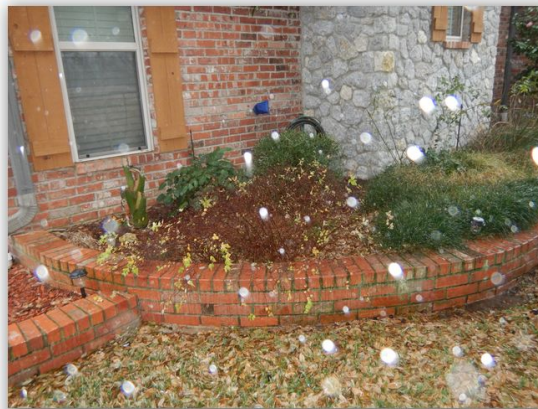
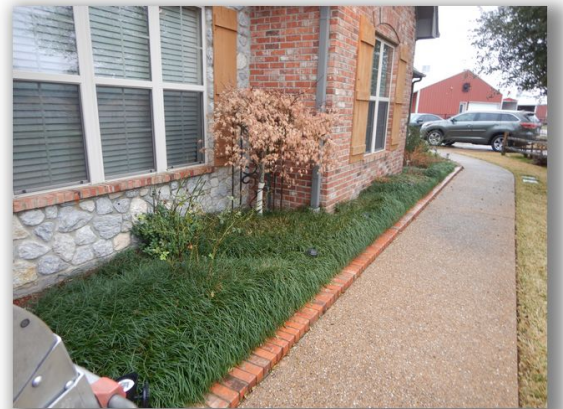
- Water runoff in the flowerbeds should be monitored. It is suspected that water may be standing in these areas at times of heavy rainfall.
- Ideally, at least 2-3 inches of clearance should be maintained between soil level and the top of the foundation walls. Improvements should be a relatively simple task

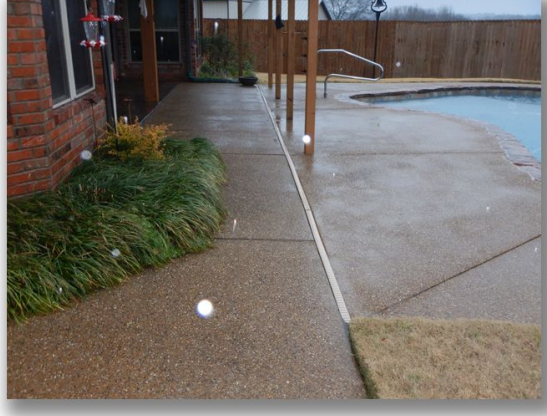
- The patio drain between the pool and rear patio area should be monitored to assure that it is performing properly. Its termination point is unknown.

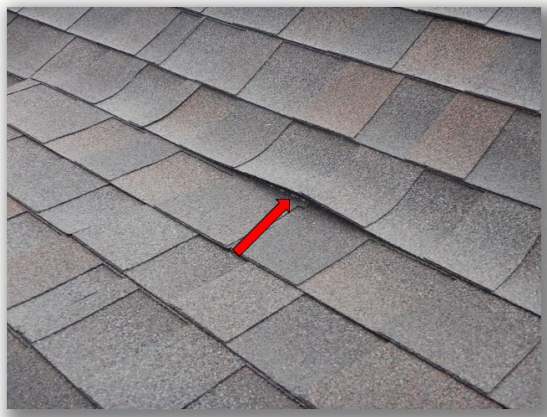
- Due to the wet/raining conditions the roof was not accessed in all areas. Most areas were viewed from a ladder at the eaves.
- The shingles appear to be in good condition. It should be noted that the roof was viewed during rainfall which hinders the ability to inspect for damages. It may be desirable to have a roof further evaluate when conditions are dry.
- Deflections/unevenness was observed to the roof decking in various areas. This condition is typically addressed at time of next roofing or if damages occur.
- A lifted shingles was observed on the back side of the house about over the master sunroom.

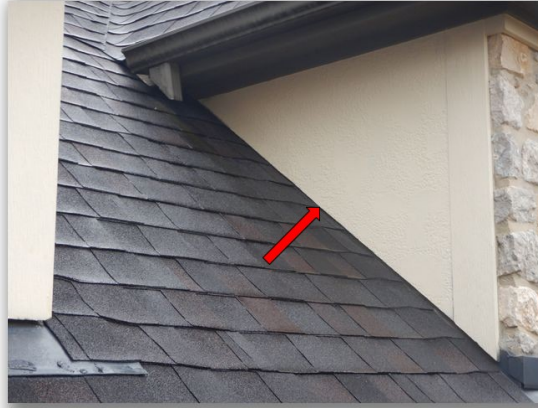
- The clearance of the siding, where it meets the roof/shingles at the front dormers, is insufficient. This condition leaves the siding vulnerable to water damages. This condition is typically addressed at time of next roofing or if damages occur.

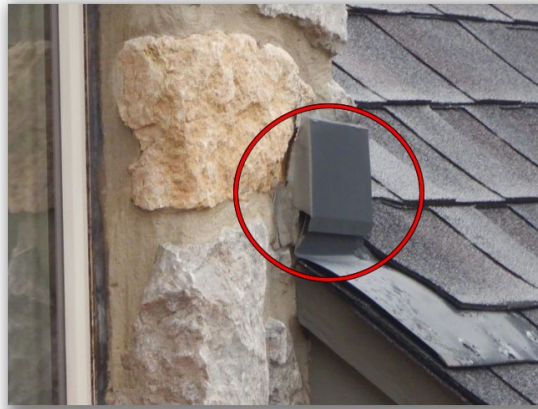
- Any missing or deteriorated sealant, observed at the flashings at the front dormers, should be replaced.

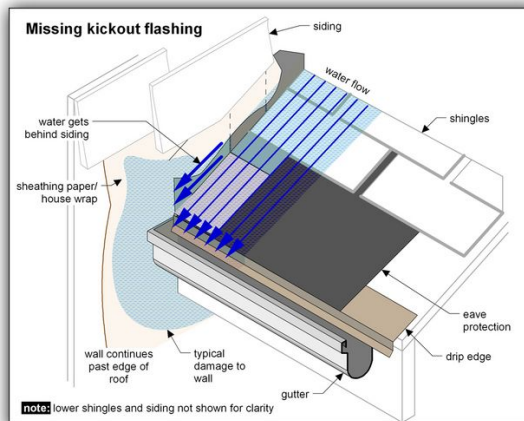
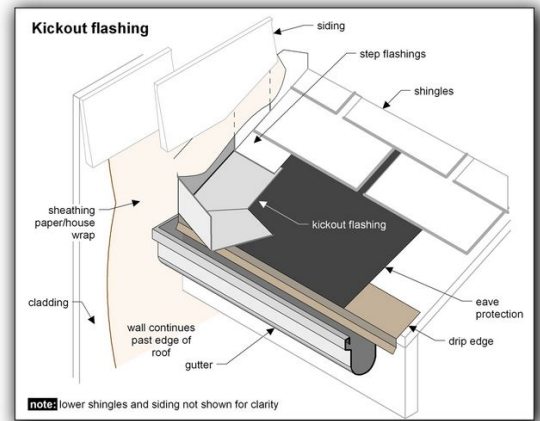
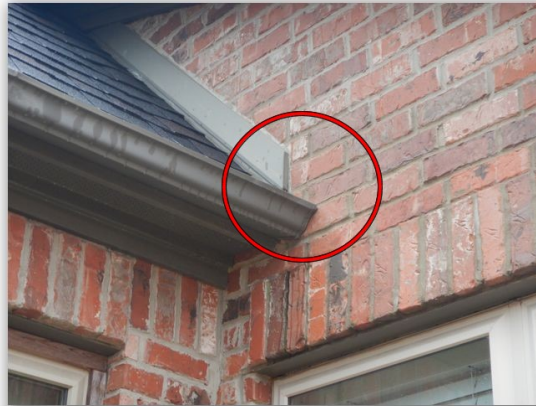
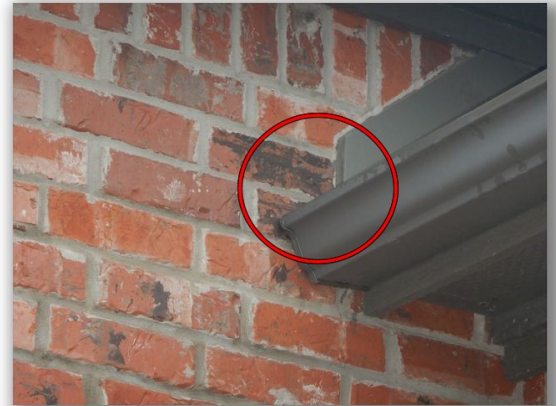
- There was no kickout flashing details observed at the lower bottom edge of the roof line interface and the sidewall that continues past the edge of the roof (various areas around the house). The lack of this kickout flashing may allow water to penetrate at these points. No significant problems were observed at time of inspection due to the absence of the kickouts.

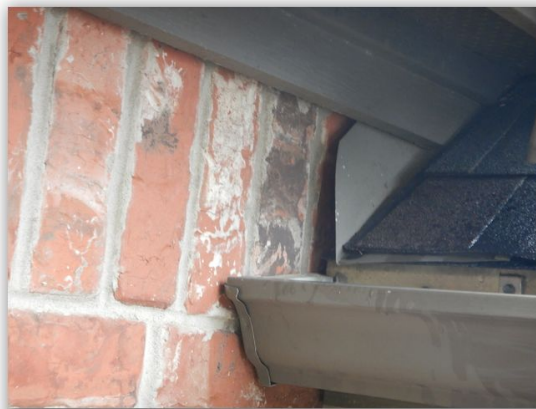
- The counter flashing should be properly installed.(observed at the front right side of the house about where the garage meets the house) This condition is typically addressed at time of next roofing or if damages occur. Until repairs are undertaken openings/gaps between the flashing and side walls should be sealed.

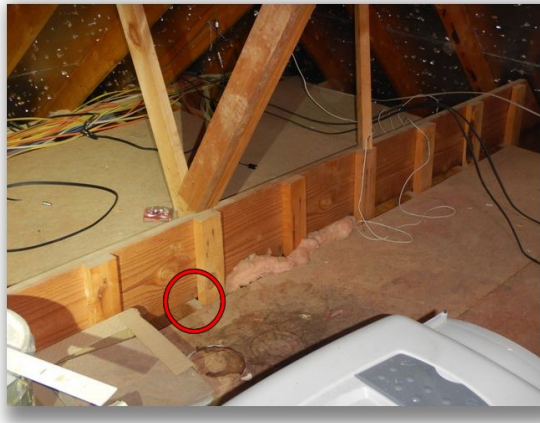
- Due to the design of the roof system and the presents of ductwork not all areas of the attic were accessible, especially the areas over the master bedroom and master bathroom
- Minor separation was observed at the ceiling joist(s) over the garage and the support beam that runs perpendicular and is attached to the joist(s). This was viewed from within the attic. The amount of movement does not suggest a significant structural problem and is common in many homes. Recommend installing proper hanger/brackets where the ceiling joists meet/attach to the beam. The rate of movement cannot be predicted in a one time inspection. This may be a contributing cause for the minor cracking observed in the garage ceiling.
- Loose hardware for the pull down stairs should be repaired/replaced as needed.

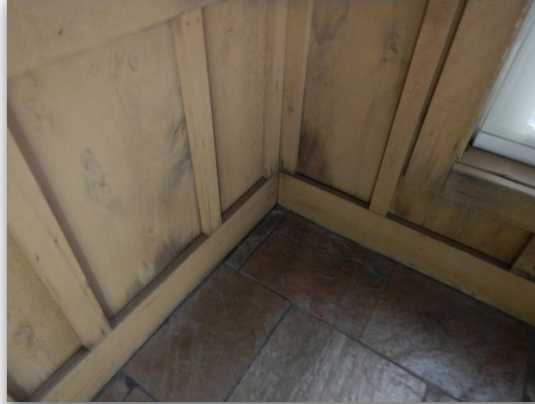
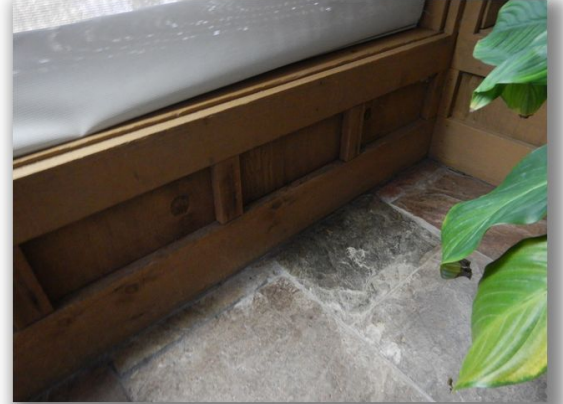
- Signs consistent with possible water stains(dark areas) were observed to the lower walls.(sunroom near master bedroom and near rear patio) The cause should be determined and repairs undertaken as needed.

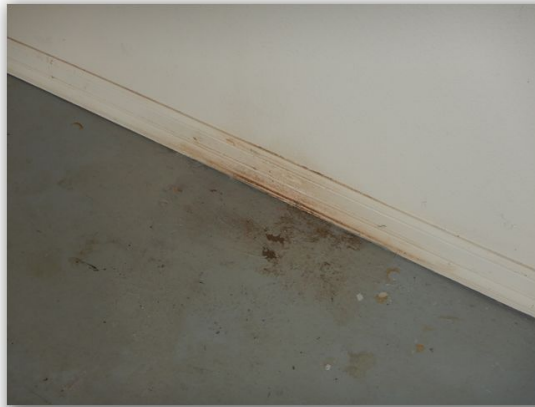
- A stain was observed on the lower wall and floor in the garage on the wall that is common with the laundry room drain/connections. This appears to be spill rather than from a leak. However, I was not able to view behind the washing machine or operate the lines/drain that connect to the washer, Further evaluation may be desired after the washer and dryer are moved.
- Walls blocked by furnishings and/or storage could not be accessed to inspect.

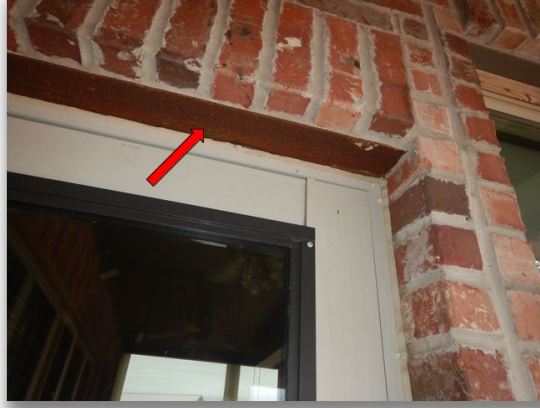
- Ideally, the lintels (in effect, a beam supporting the brickwork above a door or window) should be painted. (over sunroom exterior door, over dormer window)

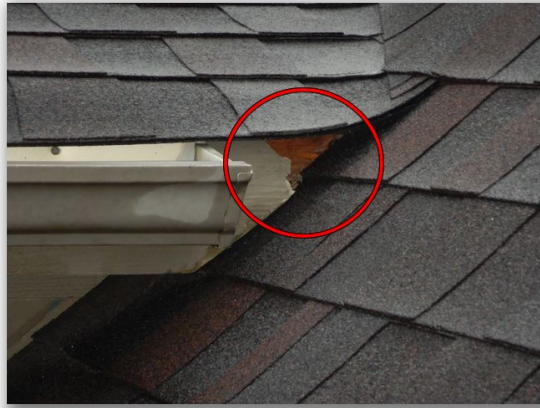
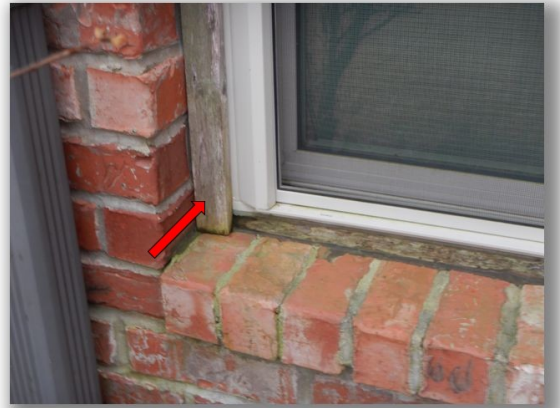
- Exposed wood should be painted.(behind the gutter on the back side of the house about over the master bedroom, trim around windows in master sunroom)
- Typical minor cracking was observed to the exterior walls of the house. This implies that some structural movement has occurred, as is typical of most building.

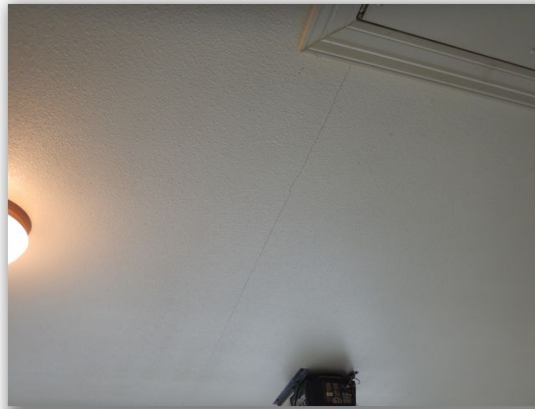
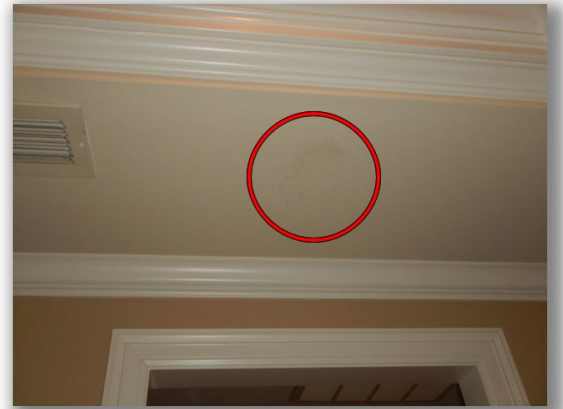
- Patching/repairs were observed in various areas. Typical of many homes this age.
- Minor ceiling cracks were observed in the garage. Minor separation was also observed at the ceiling joist(s) over the garage and the support beam that runs perpendicular and is attached to the joist(s). This was viewed from within the attic. The amount of movement does not suggest a significant structural problem and is common in many homes. Recommend installing proper hanger/brackets where the ceiling joists meet/attach to the beam. The rate of movement cannot be predicted in a one time inspection. This may be a contributing cause for the minor cracking observed in the garage ceiling.
- A stain was observed to the ceiling in the master bedroom about over the entry into the bathroom hallway. The stain appears to be from a splatter rather than a leak.

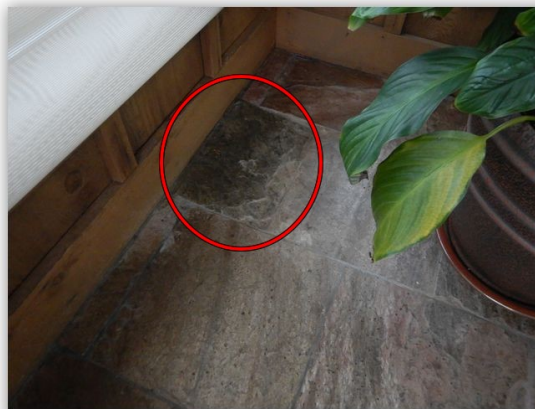
- The floor shows signs of typical wear and tear
- Water stains observed on the floor in the sunroom are suspected to be from spills rather than leaks.

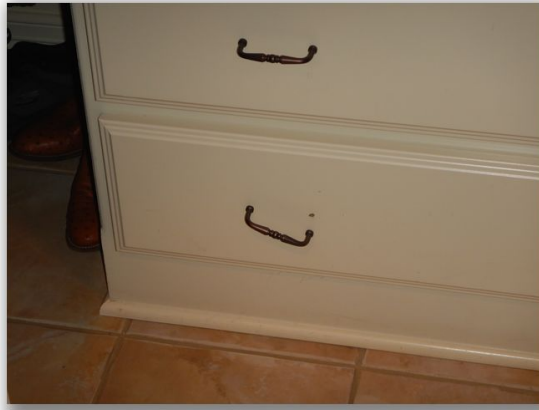
- Doors that do not stay shut when closed should be repaired/adjusted as needed. (full guest bathroom)
- I was unable to get the latch to lock on the pocket door. (3/4 guest bathroom)
- Recommend repairing/adjusting doors that do stay open on their own. (office to living room French door)
- A drawer handle is loose. (rear master closet)
- Recommend repairing/adjusting cabinet doors that strike each other when operated. (cabinet under master bathroom rear sink)

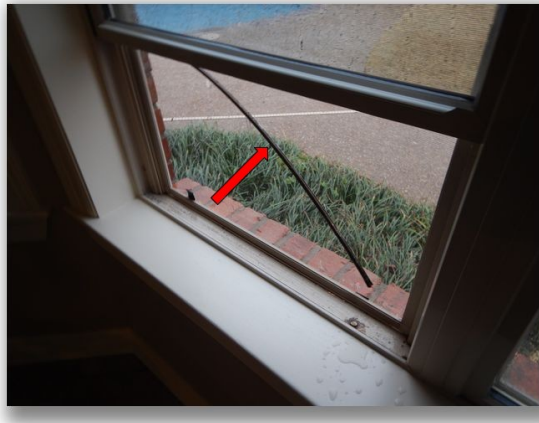
- Some of the following conditions are common in homes of this age. Some rules/guidelines may not have existed and/or been enforced at time of construction. Recommend a specialist in this field further evaluate and repairs/updates be undertaken as needed.
- Some of the windows in the home were inaccessible and could not be reached for inspection due to height, personal effects, heavy storage, furniture, etc.
- The window blinds were not inspected.
- The window guide/track mechanism was observed to be damaged and the window will not stay in the open position. (breakfast nook closest to living room)
- The lower seal on the window sash is damaged/loose. (breakfast nook furthest from living room)
- Missing or deteriorated sealant/caulk around the exterior sides of the windows should be replaced.
- Damaged window screens should be repaired. (breakfast nook, garage, front right corner bedroom)

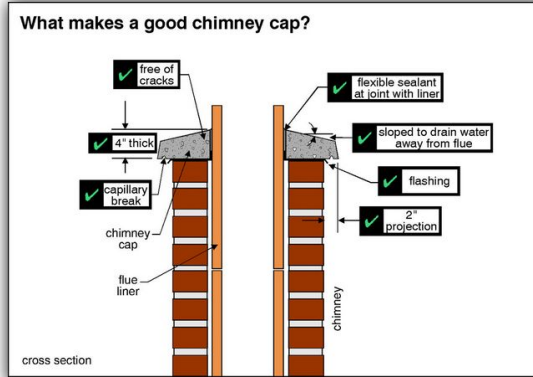
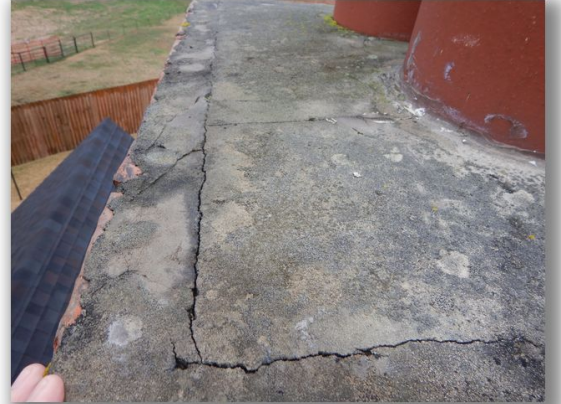
- I was unable to get the gas logs to light at time of inspection. Recommend the buyer ask the seller in regards to its proper operation or repairs be undertaken as needed.
- A rain cap should be installed.
- The roof level chimney mortar cap/crown is in need of improvement.

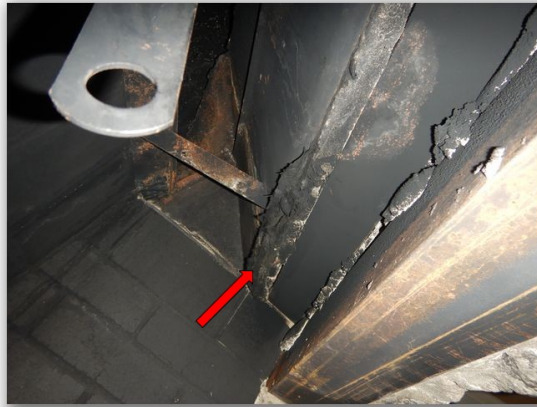
- Insulation should not be exposed at seams around the damper.

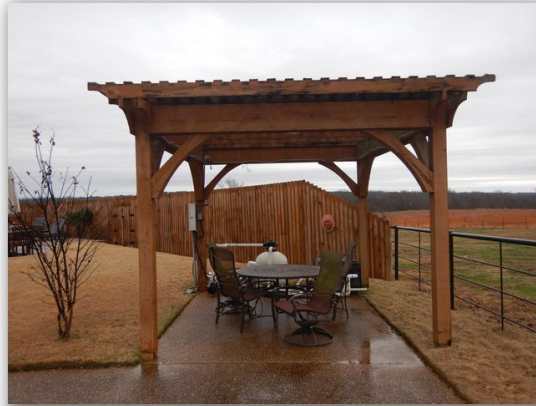
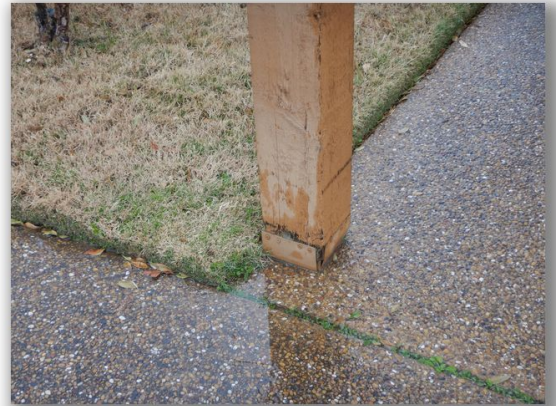
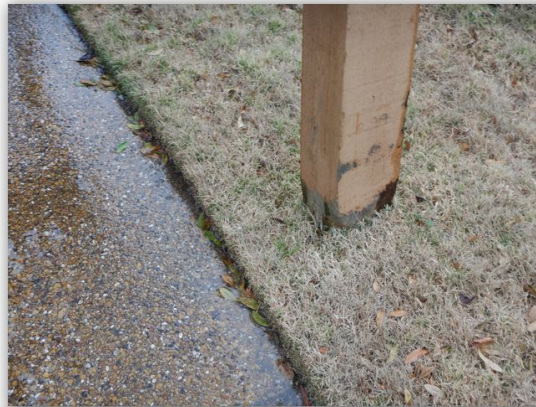
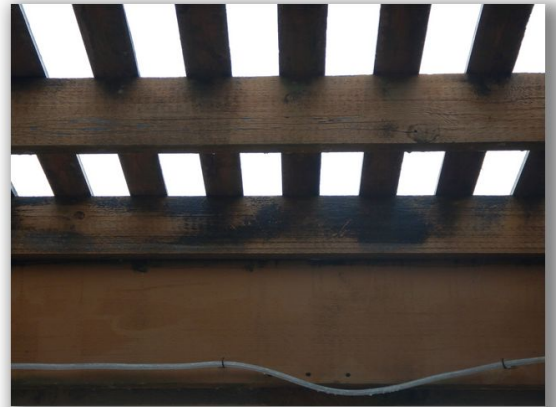
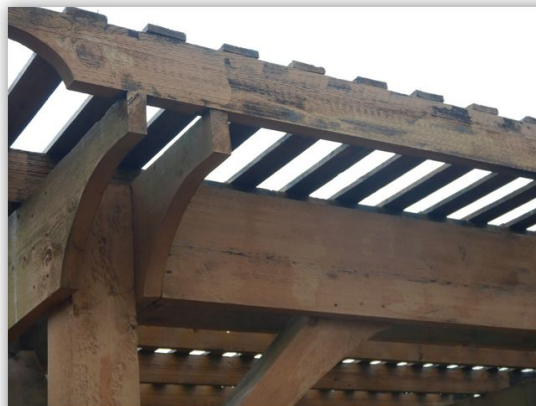
Detached Pergola

- Some damages were observed to the lower portion of the vertical post(s).
- Wood to soil contact is conducive to insect/water damages and should be corrected.
- Recommend maintaining stain/paint to increase longevity. Missing/peeling paint and staining was observed to the wood in various areas.
- Water damages were observed to the upper vertical roof boards in various areas.

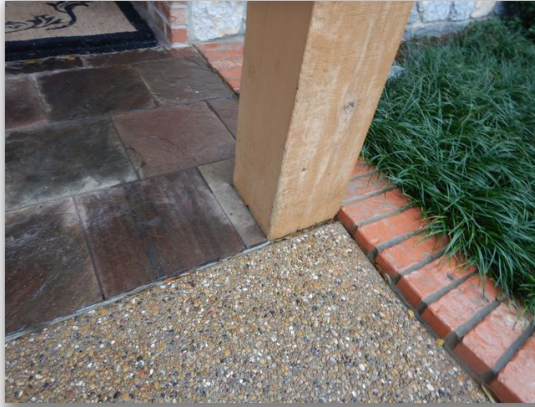
Front Porch

- Ideally, the vertical post should be supported off the ground to prevent water damages.
- Recommend maintaining stain/paint to increase longevity. Missing/peeling paint and staining was observed to the wood in various areas.
- Water damages were observed to the upper vertical roof boards in various areas.

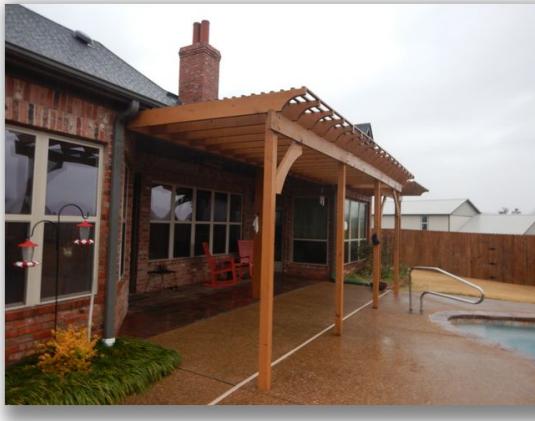
Rear Patio Pergola

- Ideally, the vertical post should be supported off the ground to prevent water damages.
- The vertical post should be better secured to the patio.
- Recommend maintaining stain/paint to increase longevity. Missing/peeling paint and staining was observed to the wood in various areas.
- Water damages were observed to the upper vertical roof boards in various areas.

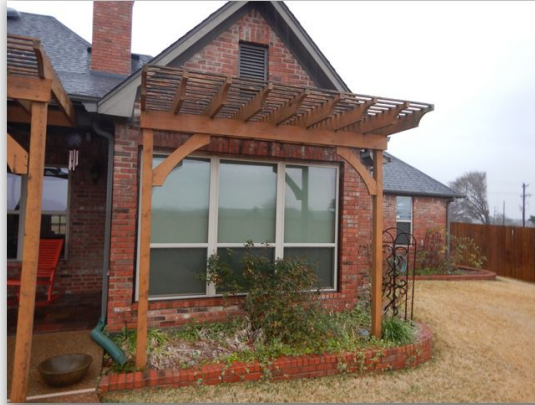
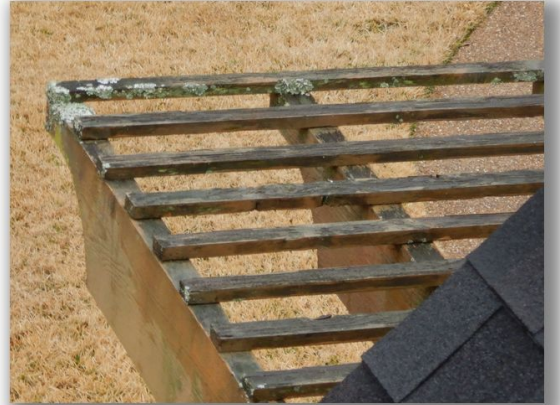
Rear Pergola Over Master Rear Flowerbed

- Ideally, the vertical post should be supported off the ground to prevent water damages.
- Wood to soil contact is conducive to insect/water damages and should be corrected.
- Recommend maintaining stain/paint to increase longevity. Missing/peeling paint and staining was observed to the wood in various areas.
- Water damages were observed to the upper vertical roof boards in various areas.

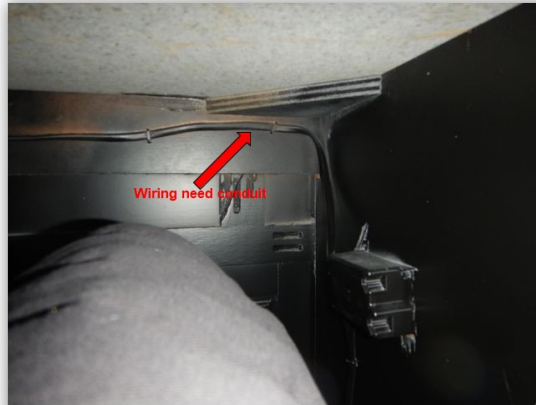
- Some conditions are common in homes of this age. Some codes/guidelines may not have existed and/or been enforced at time of construction. Recommend a licensed electrician further evaluate and repairs/updates be undertaken as needed.
- CSST (corrugated stainless steel tubing) should be properly bonded.
- Wiring exposed on interior walls should be protected by conduit. (kitchen island cabinet)

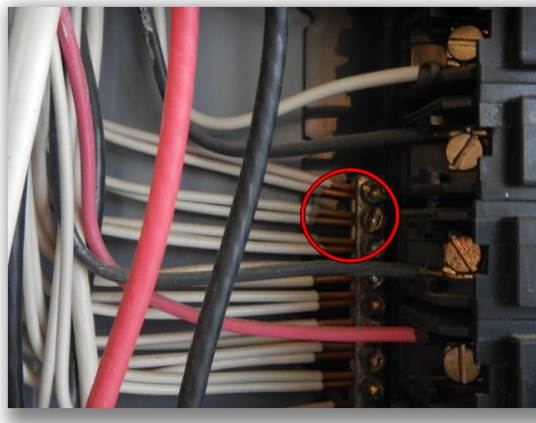
Panel Box

- Bundling/multiple neutral wires under one lug is no longer considered a standard of practice and should be updated/repaired. This condition should not be confused with multi tapped wiring at the breaker.

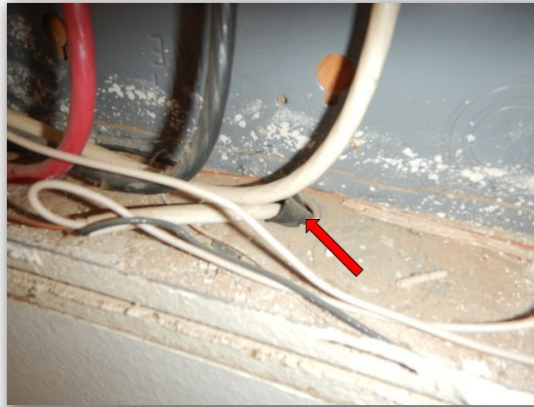
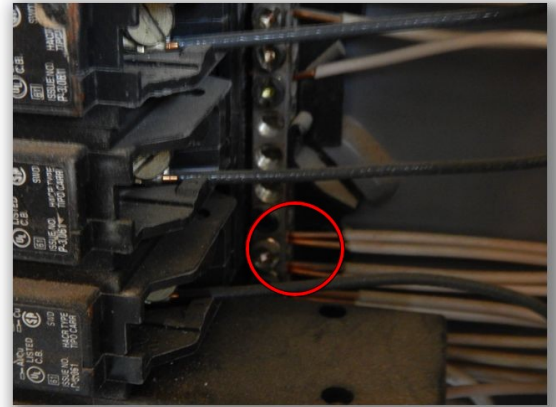
Sub Panel

- Bundling/multiple neutral wires under one lug is no longer considered a standard of practice and should be updated/repaired. This condition should not be confused with multi tapped wiring at the breaker.
- Cable clamps are required where the wires pass into panels. Cable clamps serve to protect the wiring from the sharp edges of the panel.

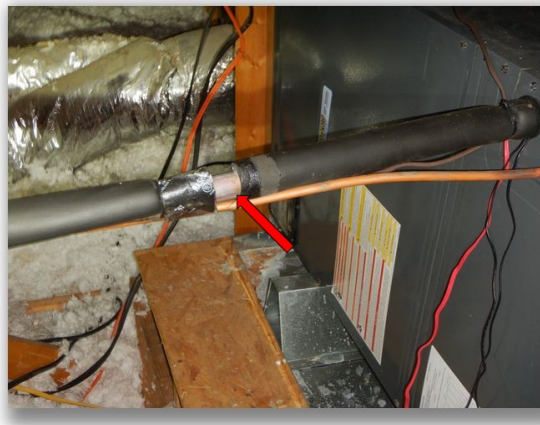
- The system was not operated due to low outside temperatures. The manufacture recommends not operating the cooling system when the outside ambient temperature is below 60 Degrees. The outdoor temperature at time of inspection was approximately 48 Degrees.
- Damaged, deteriorated and/or missing insulation on the refrigerant lines in the attic area, near the A/C system, should be repaired or replaced as necessary.

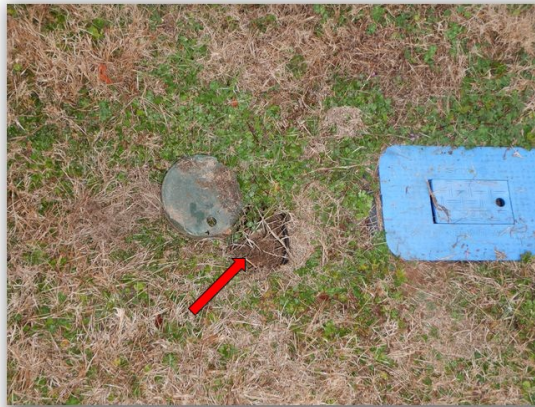
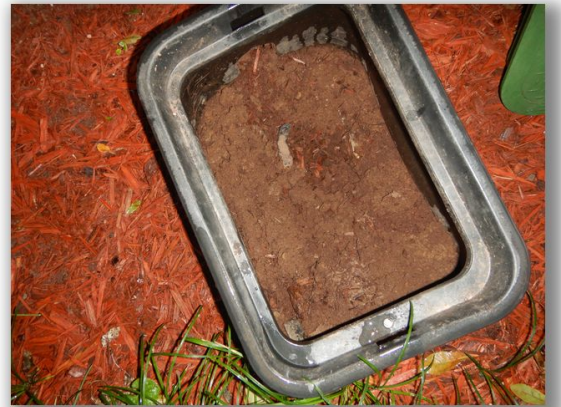
- Excessive soil in the pressure regulator box(near meter) should be removed. The damaged cover should also be replaced.
- Excessive soil in the main water supply valve box(near front hose bib on garage side) should be removed.

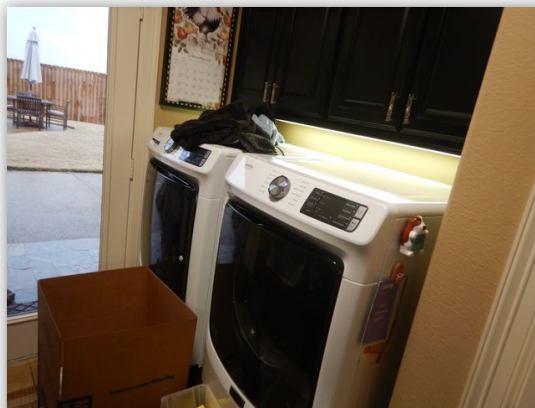
Laundry Connections & Sink

- The water lines and drain were not tested nor could they be viewed. The washing machine was in place at time of inspection.

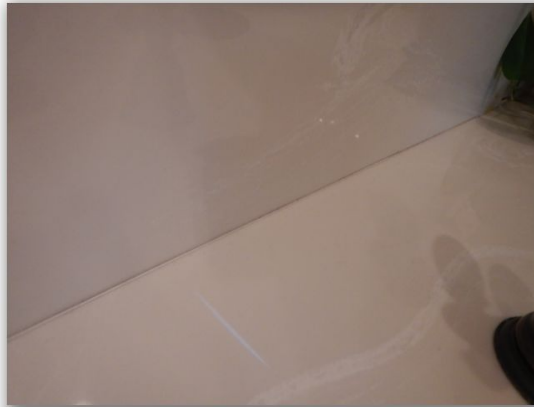
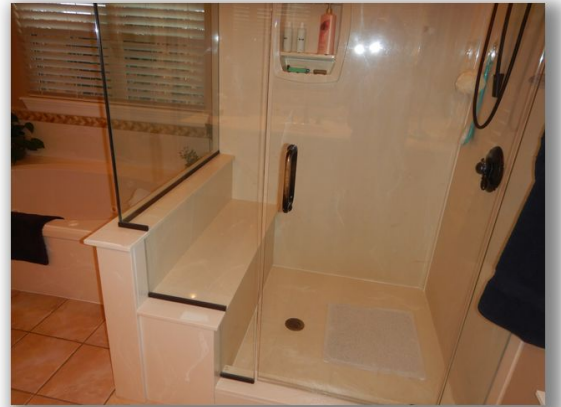
Master Bathroom

- Cracked, deteriorated and/or missing bathtub area grout and/or caulking should be repaired or replaced as necessary.
- The bathtub faucet handles are loose.(hot and cold sides)
- The design of the shower stall door is such that there is no seal between the glass door and the glass wall. If splash out occurs it may be desirable to install a seal between the the door and the glass wall.

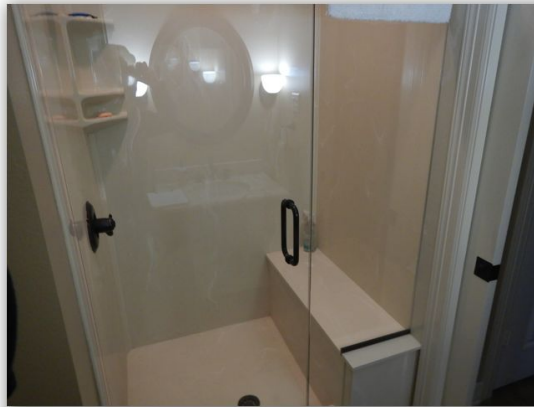
3/4 Guest Bathroom Near Office

- The design of the shower stall door is such that there is no seal between the glass door and the glass wall. If splash out occurs it may be desirable to install a seal between the the door and the glass wall.
- The lower seal for the shower stall door is missing.
- The shower area hot /cold water lines are reversed and should be repaired.

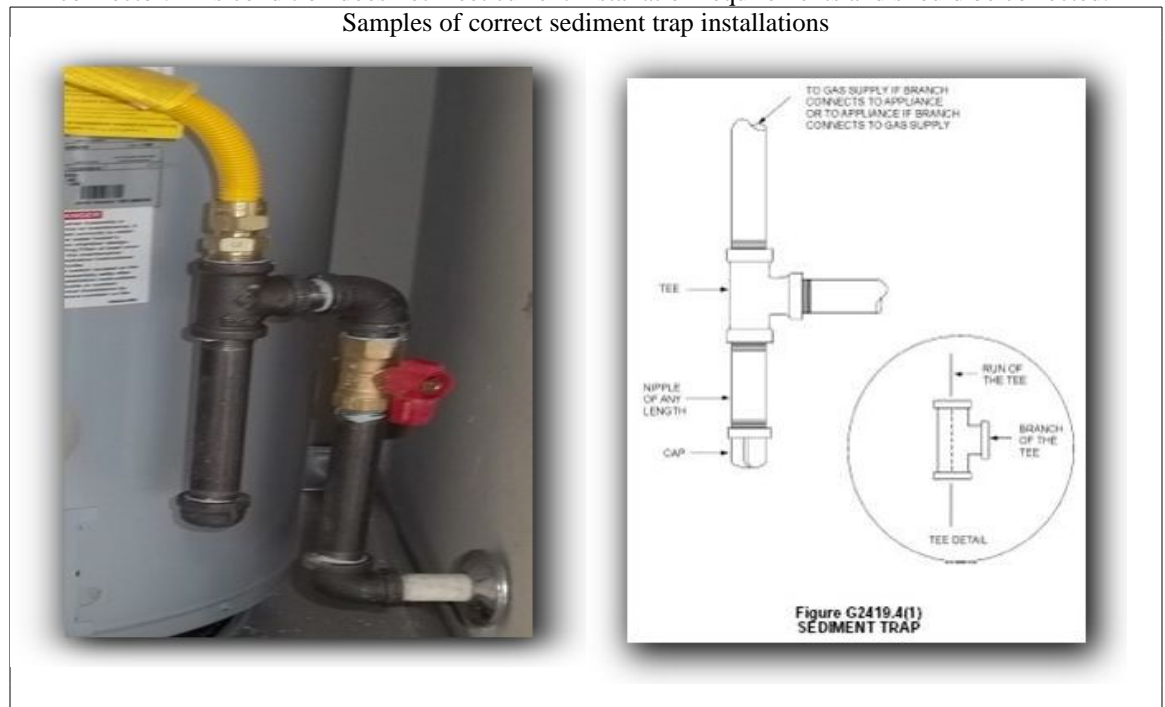
Samples of correct sediment trap installations

- Some of the following conditions are common in homes of this age. Some rules/guidelines may not have existed and/or been enforced at time of construction. Recommend a licensed plumber further evaluate and updates/repairs be undertaken as needed.
- The water heater gas supply line is not equipped with a sediment trap just before the gas appliance connector. This condition does not meet current installation requirements and should be corrected.

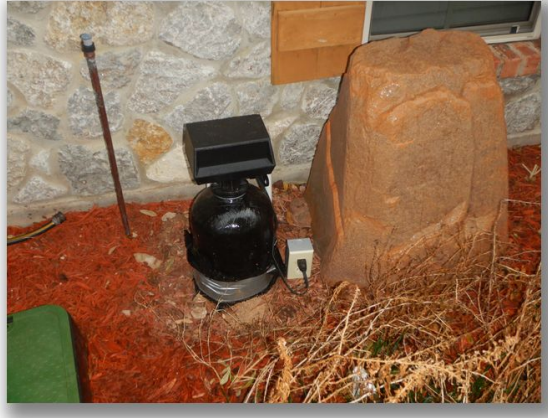
- The water filtering systems, observed partially buried into the ground in the front flower bed on the garage side of the house and under the laundry room sink, were not inspected. Recommend the buyer ask the seller and/or a professional in this field in regards to the proper operation and maintenance of the systems.

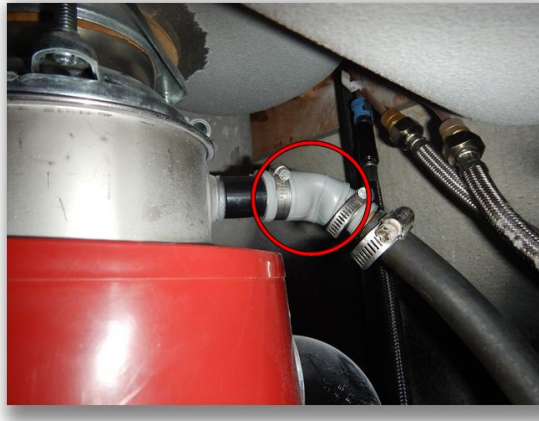
- The dishwasher drain hose is not properly installed to prevent back flow or anti-siphoning. It is recommended that an air gap device or high drain loop be installed in the drain line.
- The drain hose is kinked where it attaches under the sink. The unit did appear to be draining properly
