FOUR POINT INSPECTION

333 Turquoise Terrace
Jensen Beach, FL 34957

JUNE 21, 2024

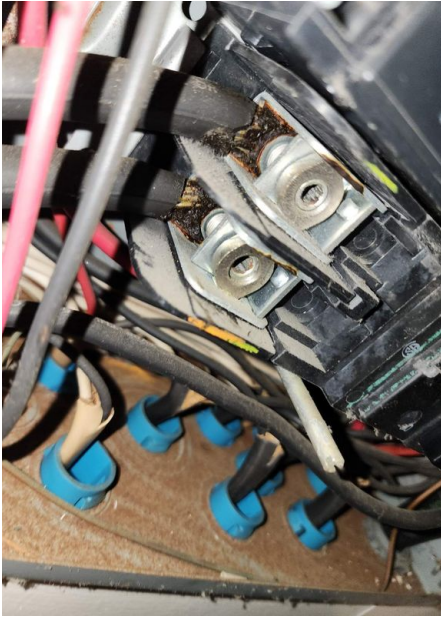
Main feed wires

Multi-Strand Aluminum
