Home Inspection Report

809
Lincoln
Coffeyville, KS 67337

Inspected By: Mark Brock

Inspected On Mon, Nov 4, 2024 at 9:07 AM

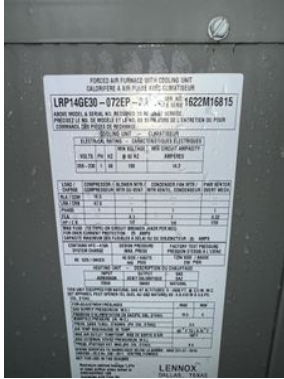
Comment 2 Deficiency

2022 both work good

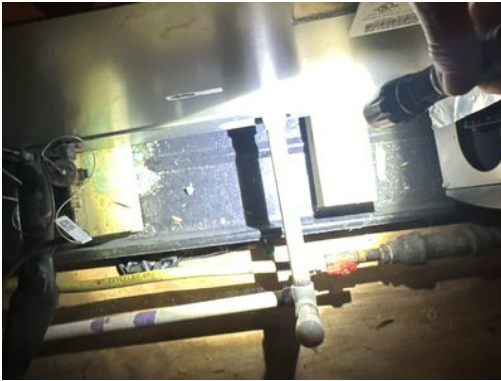
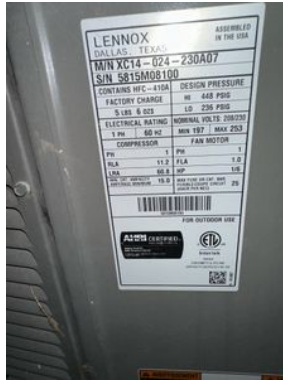
Comment 3

Missing secondary drip system or alarm shut off in the attic unit

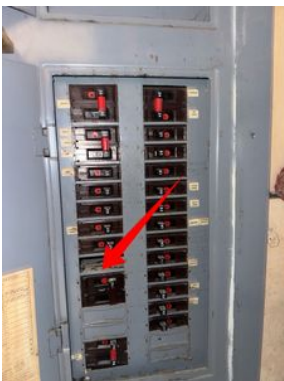
Comment 4

Missing breaker

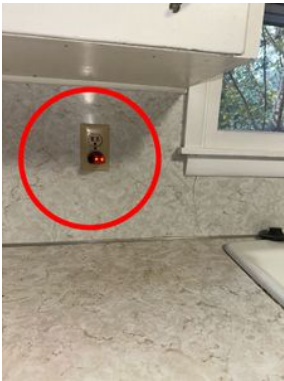
**Comment 5
Deficiency**

Counter top outlets are not gfci protected. Exterior wiring in the portable shed is not GFCI protected overall wiring appears to have been updated from knob and tube several years ago.

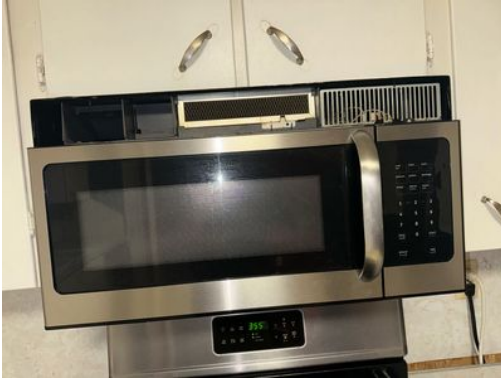
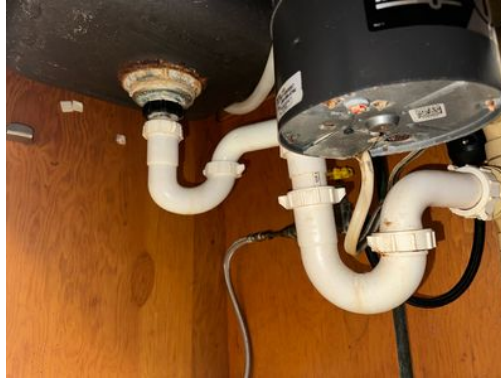
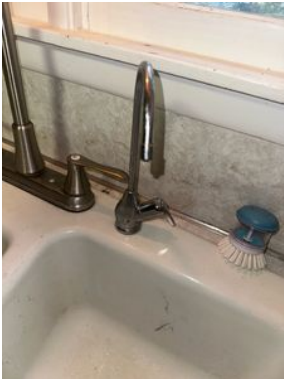
Comment 6 Deficiency

Microwave not working Filtered water not active. Dishwasher loose

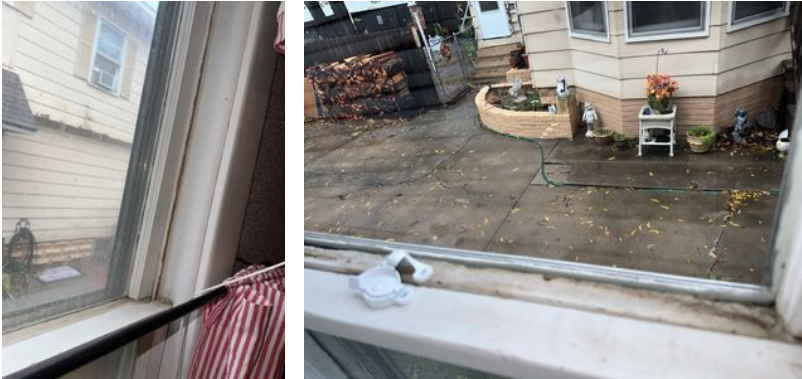
**Comment 7
Deficiency**

Several stays broken. Many screens missing pieces

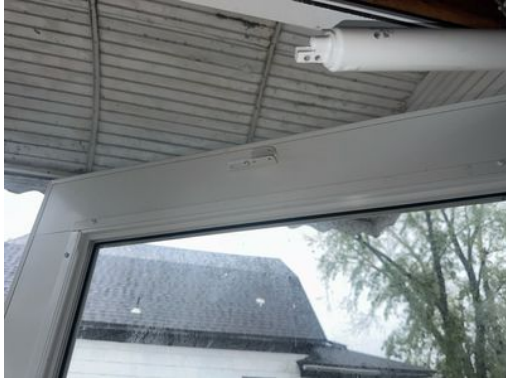
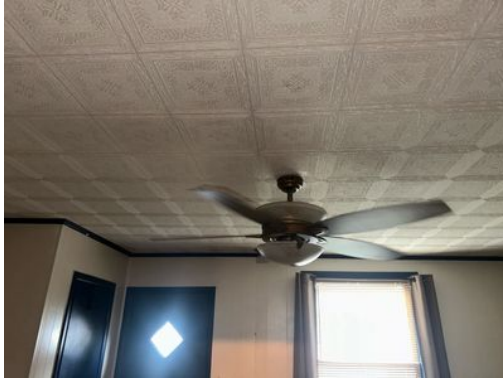
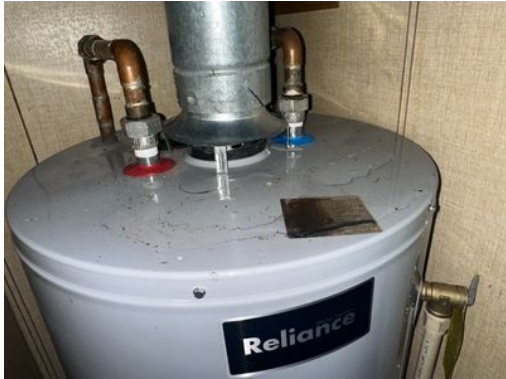
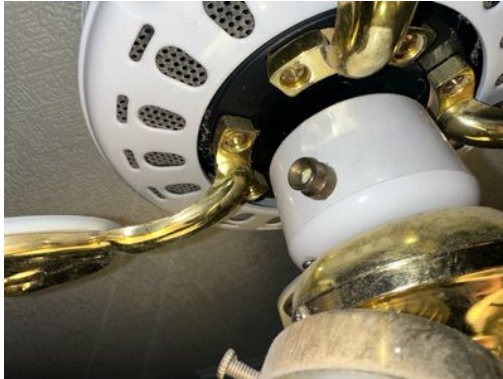
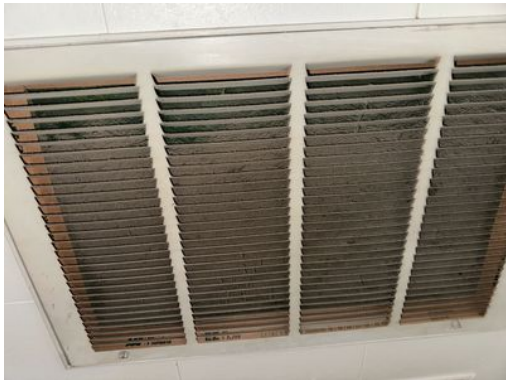
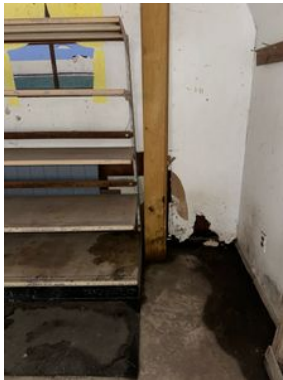
Comment 10
Information

Fan in south room wired wrong, light in utility room wired wrong. no remote. Water drip in tank closet. Attic fan not working. Overall well-built well kept Property in a nice location, normal findings for age and size.
