### HOME INSPECTION IB36

1229 Avondale Ln West Palm Beach, FL 33409

> Lionel & Sylvie Sevrain 05/10/2025

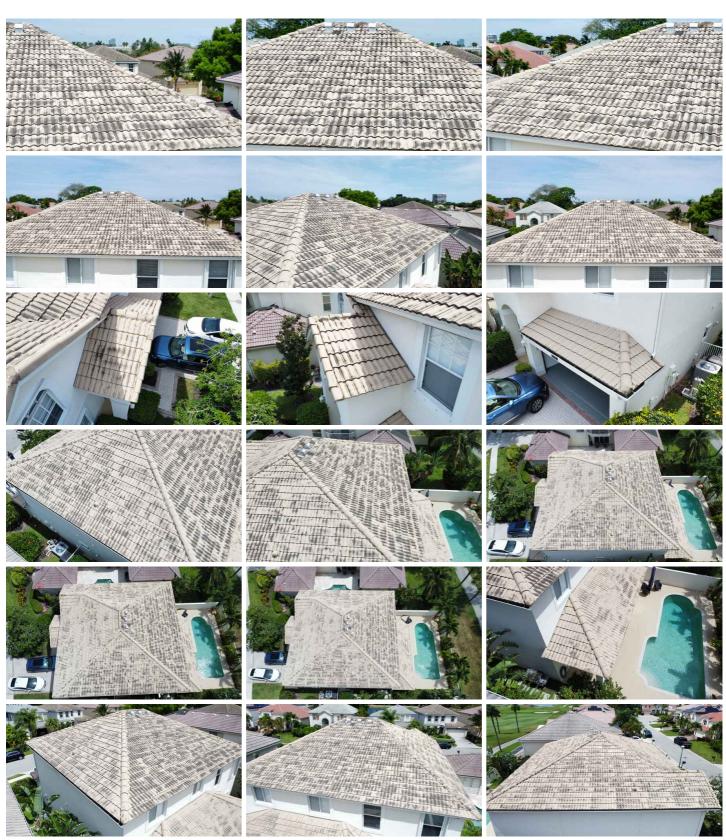
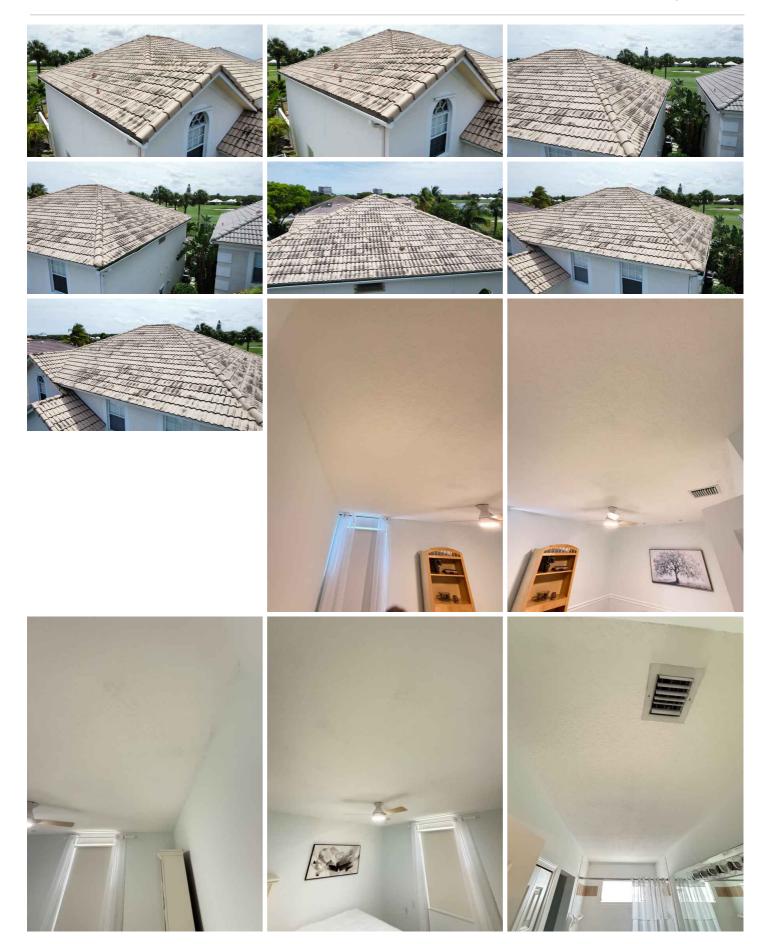
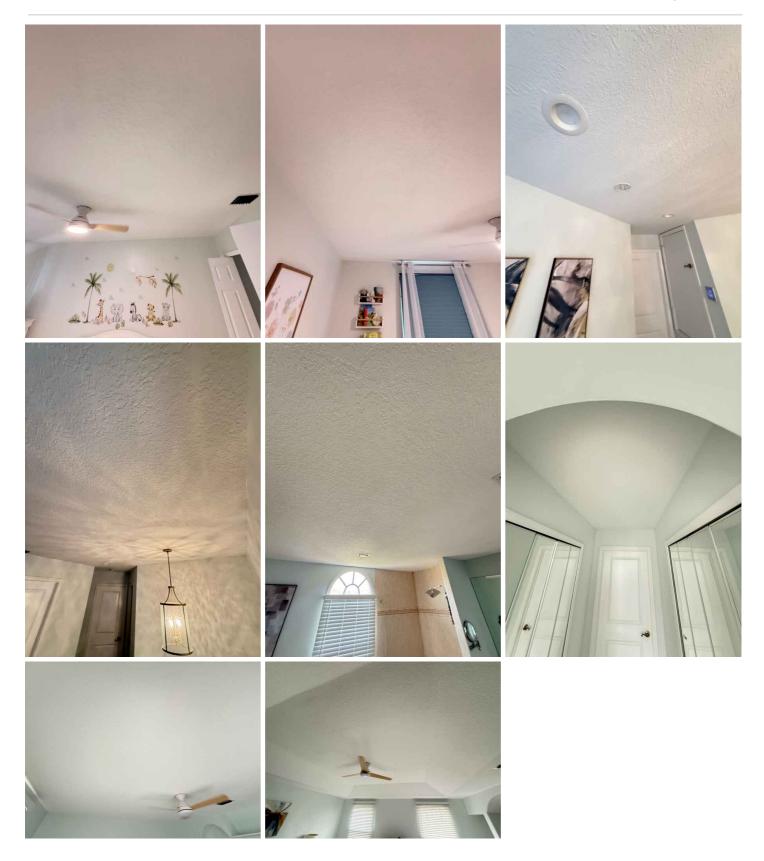
# 2.2.1 Type of Covering **CONCRETE TILES NOTED**

The inspector observed no deficiencies in the condition of the roof structure exterior, however the roof needs a pressure wash
