3301 Ricci Ln
Irving, TX 75062
Report ID:20261003-0013301 Ricci Ln

PROPERTY INSPECTION REPORT FORM

Pat Starkey <i>Name of Client</i>	03/10/2026 <i>Date of Inspection</i>
3301 Ricci Ln, Irving, TX 75062 <i>Address of Inspected Property</i>	
William Lee <i>Name of Inspector</i>	6983 <i>TREC License #</i>
<i>Name of Sponsor (if applicable)</i>	<i>TREC License #</i>

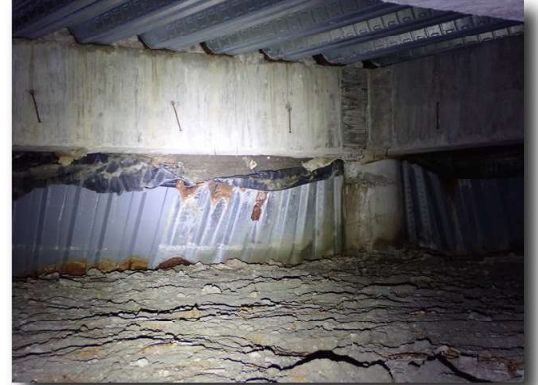
- The skirting has a couple area where it is starting to fail - one under the garage and the other by the front entry

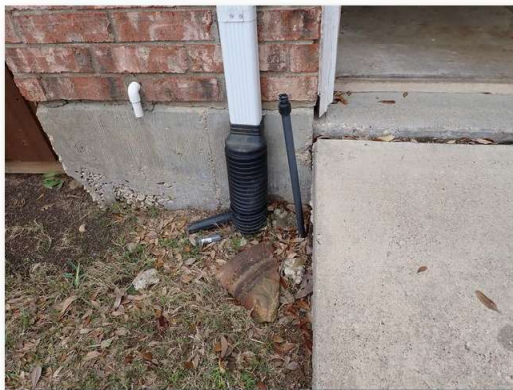
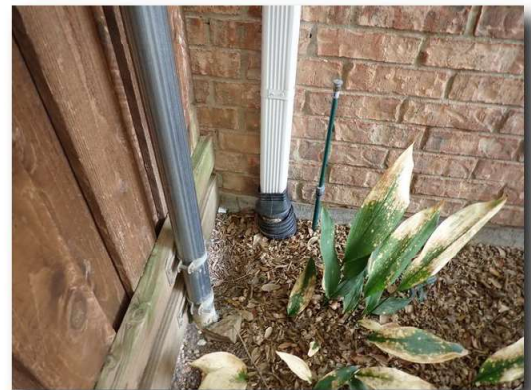
Obvious or ongoing drainage problems were observed around the perimeter of the structure during the inspection at the front flower bed. The IRC states there should be a minimum fall (slope) of 6 inches away from the foundation for the first 10 feet from the house. Monitor site drainage condition over time, especially during rainy weather, and have correction or improvements made if needed. Poor drainage can cause foundation movement, water penetration or attract termites/pest. Avoid landscaping which promotes slow water drainage.

Solutions to drainage problems are as varied as the terrain, and may include rain gutters and gutter extensions, French drains, swales and berms, retaining walls, catch basins and even sump pumps. With a little planning and some work, almost any yard can provide a healthy environment for a stable foundation, a dry house, and control of mosquitoes.

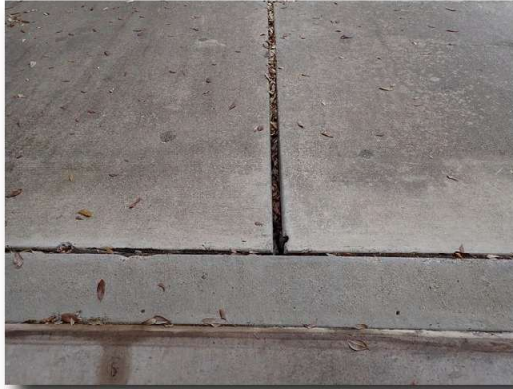
- At the joint where the garage and driveway meet, there is a gap that should be properly sealed to prevent water and debris intrusion. Sealing this area helps protect against water infiltration beneath the driveway, which can erode the supporting soil and compromise the stability of the driveway over time.

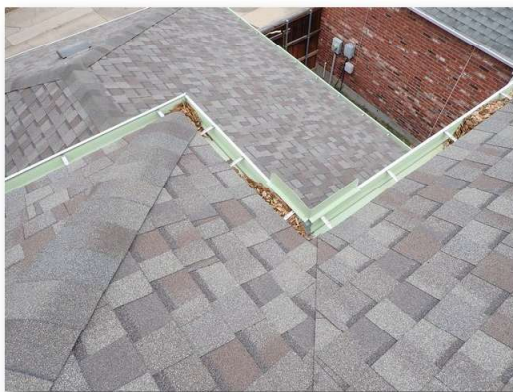
- There is excessive leaves and other debris present on the roof gutters. This material should be removed as soon as possible to prevent any damage.

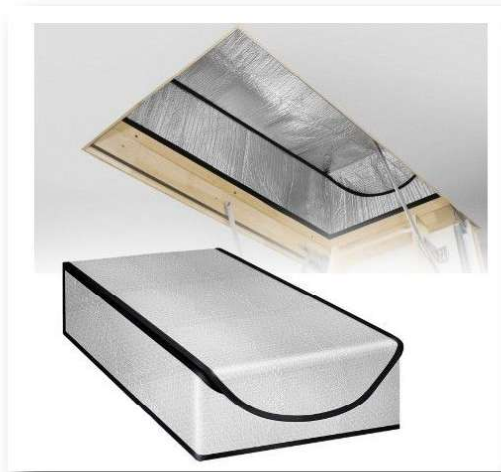
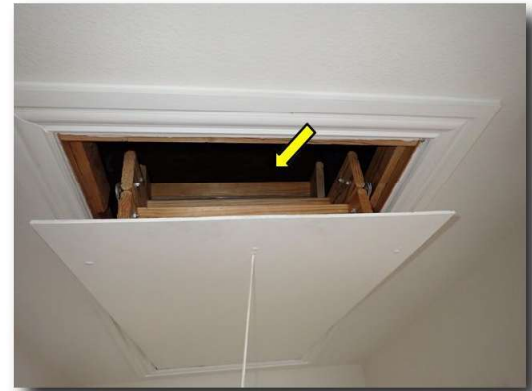
- The attic access opening is located within the conditioned portion of the home and does not appear to be adequately air-sealed or insulated. When an attic access opening is located within the conditioned space of the structure, it is recommended that the access door be properly air-sealed and insulated. An unsealed or poorly sealed attic access can allow significant air leakage between the conditioned living space and the unconditioned attic, contributing to energy loss, reduced indoor comfort, and the potential for moisture migration. Current best practices include installing a weather-tight, gasketed access cover or an insulated attic access “tent” designed to create an effective air and thermal barrier. These products help limit air infiltration, reduce thermal transfer, and improve overall energy efficiency. Installation or upgrades should be performed by a qualified contractor as needed.

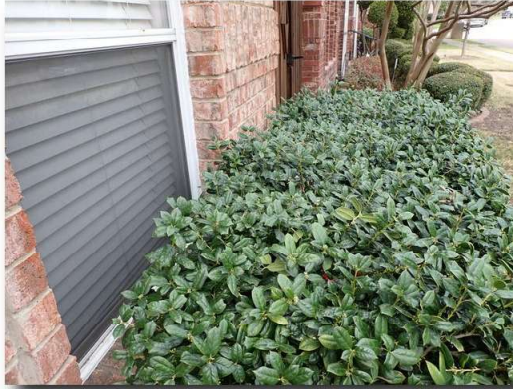
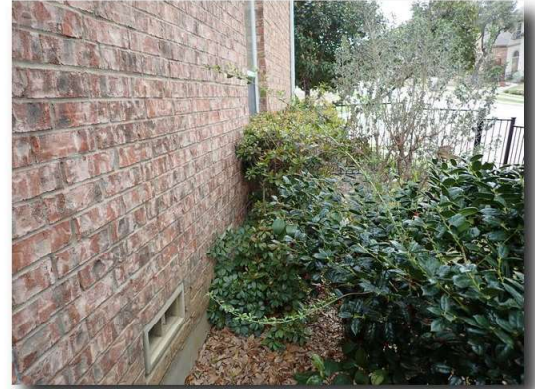
- The exterior walls consist of: Brick and Siding
- **There is vegetation in direct contact with the exterior of the structure.** All vegetation should be trimmed back 3 to 5 inches from the structure. To minimize wood rot and potential insect damage in siding and trim, allow air to freely circulate next to the house. This is typically accomplished by locating decorative plants several feet away from the exterior walls and keeping them trimmed.

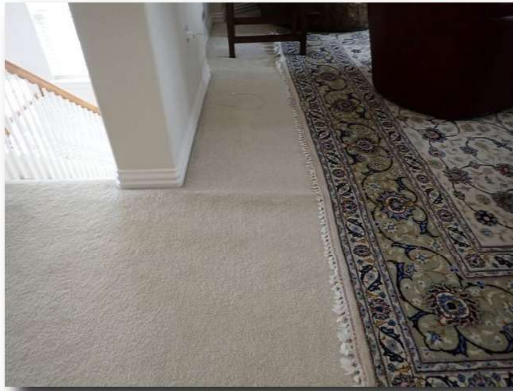
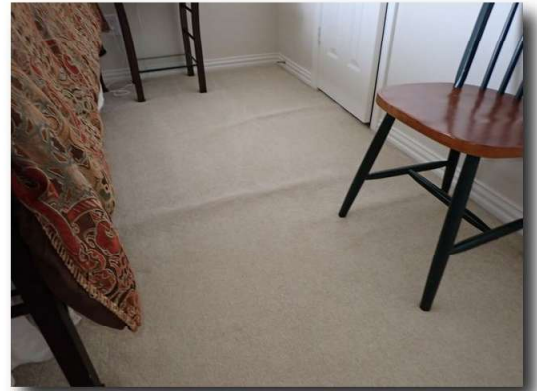
- The brick walls need to be cleared of paint at the upstairs balcony.

- All floors areas showed to be in acceptable condition at the time of the inspection.
- The upstairs living room and bedrooms have carpet loose and needs to be re-stretched.

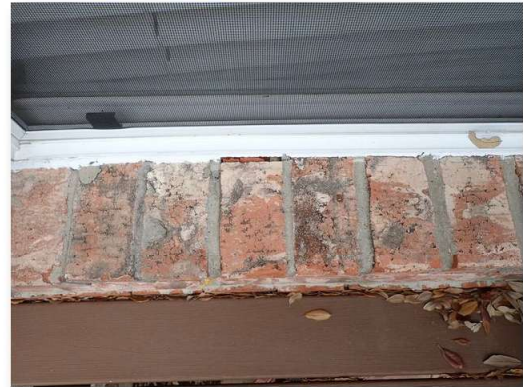
Upstairs patio

- There are a few windows that have minor caulking needs.

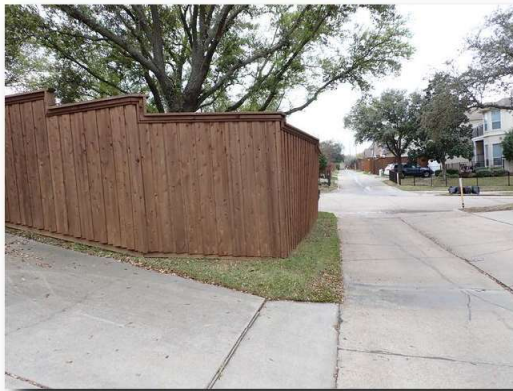
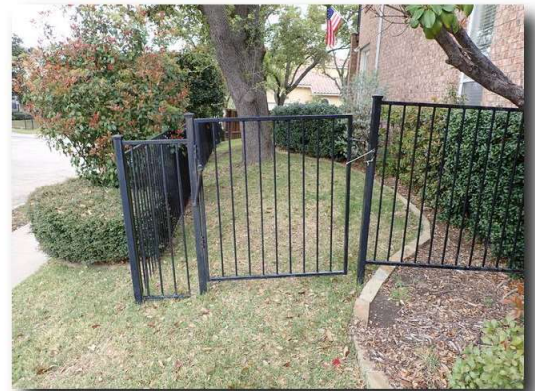
While perimeter fencing is not typically within the scope of a residential home inspection, several sections of the fence were observed to be damaged and/or deteriorated. In its current condition, the fence may not be adequate for securely containing a pet. Repairs or replacement of the affected sections are recommended to restore functionality and safety.

- The fence surrounding the property is leaning and there are several section that need to be straightened.

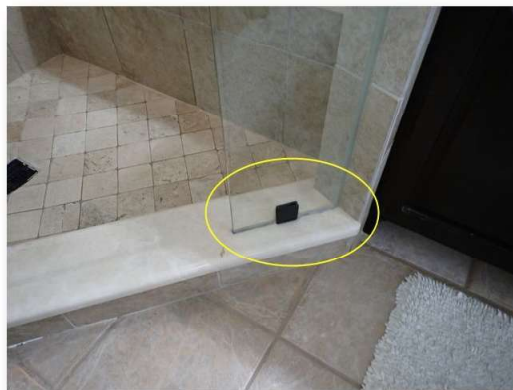
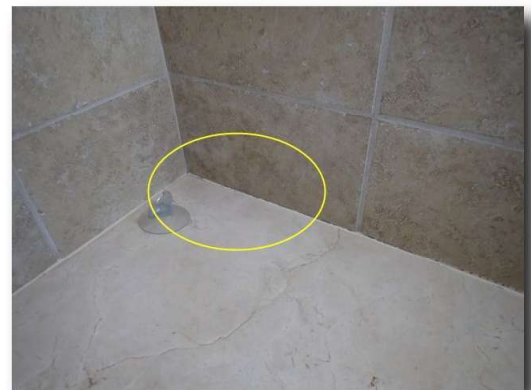
The master bathroom:

- Shower door - section of glass at bottom is loose
- Shower enclosure has caulking needs

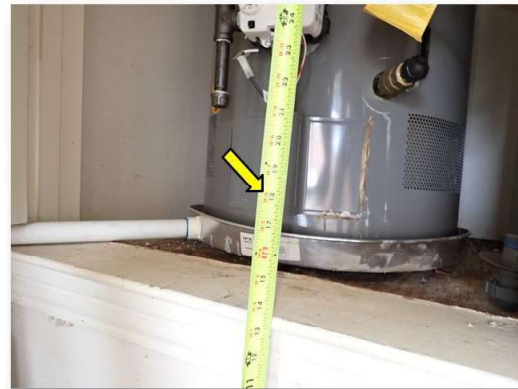
IRC G2408.2 / G2406.2 states gas-fired water heaters installed in garages must be installed so that the ignition source (burner, pilot, or heating element) is at least 18 inches above the garage floor. This requirement is intended to reduce the risk of igniting flammable vapors from gasoline or other chemicals commonly stored in garages.

The TREC Standards of Practice §535.231(b) specifically require inspectors to report as Deficient units where the ignition source *or heating elements* of a water heater in a garage are not a minimum of 18 inches above the lowest garage floor elevation, unless the unit is listed for garage-floor installation (FVIR).

- The unit is not 18 inches above the ground.

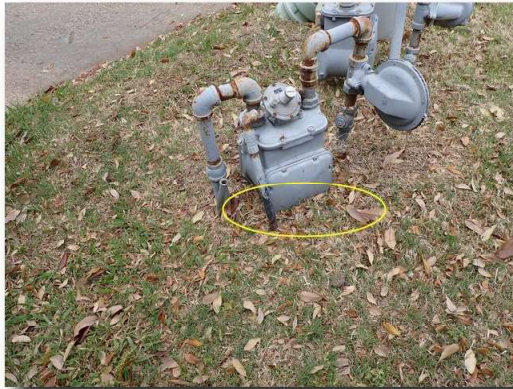
- The outside meter base should NOT be in contact with the ground (4 inch clearance minimum).

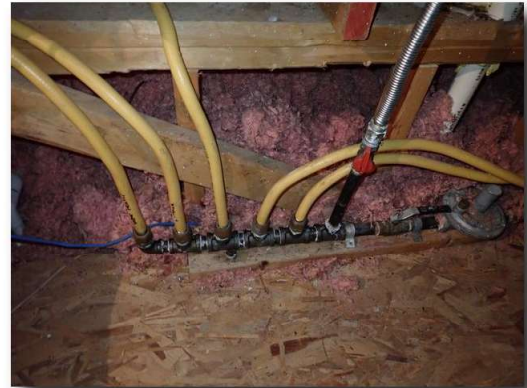
Example of proper bonding

The gas supply piping in the home is Corrugated Stainless Steel Tubing (CSST). This material has a slight risk of developing leaks during lightning storms. CSST is conductive as is copper and it also terminates into the ground as does the grounding system of the electrical system. Should the electrical system become super charged during an indirect lightning strike, there is a possibility that the grounding conductor of the Romex line will arc to the CSST when they are located together.

This arcing is the problem because CSST is so thin, a hole can easily be burned into the pipe. As part of a Class action settlement, a mandatory installation procedure was developed whereas the electrical grounding system and the gas piping system are to be bonded together to prevent arcing.

- There is Corrugated Stainless Steel Tubing present in the attic and there is not visible grounding at the gas manifold.
