# Home Inspection Report

720 Third Road, Grand Island, NE 68801

KYH26C27B

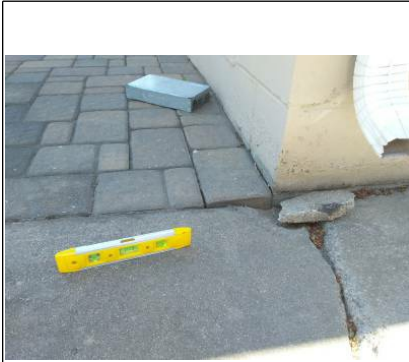
**Comments** Exterior North central w alkway cracked and settled and pitched toward the house; recommend repair or replacement of damaged section(s).  
Gaps between walkway and house; recommend sealing to prevent water penetration.  
Other walkways cracked and settled, but usable; recommend filling crack(s) and sealing and repair or replacement of damaged section(s) as needed.

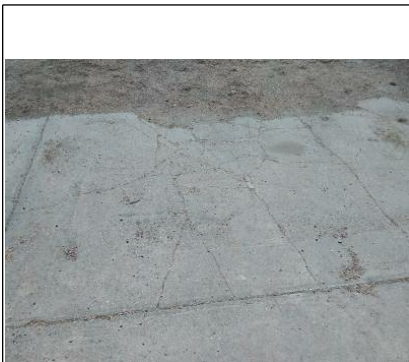
Southwest

**Comments** Driveway cracked and settled and breaking up in some areas, but usable; recommend filling crack(s) and sealing and repair or replacement of damaged sections as needed.

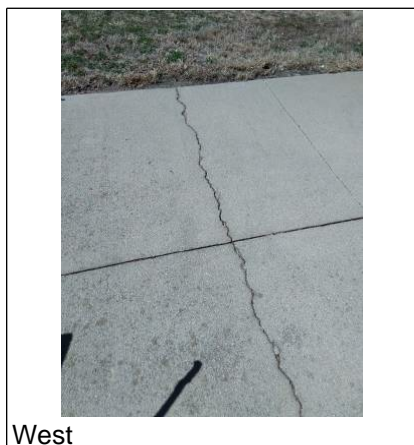
West

Patio cracked and settled, but usable; recommend filling crack(s) and sealing to prevent water penetration.

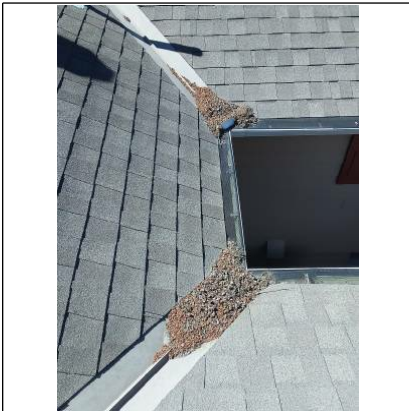
North central

Debris restricting drainage of roof valleys; recommend cleaning .

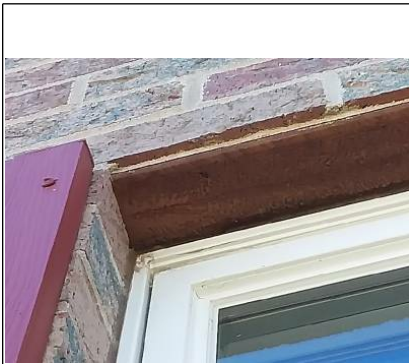
East

Steel lintels above door and window openings rusted; recommend painting to prevent brick damage.

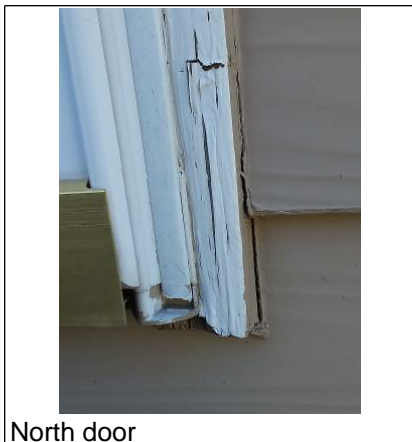
North door

**Comments** Peeling paint at the North door; recommend normal painting maintenance for wood trim.

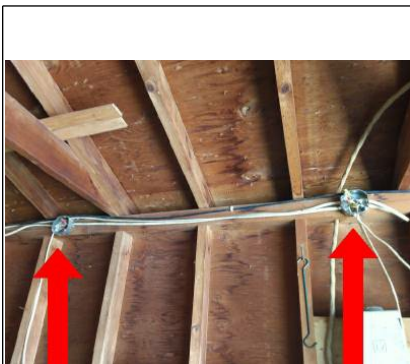
**Comments** Covers not present on East wall junction boxes; recommend installing for improved safety. As a safety improvement opportunity, recommend installation of GFCI style receptacle(s) or circuit breaker(s) to meet current recommendations.

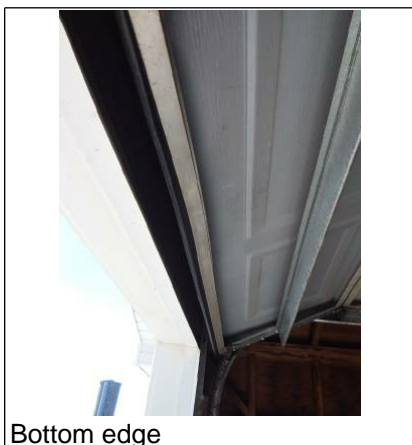
**Comments** Garage vehicle door damaged/bent, but operable; recommend repair or replacement as desired.

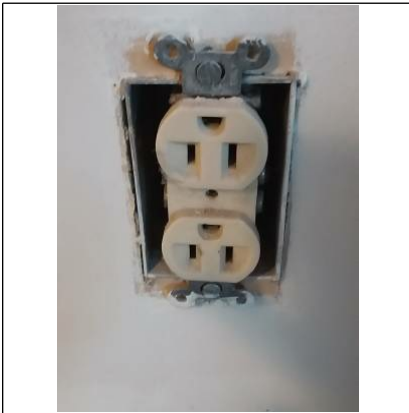
**Comments** Appliances only tested for operation, working or not. Quality or extent of operation not part of testing or inspection.  
 Cover not present on West central wall outlet box; recommend installing for improved safety.

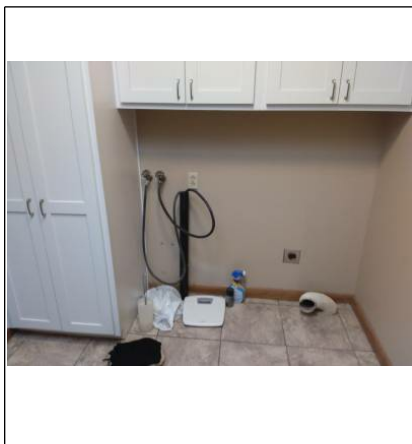
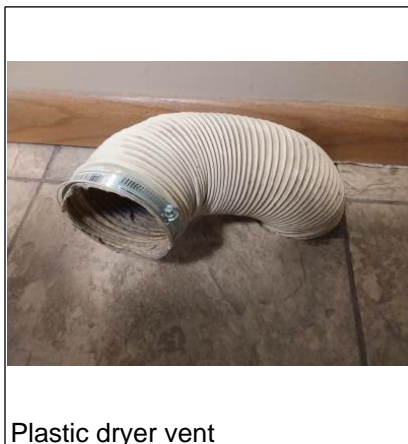
**Comments** Plastic dryer vent present; recommend replacing with an approved material for improved fire safety. As a safety improvement opportunity, recommend installation of GFCI style receptacle(s) or circuit breaker(s) for all locations within 6 feet of water to meet current recommendations.

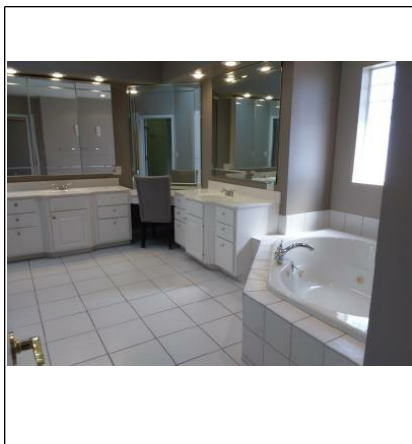
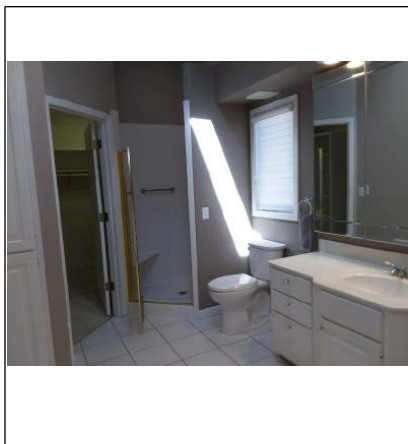
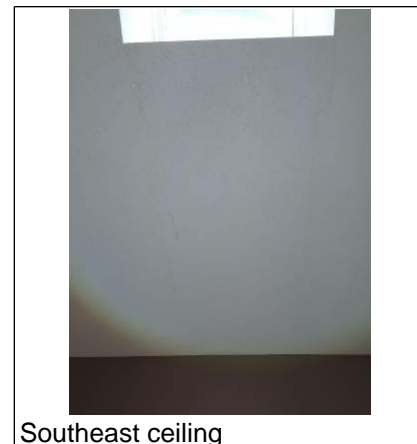
Southeast ceiling

- Heat Source Present**  Yes  No
- Door(s)**  None  N/A  Satisfactory  Marginal  Poor
- Window(s)**  None  N/A  Satisfactory  Marginal  Poor
- Comments** Moisture stains on the Southeast ceiling; no excess moisture detected during the inspection.

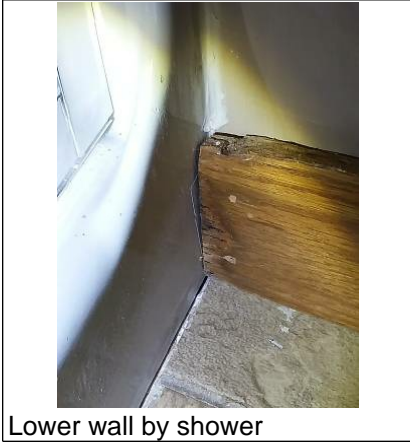
Lower wall by shower

**Comments** Moisture stains on lower wall by the shower; no excess moisture detected during the inspection.  
 As a safety improvement opportunity, recommend installation of GFCI style receptacle(s) or circuit breaker(s) for all locations within 6 feet of water to meet current recommendations.

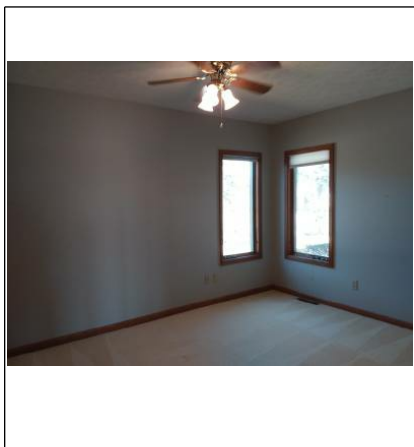
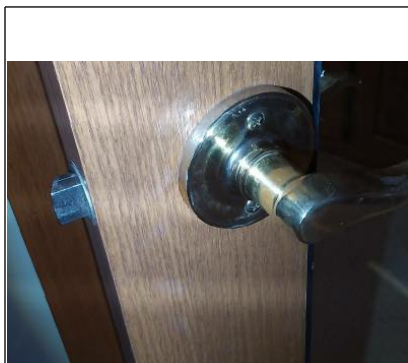
**Comments** Entry door knob/latch not lockable; recommend replacement as desired.

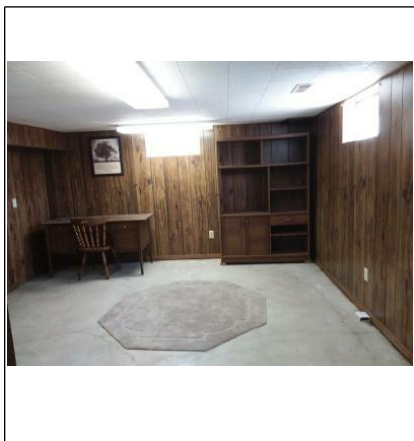
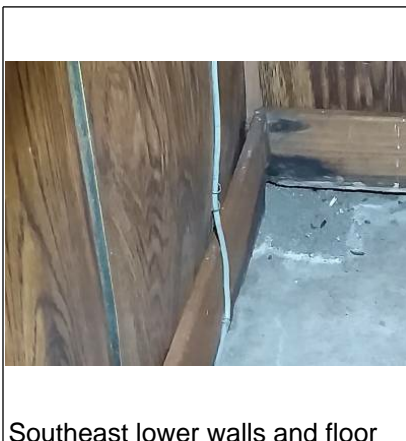
Southeast lower walls and floor

**Comments** Moisturestains on lower walls and floor; no excess moisture detected during the inspection.

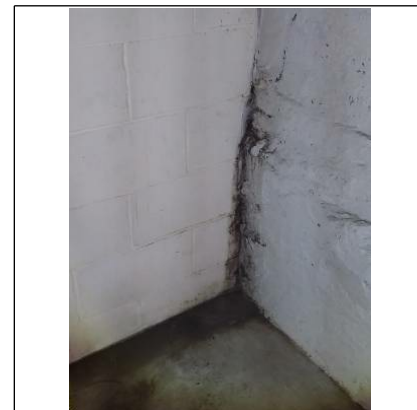
Southeast lower walls and floor

**Comments** Ceiling unfinished. Only wall finished is at South wall West.  
Moisture stains on Southeast lower walls and floor; no excess moisture detected during the inspection.  
Cover not present on electrical junction box at Northwest ceiling; recommend installing for improved safety.

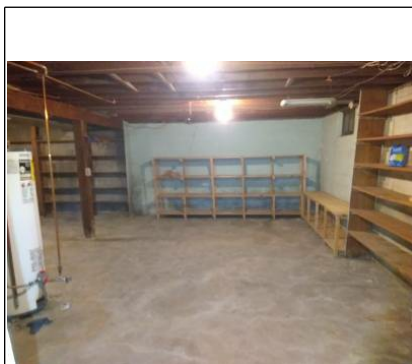
South Central

**Comments** Moisturestains on lower walls and floor; no excess moisture detected during the inspection.  
Cover not present on electrical switch box in South central room Southwest ceiling; recommend installing for improved safety.  
Cover not present on electrical outlet box in South central room East ceiling; recommend installing for improved safety.  
Covernot present on electrical junction box in the South central room Northwest ceiling; recommend installing for improved safety.  
As a safety improvement opportunity, recommend installation of GFCI style receptacle(s) or circuit breaker(s) for all locations within 6 feet of water (water softener and sump pump) to meet current recommendations.  
Entry door to the South central room frame loose and displaced; recommend repair or replacement.  
Entry door to the Southeast room does not have knobs installed; recommend installing as desired.

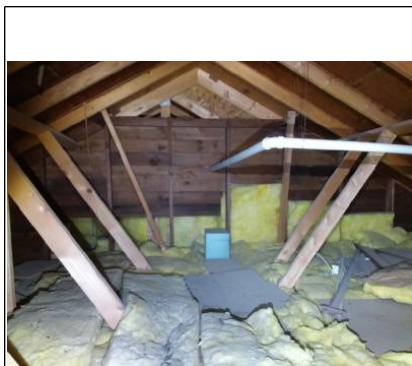
View toward East

Cover not present on electrical outlet box at the West wall; recommend installing for improved safety.

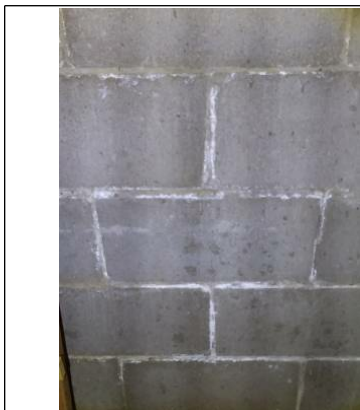
South wall East

**Comments** Not visible in the Southwest room.  
 Foundation walls not visible due to interior wall finishes not evaluated; comments reflect visible areas only.  
 Stain(s) and/or efflorescence present caused by dampness or moisture; recommend monitoring to determine if due to past or continuing issue(s).

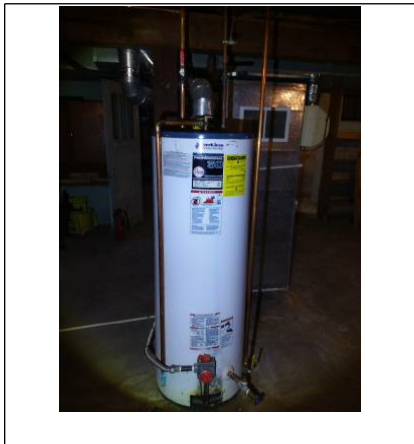
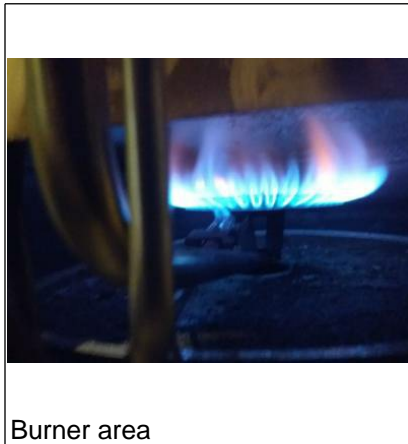
Burner area

**Comments** Rusting and flaking present on the bottom of the tank.  
Good blue/orange flame observed.  
Based on age, this item will probably need to be replaced in the next five years.
