Prepared for: Homes of Riviera Dunes, Palmetto, FL

Floating Dock Assessment Report

Submitted: March 2026

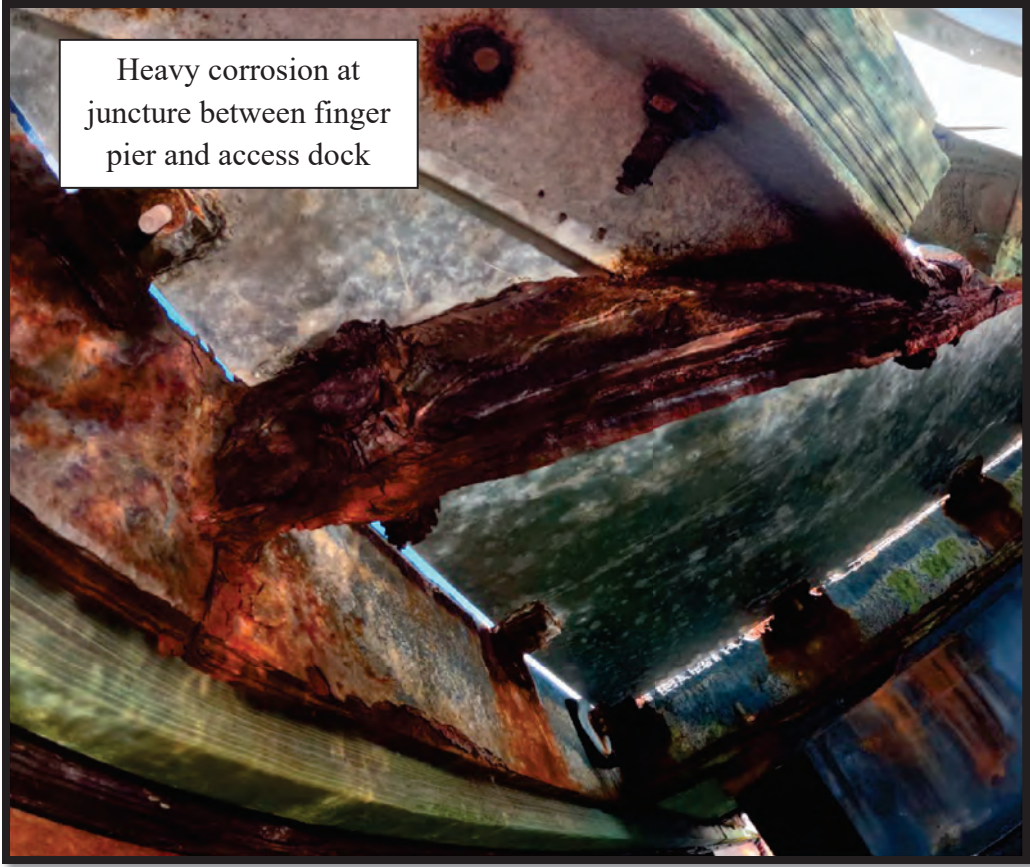
The junctions between the finger piers and the access dock were found to be in particularly poor condition.

Heavy corrosion at juncture between finger pier and access dock

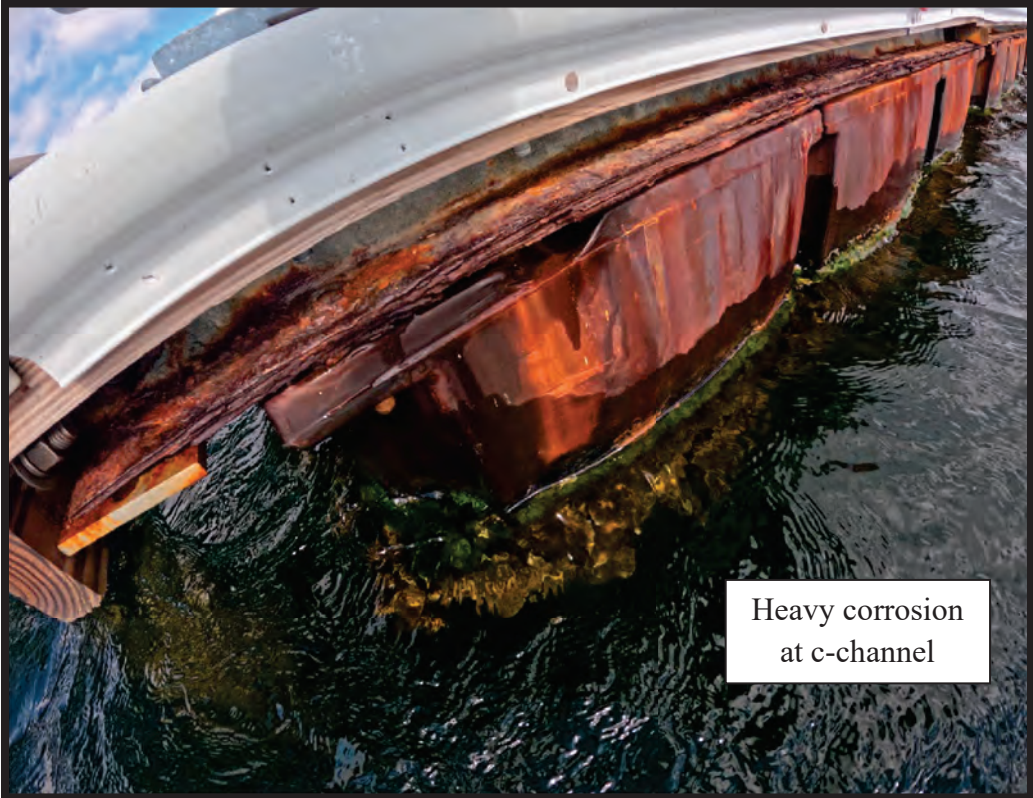
Hardware (C-channels, Angles, Through Bolts) – A prevalent defect in the floating docks is the corrosion of the c-channel which joins the deck slab to the floats underneath. In some extreme cases, there was visible material loss, such that the through bolts providing connection to the floats had no material to bear upon. The through bolts themselves were also found to be heavily corroded.

Heavy corrosion at c-channel

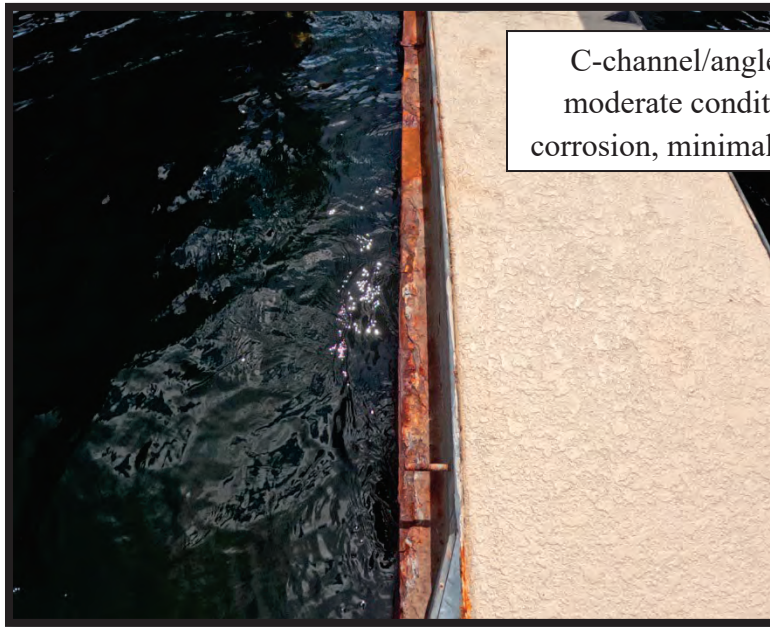
C-channel/angle bracket in moderate condition (surface corrosion, minimal material loss)

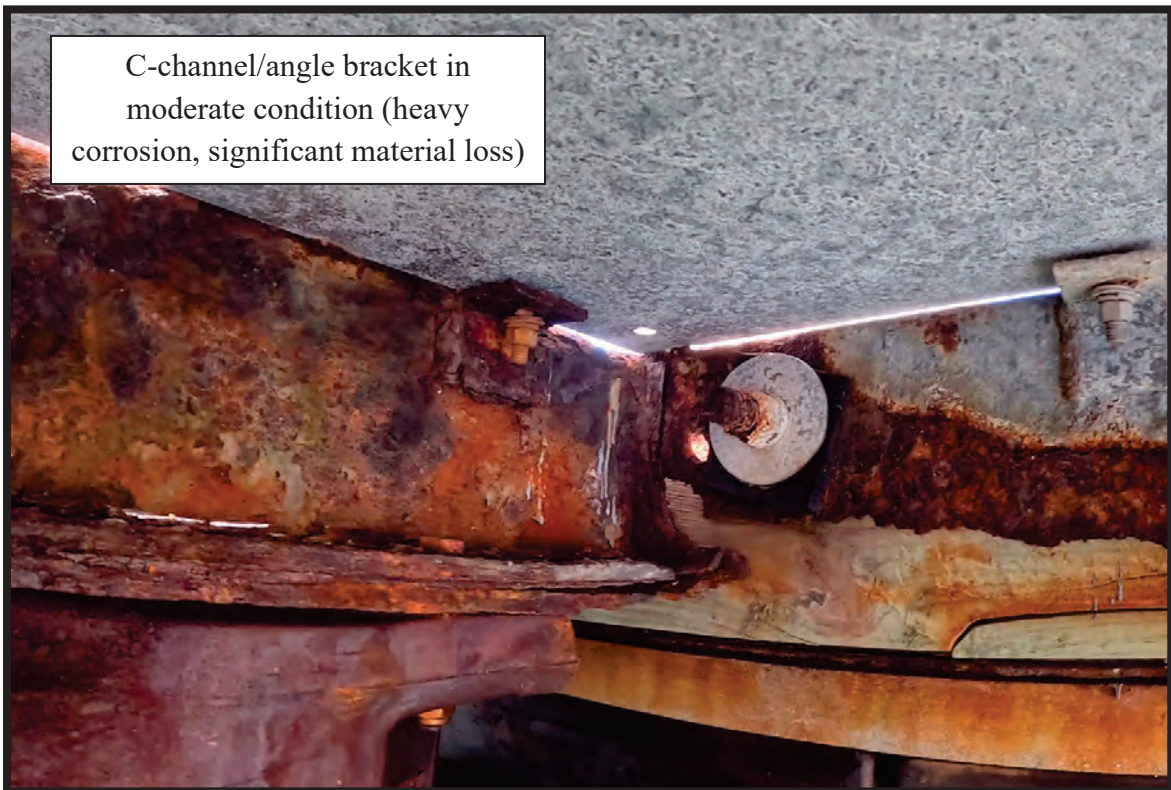
C-channel/angle bracket in moderate condition (heavy corrosion, significant material loss)

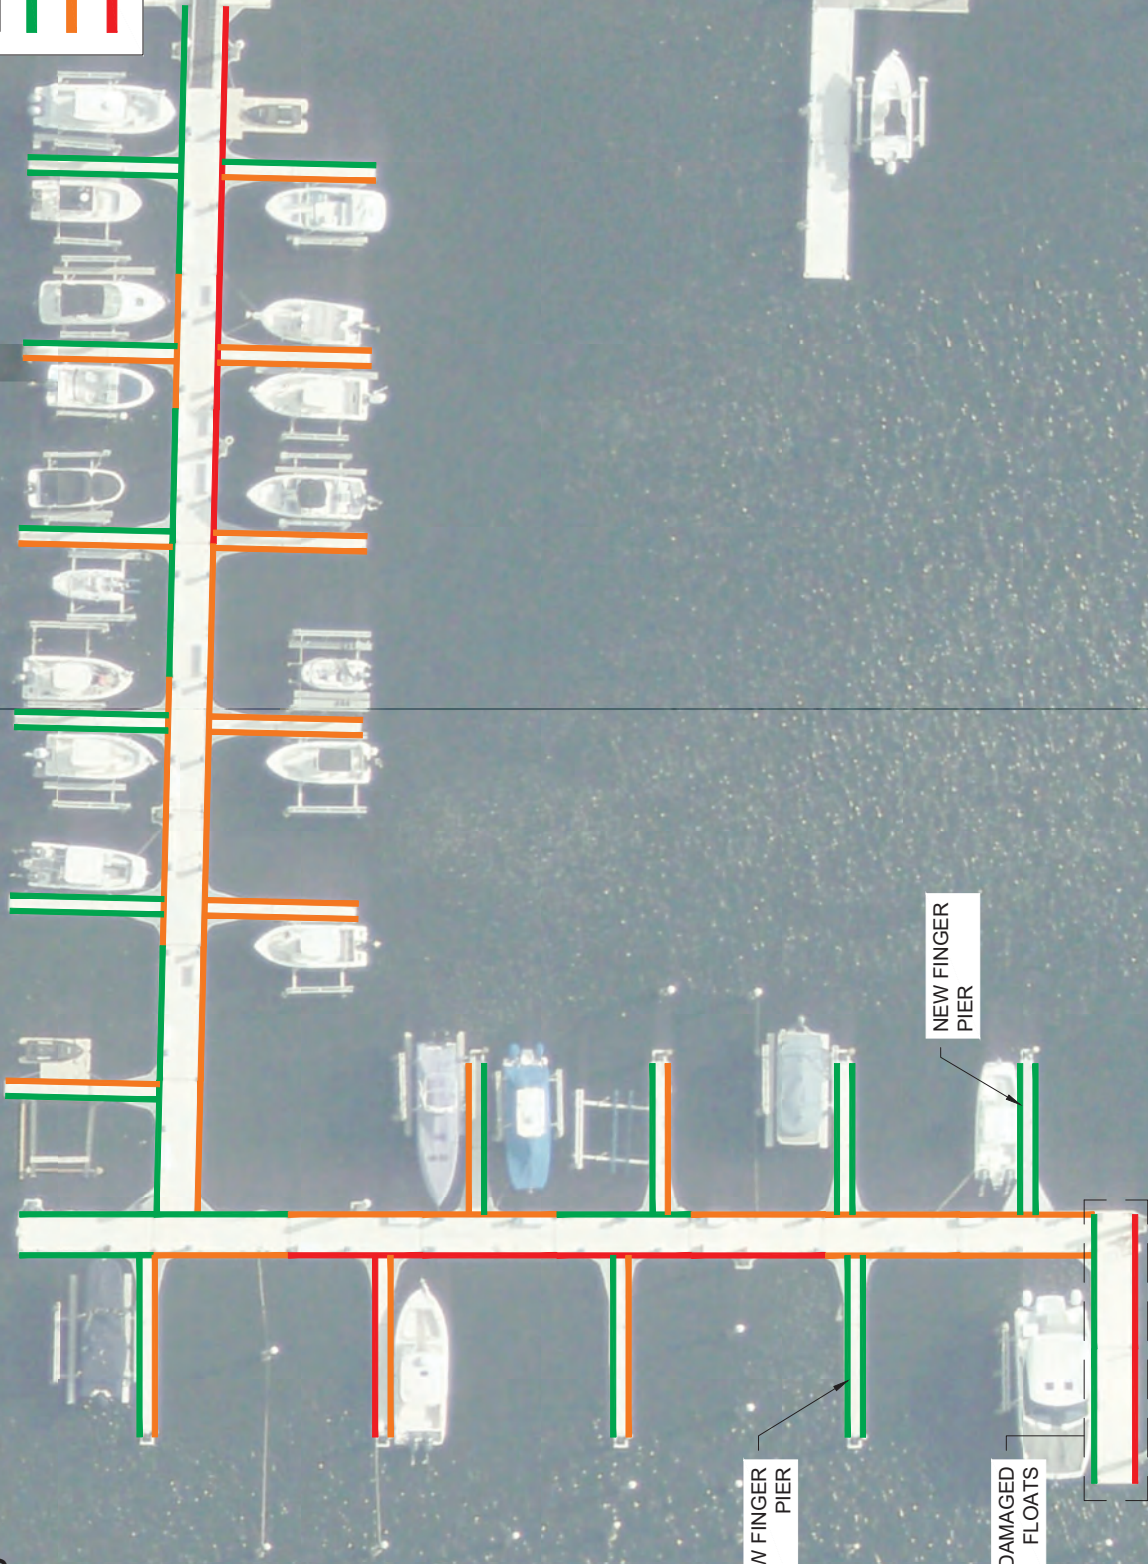
DOCK B

Each c-channel was assessed a label of either fair, moderate, or poor based on its observed condition. A condition map may be found on the following pages. In summary, the majority of the c-channels at Docks A (74%) and B (58%) were found to be in either moderate or poor condition, while Dock C was in better shape with just over one-third of the c-channels being in either moderate or poor condition (36%). This is to be expected, as Dock C is the newest of the three Docks.

DAMAGED FLOATS

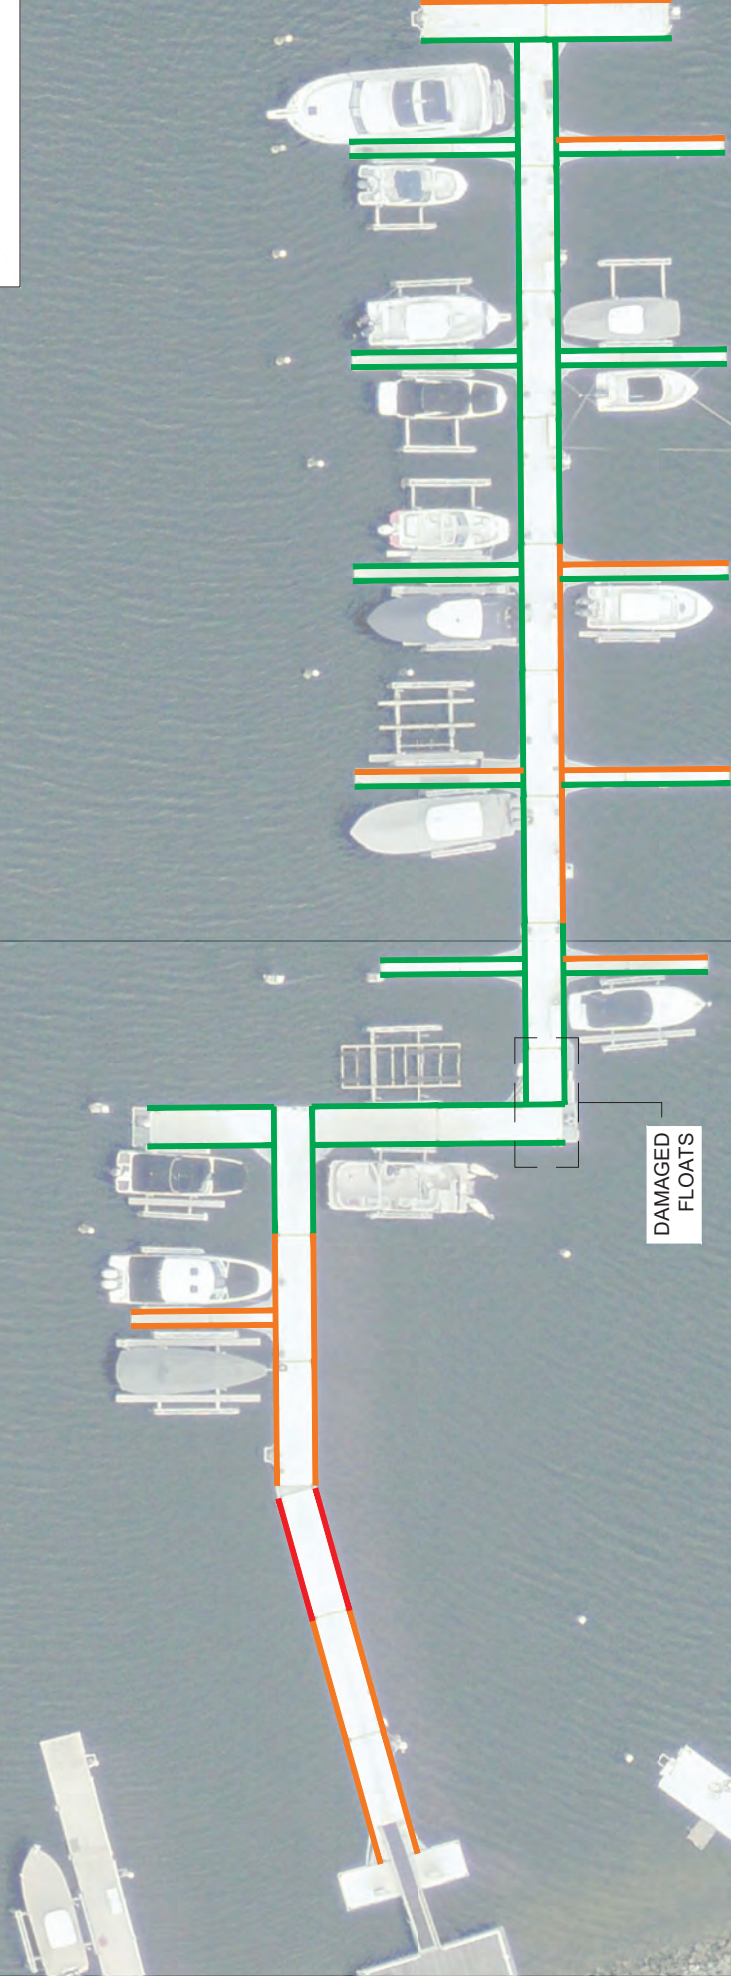
DOCK C

DAMAGED FLOATS

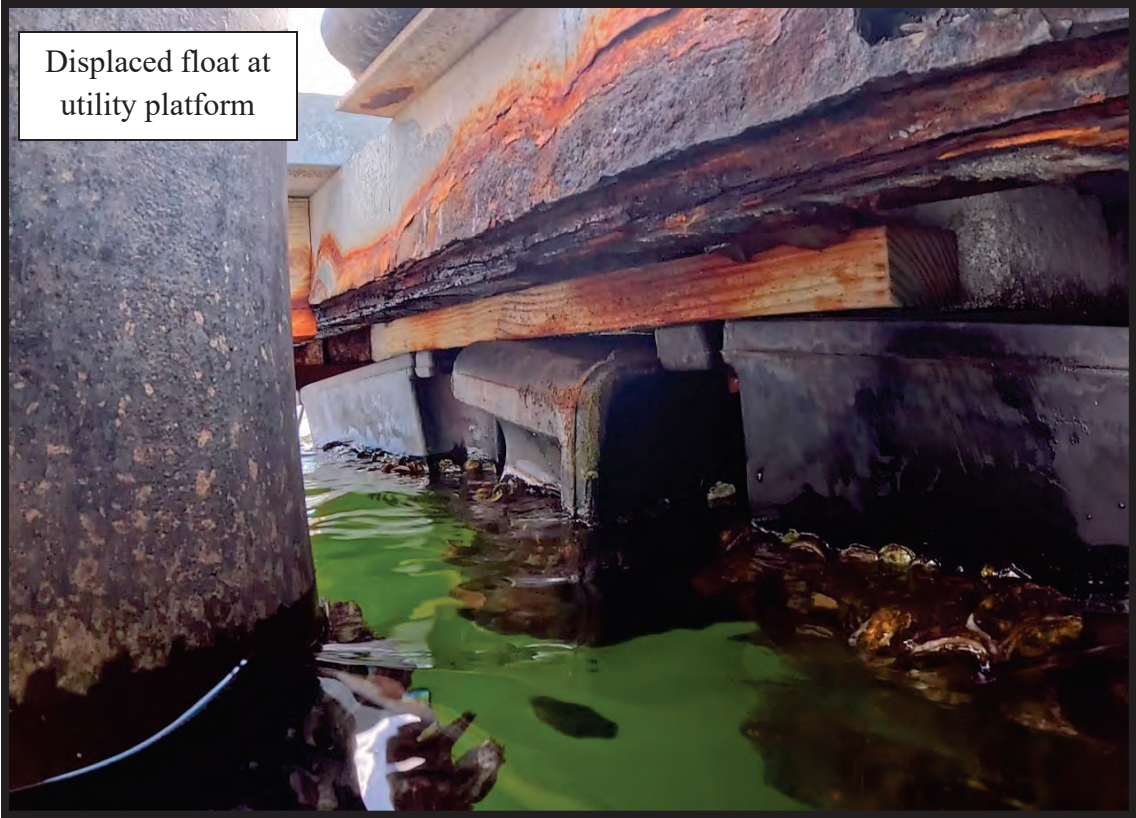
Utility Platforms – Each dock has a utility platform behind the gangway access point. Each of these utility platforms was found to be listing severely. The utility platforms are very well-shielded from wave energy, relative to the rest of the docks; therefore, this list is likely due solely to the weight of the utilities being run through the platform. Additional floatation can be added to help with the listing. The listing of these platforms can lead to stress in the busbars housed inside the panels; therefore, it is recommended that this issue be addressed ASAP.

Displaced float at utility platform

Phase 1 – 1 year: Install supplemental floats at each utility platform to prevent damage to utility lines/utility housing.

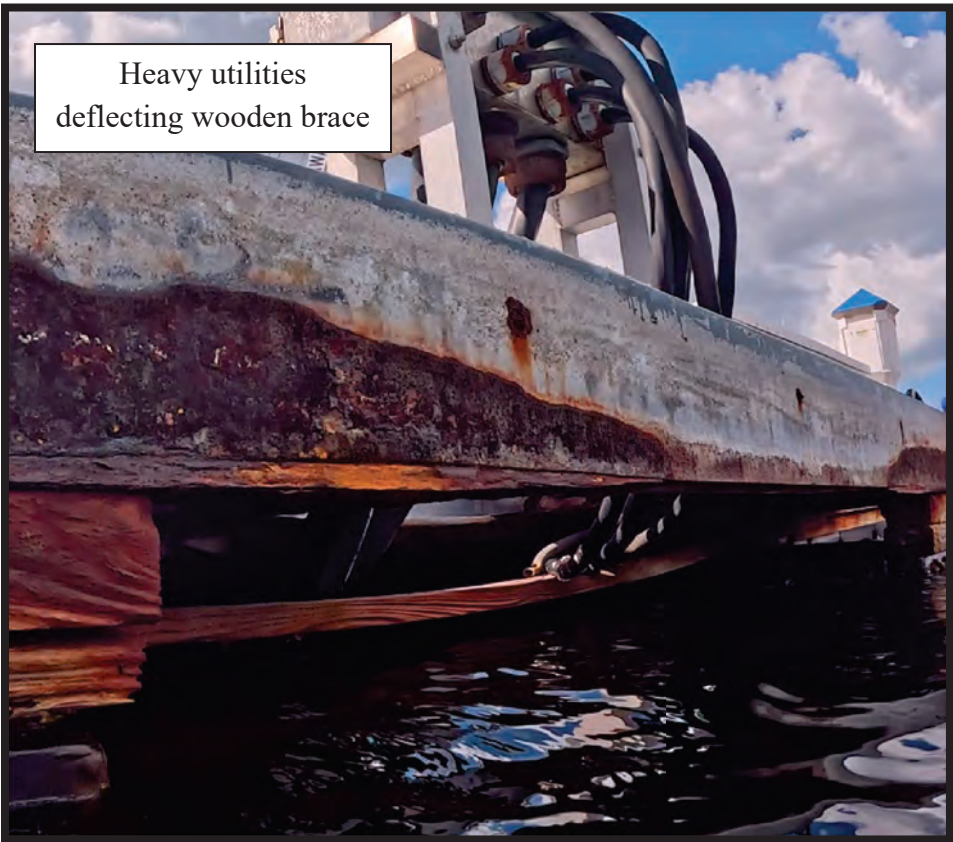
Heavy utilities deflecting wooden brace
