SUMMARY
2 Fundy Ct, Simpsonville, SC 29681
Rob Knight
04/24/2024

Michael DiBenedetto
SC License # RBI 49765
Veterans Home Inspection
8649186581
mike@vhihomeinspection.com

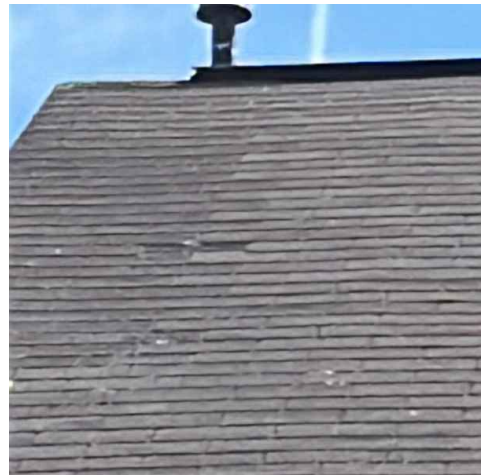
2.2.1 Roof Covering

CRACKED AND DAMAGED ROOF COVERING

FRONT LEFT TOWARDS THE MIDDLE OF THE ROOF

I observed areas of cracked/splitting and damaged roof-covering materials. This is a major defect. Prone to water leaking into the house. I recommend that a qualified roofing contractor to further evaluate and make repairs to the roof system,.

Contact a qualified roofing professional.

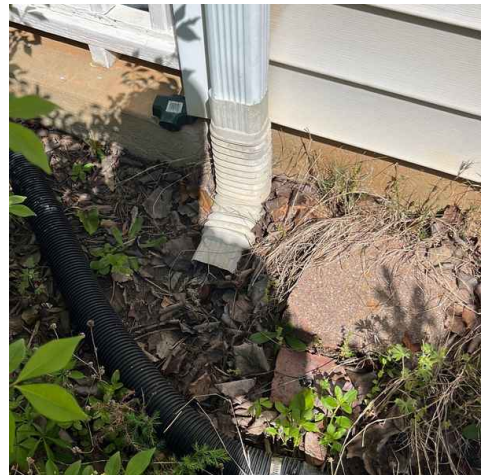
2.4.1 Gutters & Downspouts

DOWNSPOUTS DRAIN NEAR HOUSE

One or more downspouts drain too close to the home's foundation.

This can result in excessive moisture in the soil at the foundation, which can lead to foundation/structural movement. Recommend a qualified contractor adjust downspout extensions to drain at least 6 feet from the foundation. A handy homeowner should be able to do this project.

Recommended DIY Project

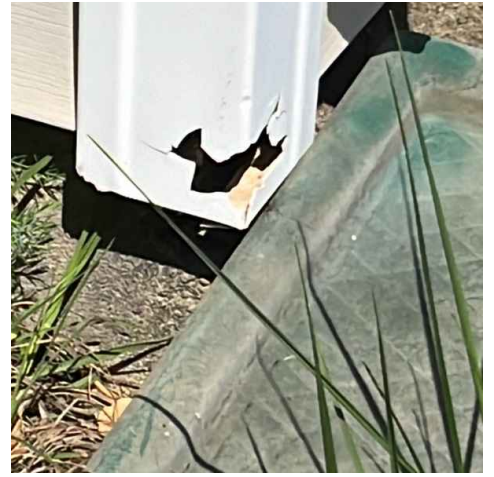
3.3.1 Wall-Covering, Flashing & Trim

DAMAGED WALL-COVERING MATERIAL

BACK RIGHT CORNER OF HOME

I observed indications of a defect at the exterior wall-covering material.

Correction and further evaluation is recommended.

Recommendation
Contact a qualified professional.

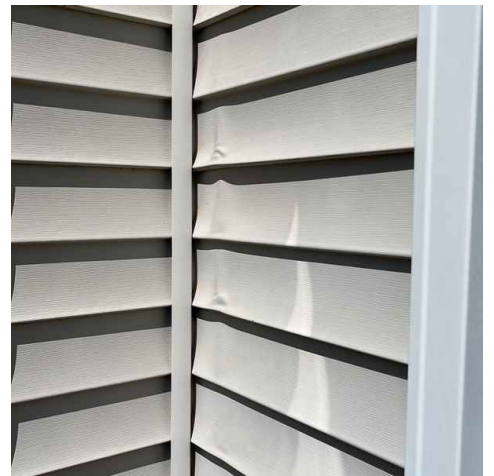
3.3.2 Wall-Covering, Flashing & Trim
DAMAGED WALL-COVERING MATERIAL 2

BACK PORCH LEFT SIDE OF SLAB

I observed indications of a defect at the exterior wall-covering material. This was caused by heat.

Correction and further evaluation is recommended.

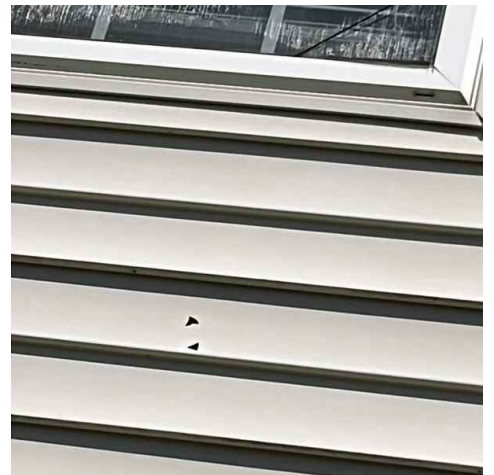
3.3.3 Wall-Covering, Flashing & Trim
HOLE IN SIDING

RIGHT SIDE OF HOME TOWARDS BACK

Recommend sealing hole to prevent moisture intrusion

Recommendation
Contact a qualified professional.

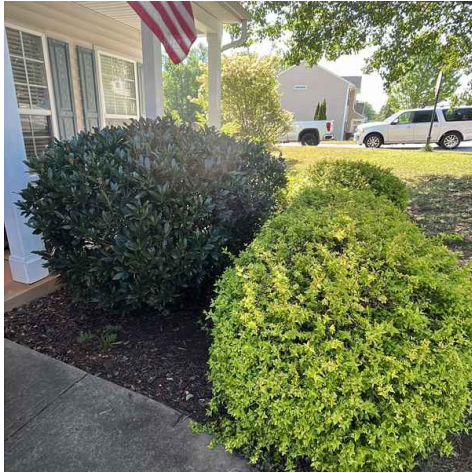
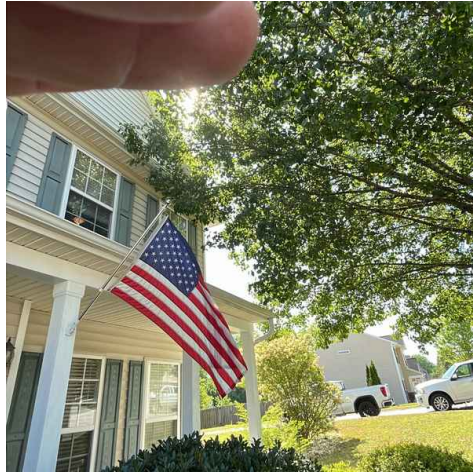
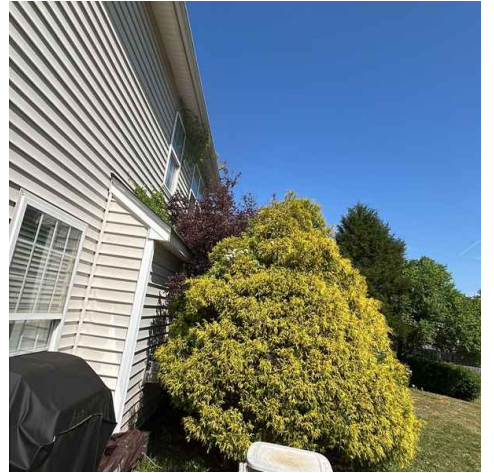
3.4.1 Vegetation, Surface Drainage, Retaining Walls & Grading
DENSE VEGETATION

I observed dense vegetation around the house in areas. This condition limited and restricted my visual inspection. Dense vegetation and landscaping up against or near the house foundation and exterior walls may be prone to water penetration and insect infestation.

Trimming, pruning and some landscaping is recommended.

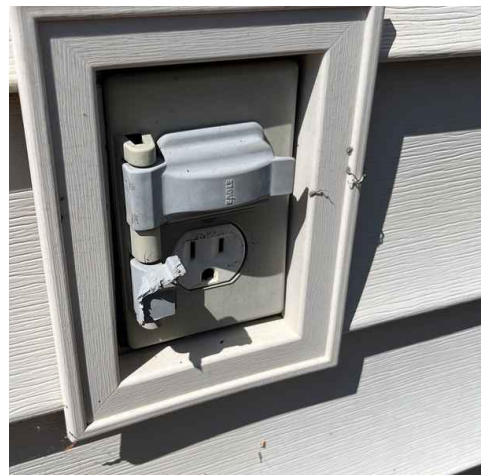
3.5.1 GFCIs & Electrical

BACK PORCH GFCI

I observed indications of a major defect during the inspection. Damaged receptacle cover. Hazard. Correction and further evaluation is recommended.

Contact a qualified electrical contractor.

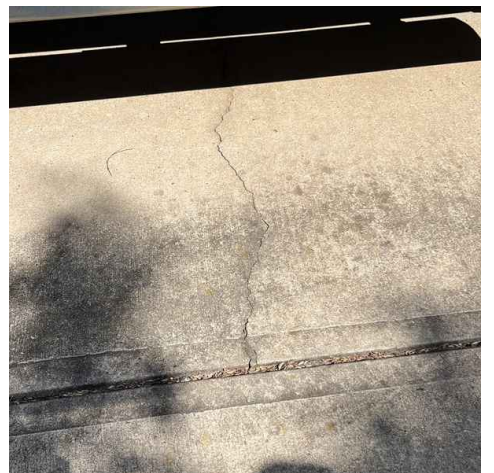
3.6.1 Walkways & Driveways

MINOR CRACKING AT DRIVEWAY

FRONT LEFT SECTION OF DRIVEWAY

I observed indications of minor cracking at the driveway.

Monitoring recommended.

Contact a qualified concrete contractor.

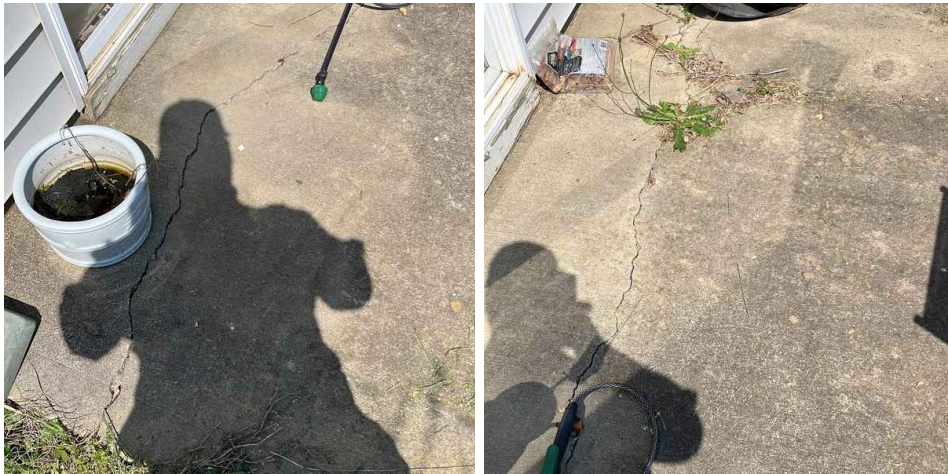
3.8.1 Porches, Patios, Decks, Balconies & Carports

MAJOR CRACKS IN CONCRETE

BACK PORCH SLAB BY

There were major cracks in back porch slab. I recommend calling a concrete contractor for repair.

Contact a qualified professional.

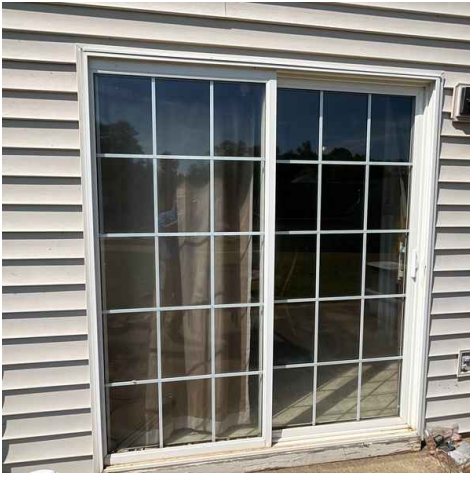
3.10.1 Windows

MISSING WINDOW SCREEN

VARIOUS LOCATIONS

I observed a missing window screen.

Correction and further evaluation is recommended.

Contact a qualified handyman.

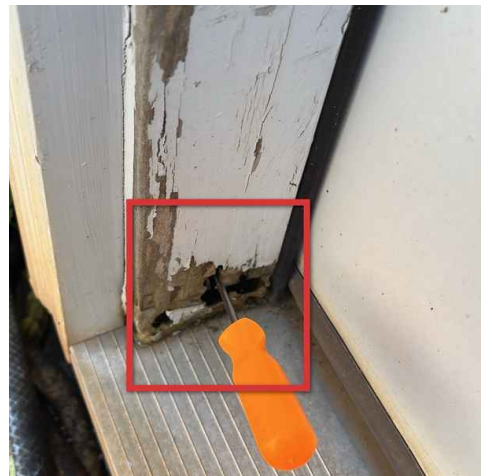
3.11.1 Exterior Doors
WOOD ROT AT DOOR

LEFT SIDE DOOR

I observed wood rot at the exterior door.

Correction and further evaluation is recommended.

Recommendation
Contact a qualified professional.

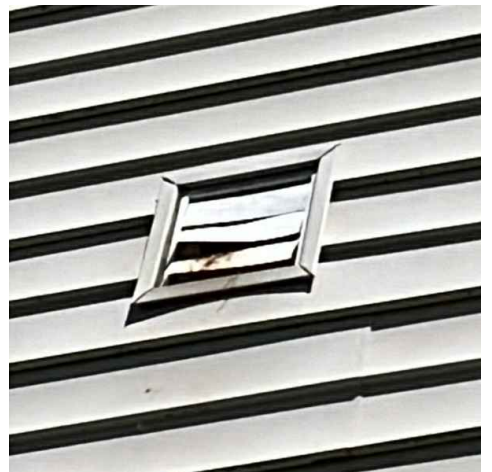
3.12.1 Exhaust Hoods
DAMAGED EXHAUST HOOD

RIGHT SIDE OF HOME

I observed an exhaust hood that was damaged. Recommend repair or replace.

Recommendation
Contact a handyman or DIY project

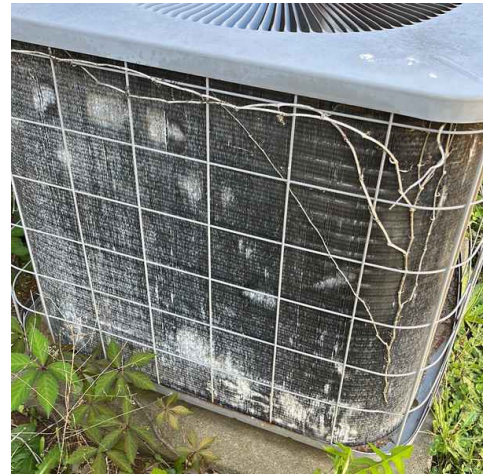
6.1.1 Cooling System Information

FINS DAMAGED

LEFT SIDE OF HOME

I observed indications of damaged fins on the exterior compressor unit of the cooling system.

Contact a qualified HVAC professional.

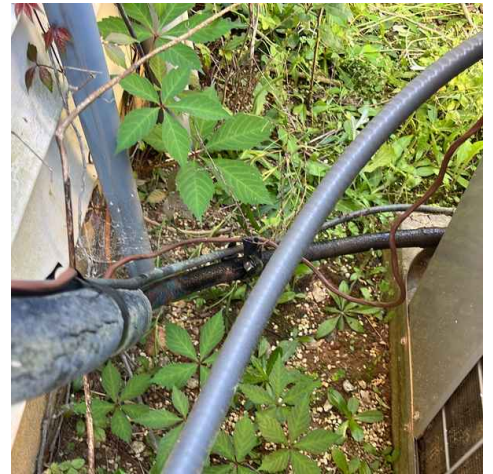
6.1.2 Cooling System Information

REFRIGERANT LINE INSULATION MISSING OR DAMAGED

LEFT SIDE OF HOME

I observed missing or damaged foam insulation at the cooling system's refrigerant line, which can cause energy loss and condensation.

Contact a qualified HVAC professional.

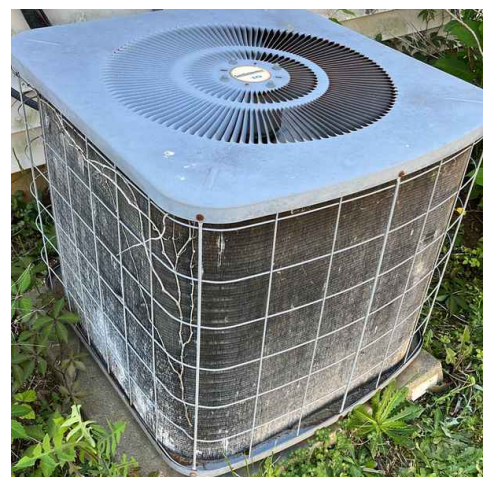
6.1.3 Cooling System Information

OLD SYSTEM

I observed during my inspection that the system appeared to be old and at the end of its service life. It may not be reliable. Ask the homeowner or occupant about its recent performance. Regular maintenance and monitoring of its condition is recommended. Budgeting for repairs and future replacement is recommended. [InterNACHI's Standard Estimate Life Expectancy Chart for Homes](#)

Recommend monitoring.

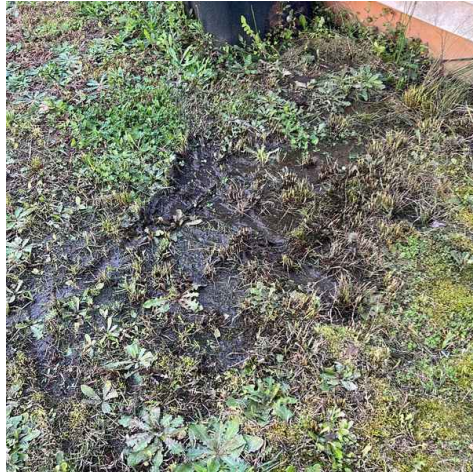
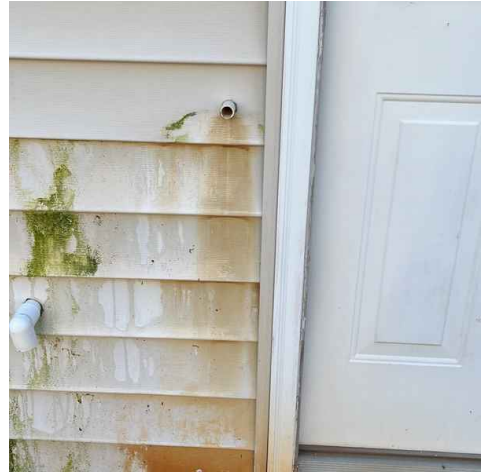
6.3.1 Condensate

CONDENSATE DISCHARGE SHOULD BE EXTENDED

The condensate discharge pipe should be extended so that the water is diverted far enough away from the house foundation.

Recommendation
Contact a qualified professional.

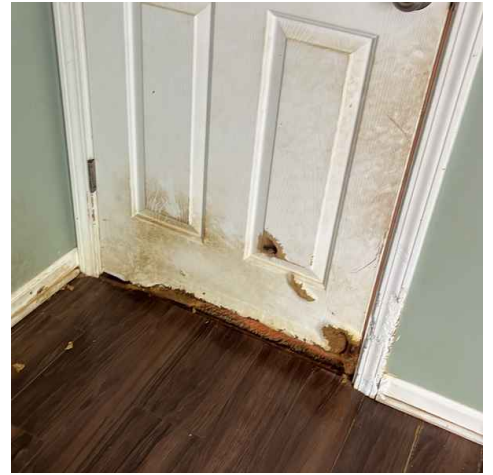
9.1.2 Doors

DAMAGED DOOR

1ST FLOOR ROOM ON BACK LEFT SIDE OF HOME

I observed damage to the door.

Recommendation
Contact a qualified handyman.

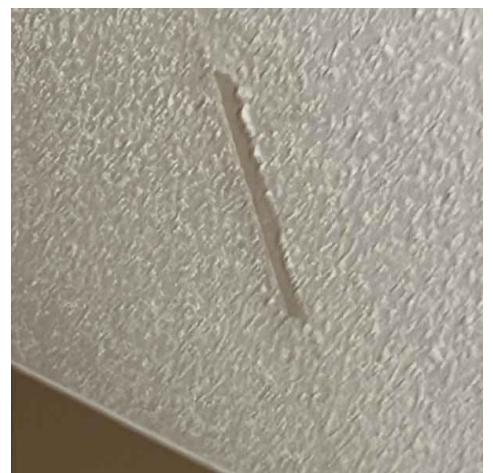
9.4.2 Floors, Walls, Ceilings
MINOR DAMAGE

2ND FLOOR MASTER BEDROOM

Minor damage or deterioration to the ceiling was visible at the time of the inspection.

Recommendation
Contact a qualified professional.

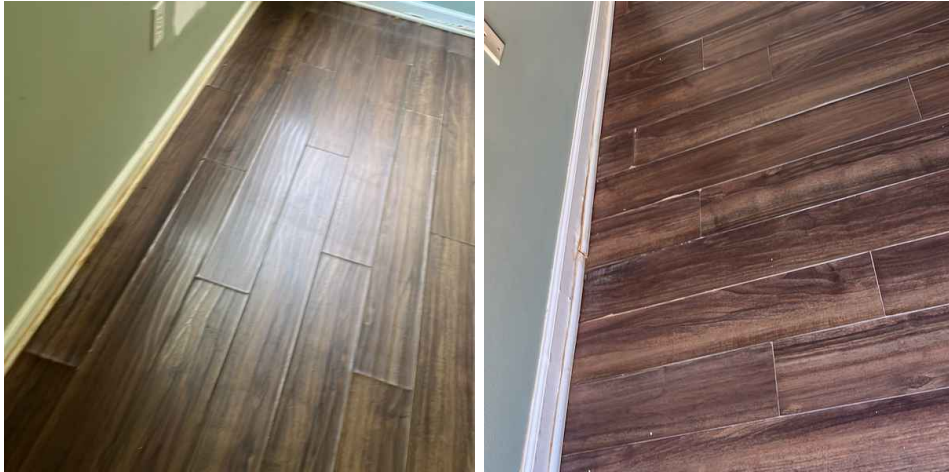
9.4.3 Floors, Walls, Ceilings

ROTTED FLOOR

1ST FLOOR BACK LEFT ROOM

Wood rot in floor. Recommend repair.

Recommendation
Contact a qualified professional.

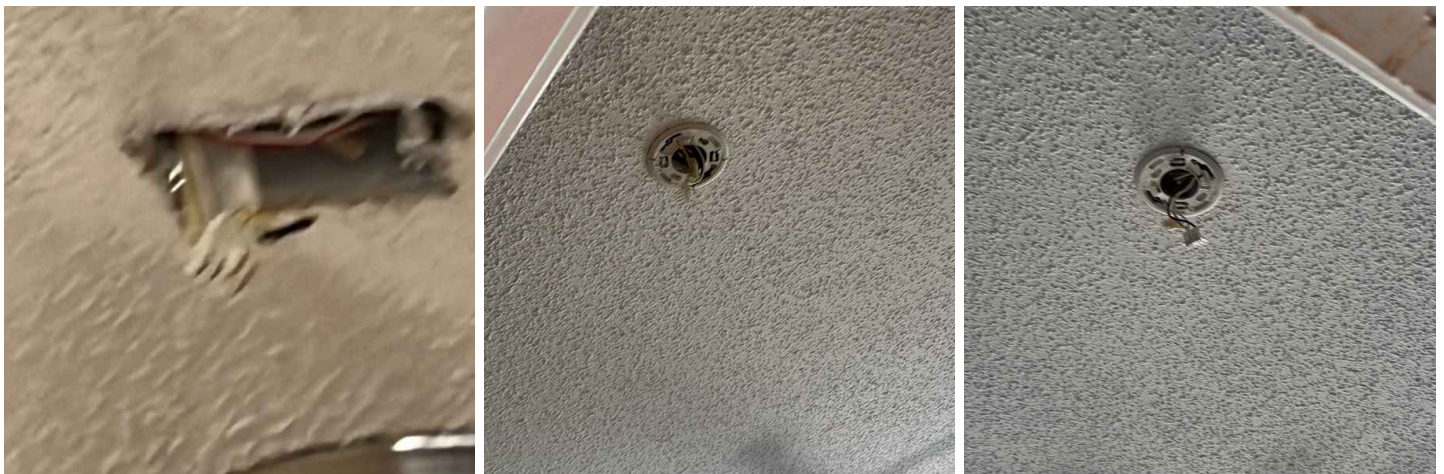
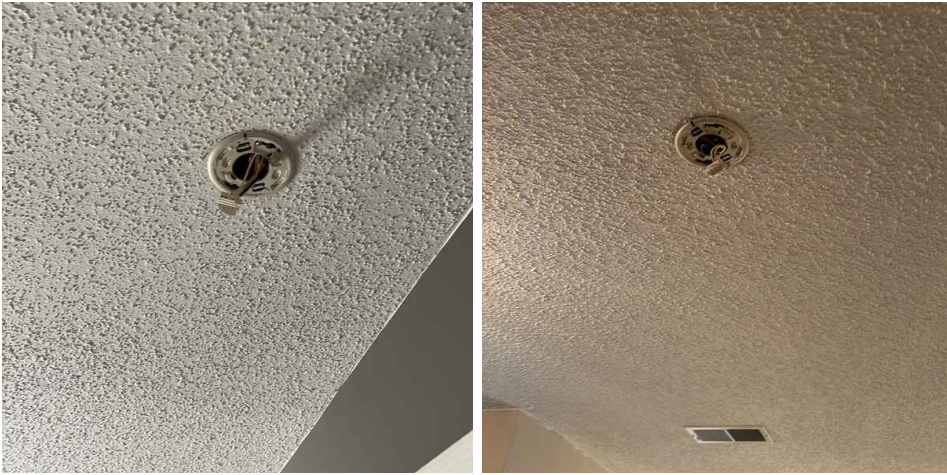
9.7.1 Presence of Smoke and CO Detectors

MISSING SMOKE DETECTOR

ALL EXCEPT MASTER BEDROOM

I observed indications of a missing smoke detector. Hazard.

Recommendation
Contact a qualified professional.

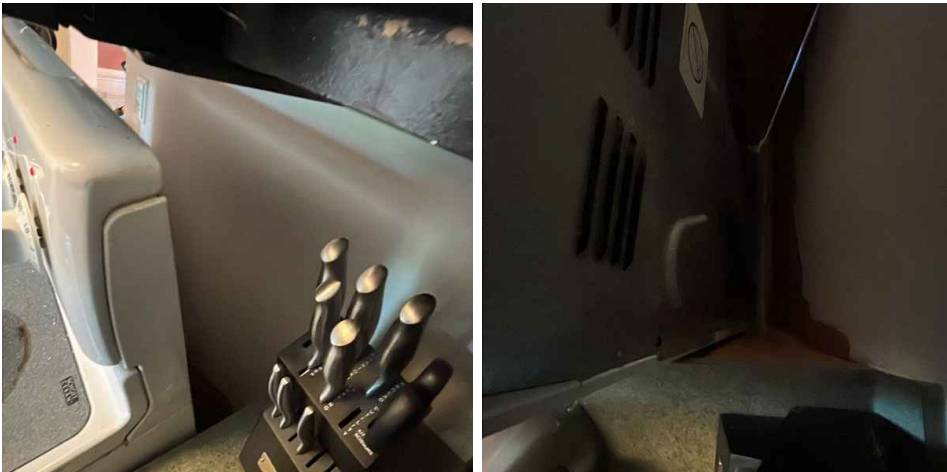
10.6.1 Range/Oven/Cooktop

MISSING ANTI-TIP

KITCHEN

I observed that the stove and oven appliance was not fastened to the wall. Anti-tip device is missing. This poses a safety hazard to children.

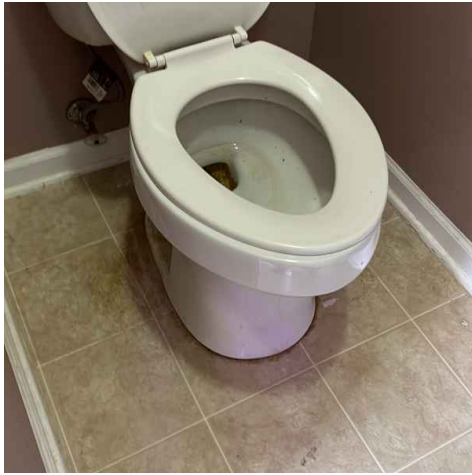
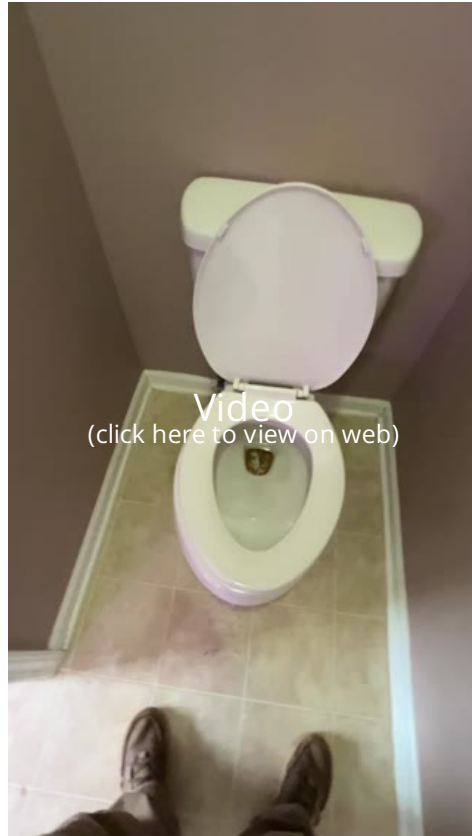
11.1.1 Bathroom Toilets

LOOSE TOILET

MASTER BATHROOM

Toilet was very loose. This is due to a deteriorating wax ring or loose fasteners or both. This can lead to leaking water from under the toilet. Recommend repair.

Contact a qualified professional.

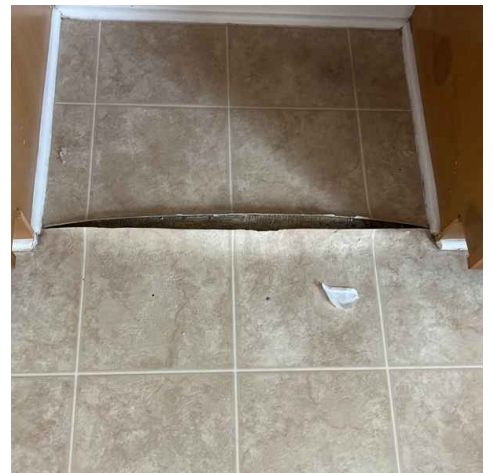
11.6.1 Cabinetry, Ceiling, Walls & Floor
FLOOR DAMAGE

2ND FLOOR MASTER BATHROOM

I observed damage at the bathroom floor.

Recommendation
Contact a qualified handyman.
