**202 S Garland Street
Plainview, TX 79072**

PROPERTY INSPECTION REPORT FORM

04/25/2024

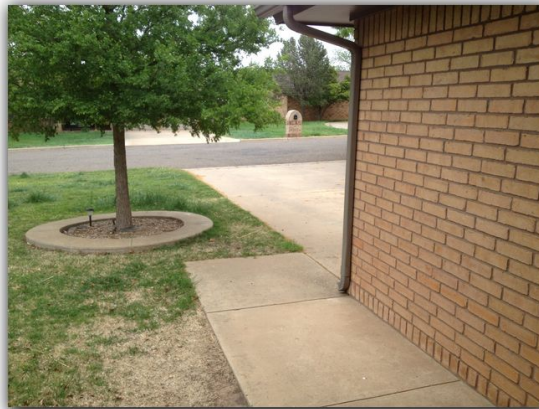
NOTE: Trees are growing in close proximity to the foundation. See the following image. There is no visible damage at this time.

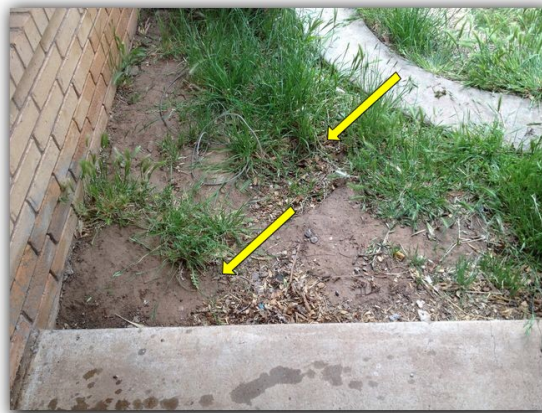
- Low areas are present at the following locations: back yard flower beds. See the following image.

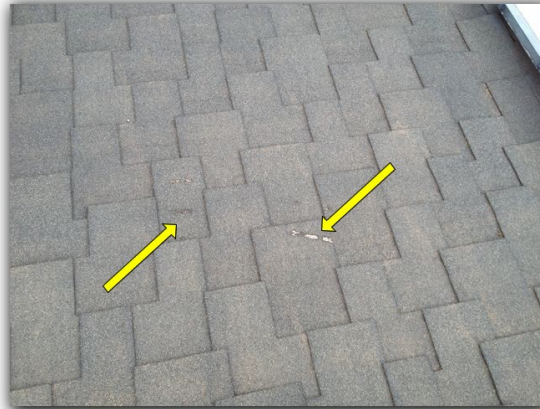
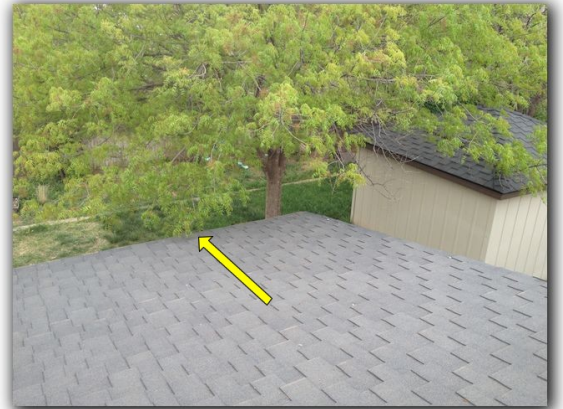
- Light granule loss is present at various shingles on the roof. See the following image.
- Trees should be trimmed to reduce the opportunity for damage to the roof covering. See the following image.

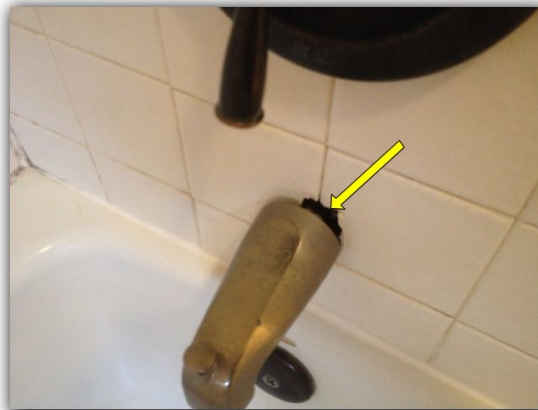
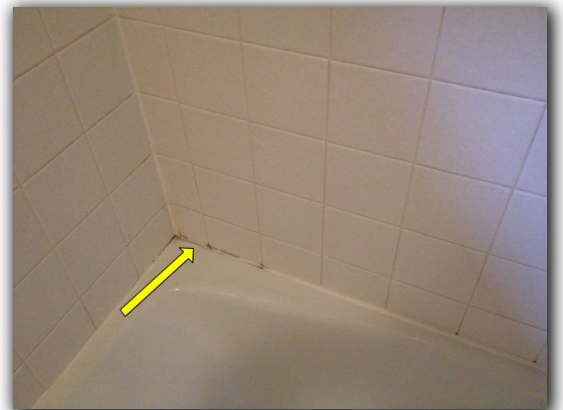
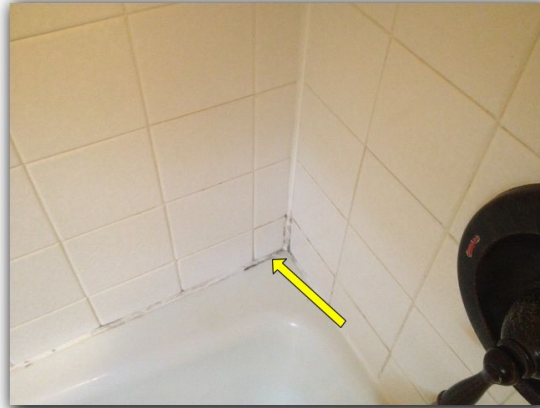
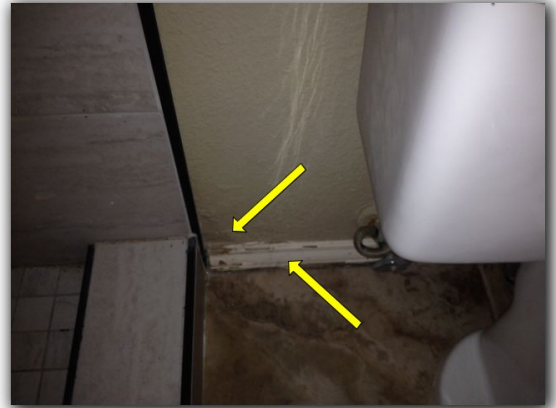
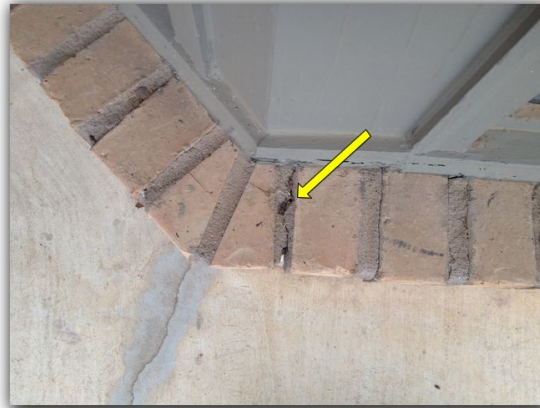
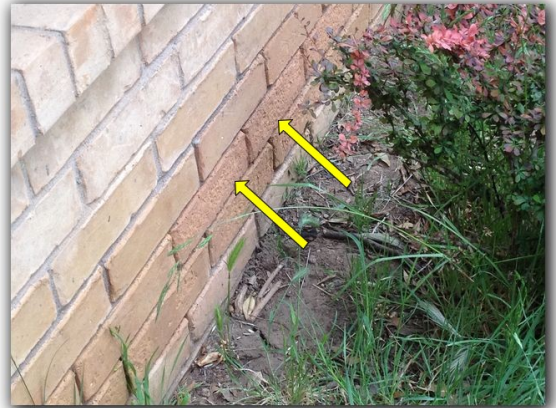
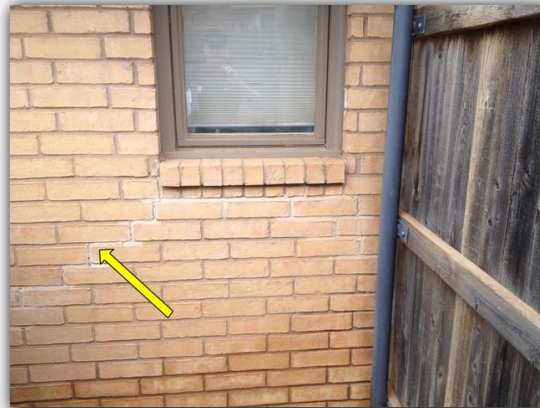
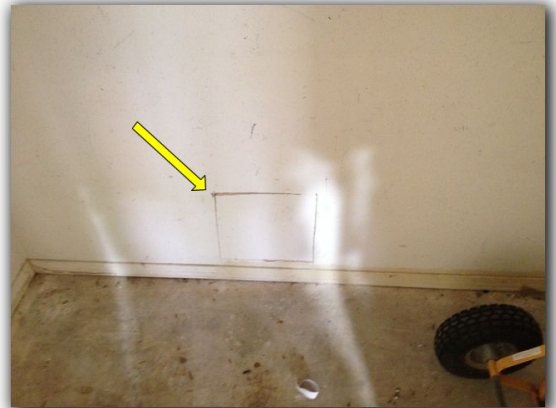
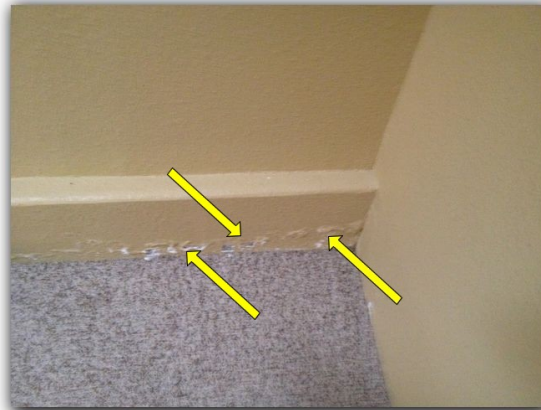
- Caulk/grout maintenance is needed at the following tub/shower surround: north hall bathroom. See the following two images.
- Unidentified growth is present at the following locations: north hall bathroom. See the following image.
- Water damage is present at the following interior walls: master bathroom toilet baseboard area. See the following image.
- Mortar repair is needed at various exterior brick locations around the home. See the following image.
- Delaminated brick are present at each exterior elevation. See the following image.
- Settling cracks are present around the following doors/windows: south back yard exterior brick window. See the following image.

NOTE: Past wall repairs have been made at the following locations: laundry room under the water supply faucets, garage storage closet and exterior joint voids. See the following image.

NOTE: Spalling/scaling concrete at the the living concrete northwest corner. See the following image.

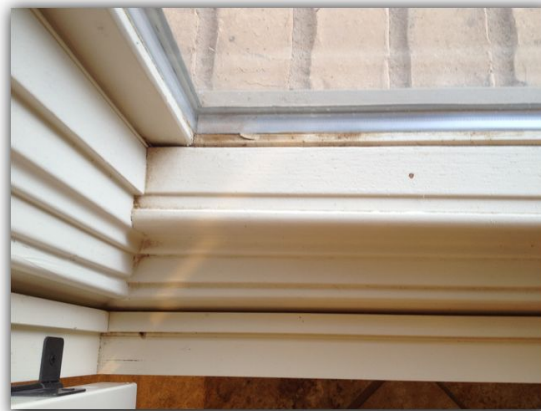
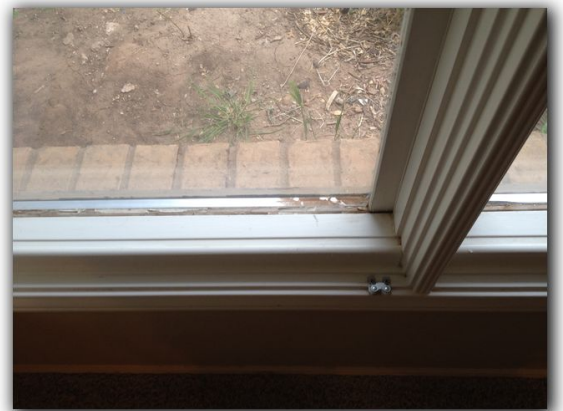
- Peeling paint is present at various interior window sills. See the following image.
- Screens are missing at various windows around the home.

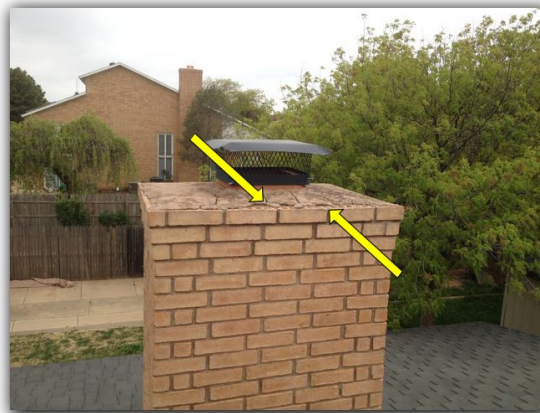
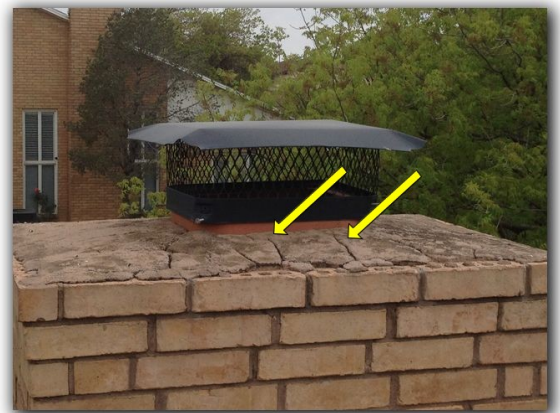
- Build up is present at the firebox and chimney flue. Consider having the fireplace cleaned and further evaluated by a qualified chimney sweep.
- The chimney capping does not extend to the edges of the brick. See the following image.
- Cracks are present in the cement chimney capping. See the following image.

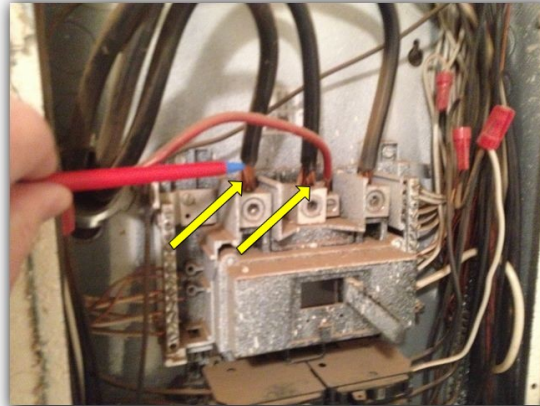
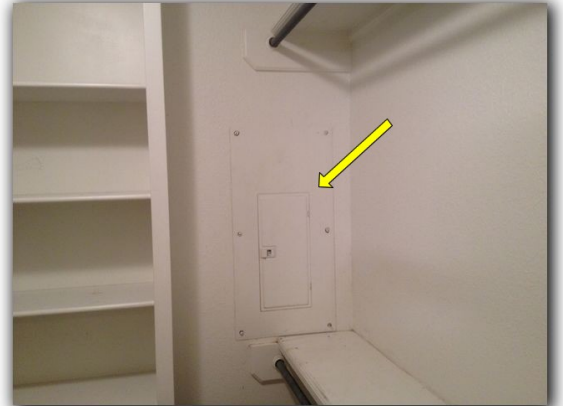
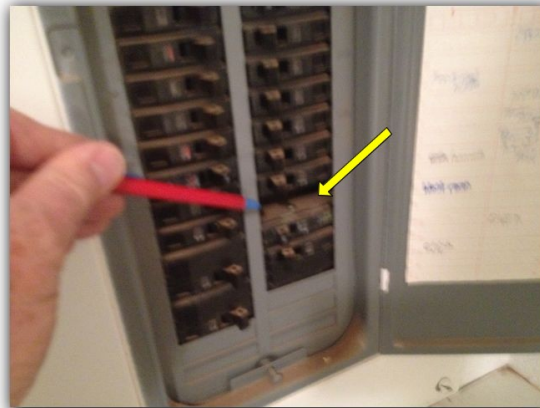
- Antioxidant paste is missing at the service entrance wires. See the following image. This condition is recognized by the Texas Real Estate Commission Standards of Practice but may not be enforced by regional building officials.
- The breaker panel is located at the following hazardous location: master bedroom closet.
- More than one circuit is wired to a single pole main in the breaker panel.
- Knockout spacers are missing at the breaker panel cover. See the following image.

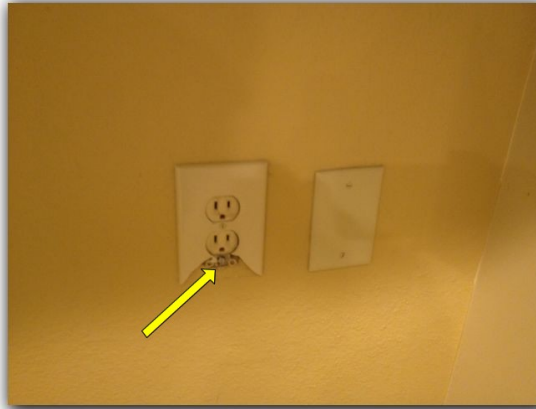
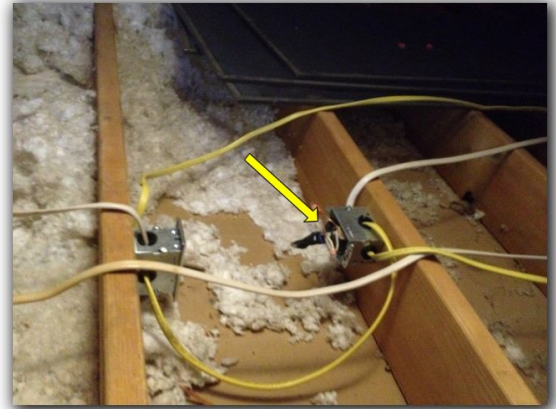
- Smoke detectors are not present at the following locations: each bedroom.
- Uncovered junction boxes are present at the following locations: attic space. See the following image.
- Devices were not identified for the switches identified with blue tape.

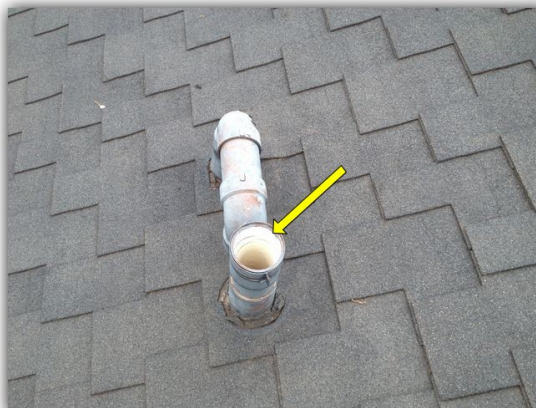
- A sediment trap is missing at the furnace. This condition is recognized by the Texas Real Estate Commission Standards of Practice but may not be enforced by regional building officials.
- The furnace rain vent cap/open vent pipe at the roof top. See the following image.

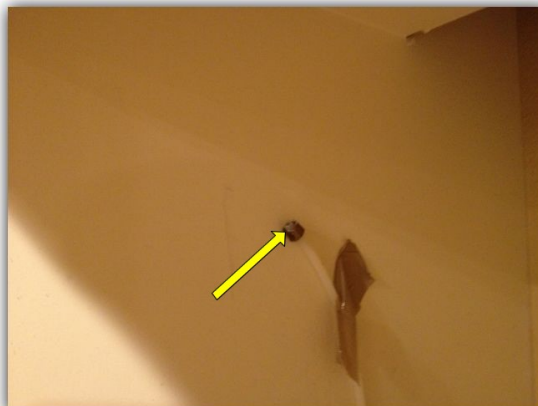
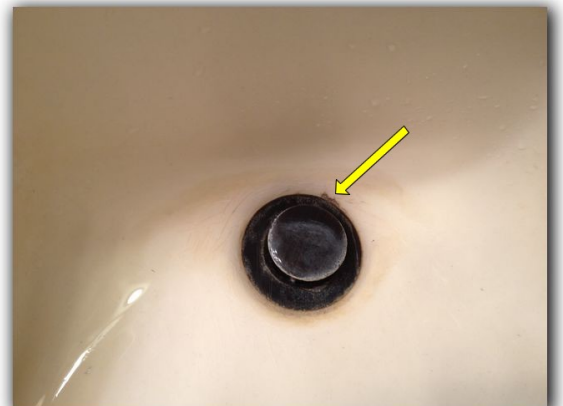
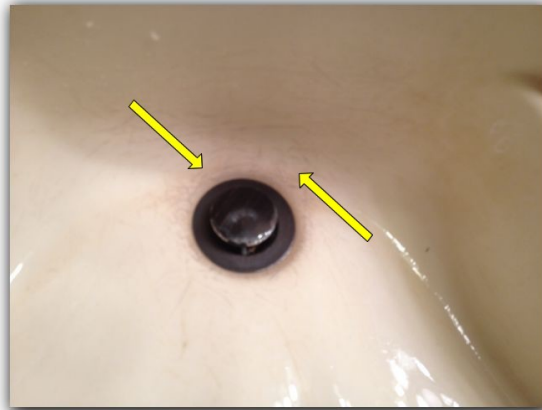
- Drips are present at the kitchen refrigerator ice maker water supply line. NOTE: There was no shut-off control valve present. See the following image.
- The laundry room faucet sprayer is partially clogged and does not operate as intended.
- The porcelain finish is damaged at the following fixtures: both master bathroom sinks. See the following image.

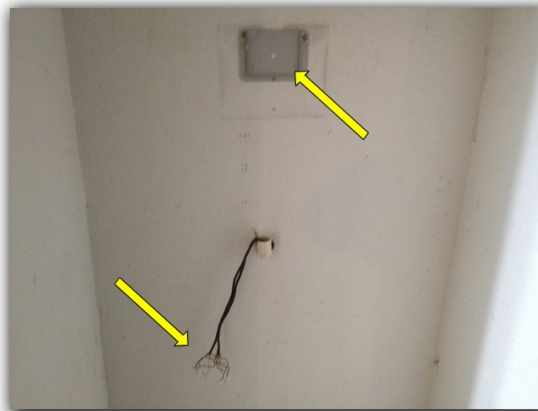
NOTE: The automatic controller was not present at the time of the inspection. NOTE: The system was disconnected. See the following image.
