Denton County Home Inspection

Home Inspection

Property Address: undefined Rosecomb Street, Northlake, Texas 76247
House | 0 sqft | Built in 2023 | 0 Bedrooms | 0 Bathrooms

PROPERTY INSPECTION REPORT FORM

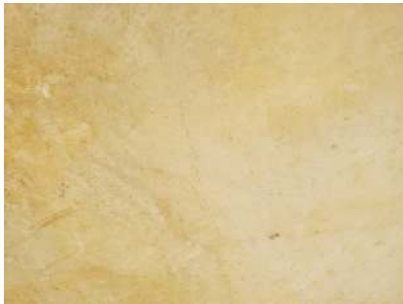
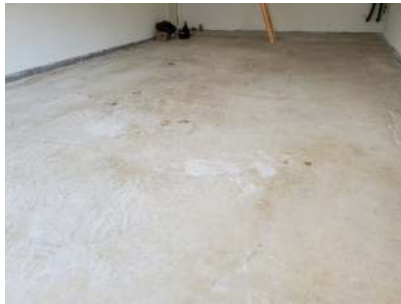
A. Foundations

In the Inspectors opinion, the foundation is performing as intended. Visual evidence of excessive structural movement was not observed at the time of inspection. Some small surface cracks were noticed in the garage floor.

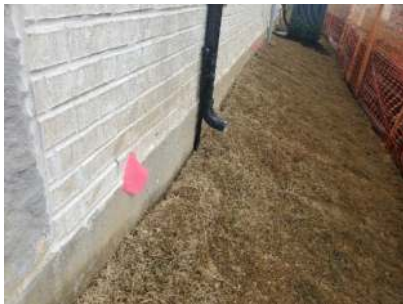
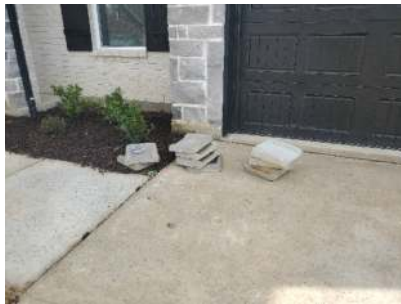
B. Grading and Drainage

Splash blocks should be installed under downspouts. This will help to prevent erosion around the foundation and direct roof run off away from the structure. Some splash blocks were on site but not installed at the time of the inspection.

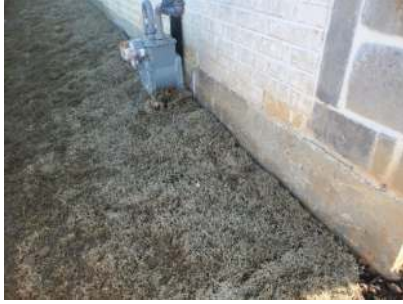
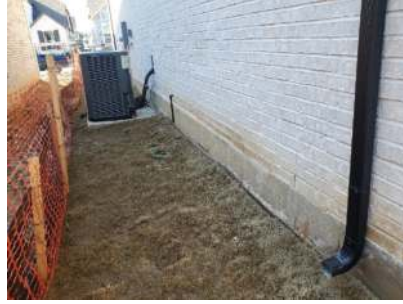
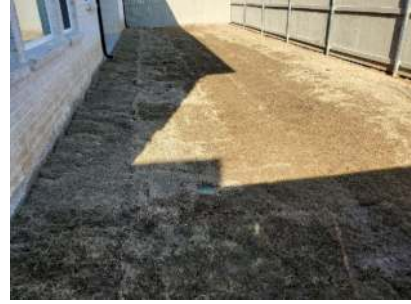
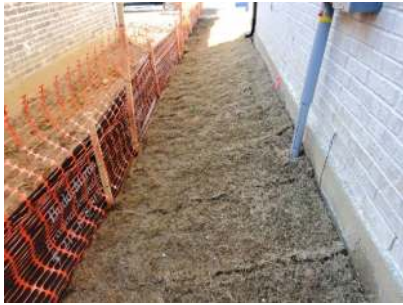
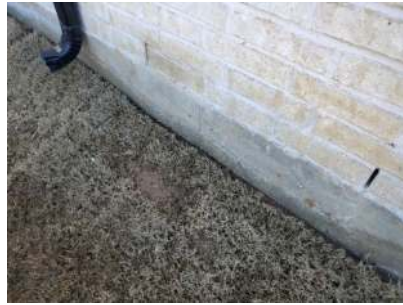
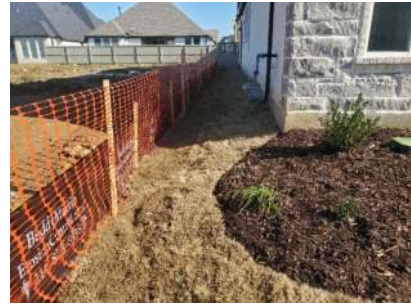
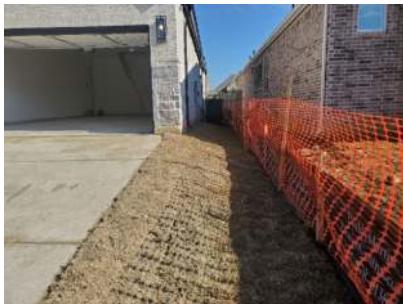
The perimeter beams of the home could use more soil around them in some areas. Two to eight inches down from the brick or siding is recommended. Monitoring low areas for ponding water is recommended.

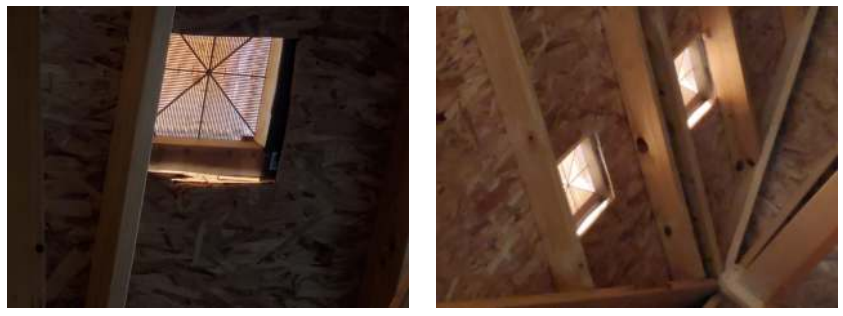
C. Roof Covering Materials

The roofing shingle materials appeared to be performing as intended at the time of the inspection. A few of the roof vents are showing light at the bottom; fastening or sealing may be needed.

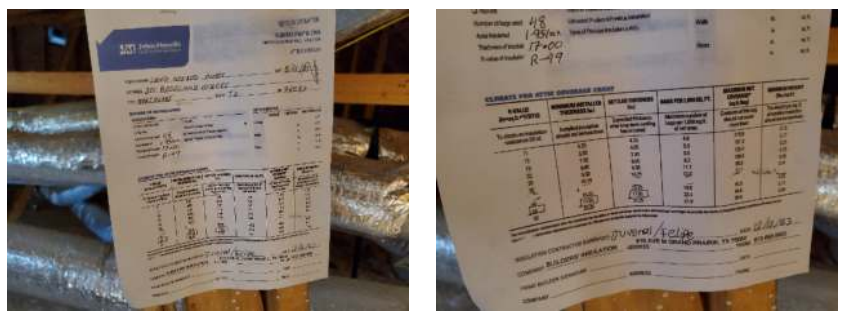
D. Roof Structures and Attics

The roof structure was viewed form the ground and attic space. An insulation certificate was stapled near the attic access stating an R-49 when installed.

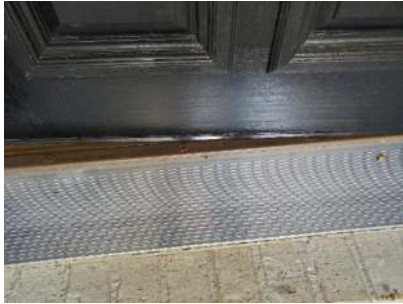
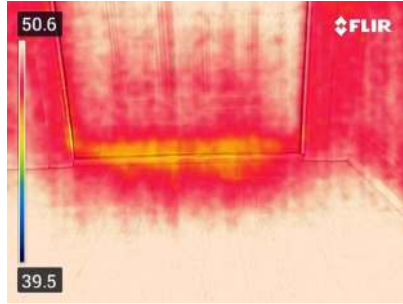
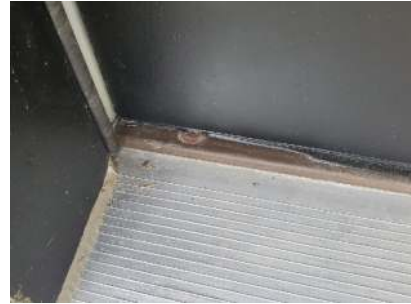
G. Doors (Interior and Exterior)

The sweep on the front door was not touching the threshold on some places; the sweep is dragging on the back door to patio. Adjustments to the bottom seals are recommended.

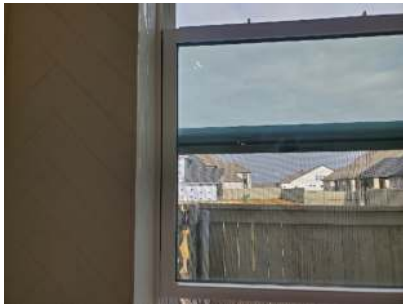
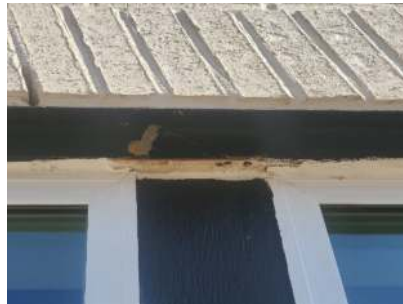
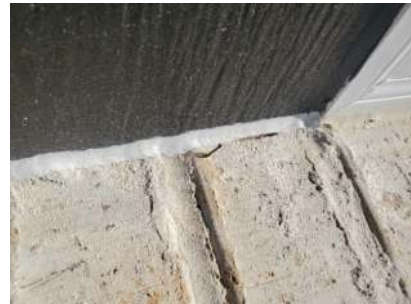
H. Windows

Some of the windows are stiff while operating. The sealant is missing in a couple of areas on the windows on the front. One of the bricks on the window sill is cracked.

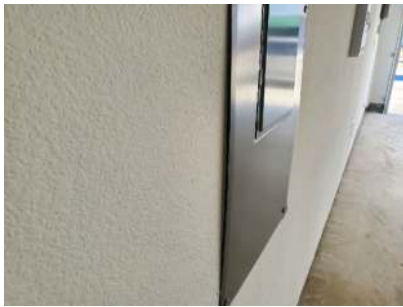
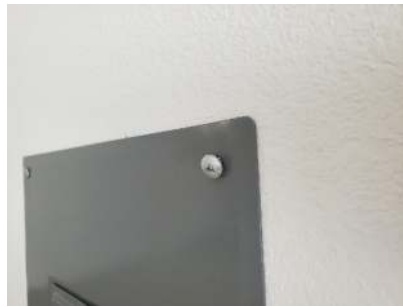
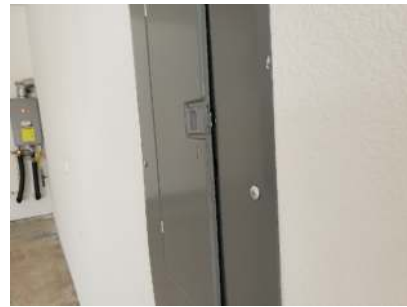
A. Service Entrance and Panels

The panel cover does not fit the wall well; the screws appear to be in crooked or cross threaded. Adjustments to the cover are recommended.

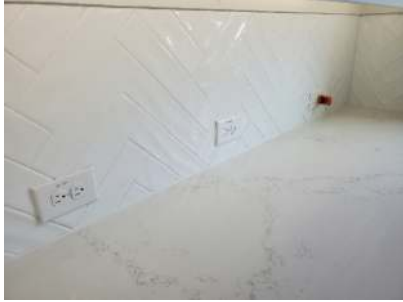
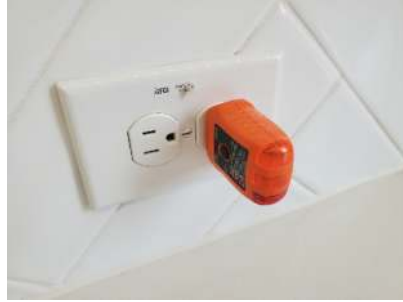
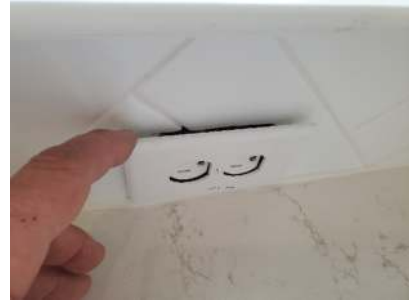
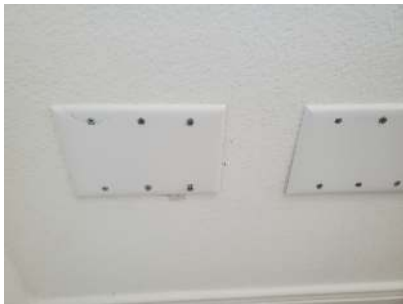
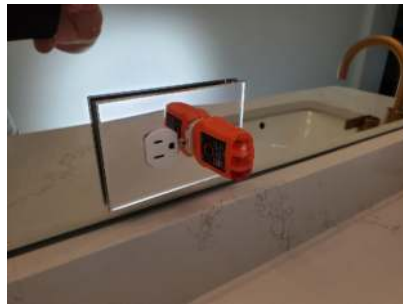
B. Branch Circuits, Connected Devices, and Fixtures

Some of the plugs in the small room off of the kitchen and master bathroom were not working at the time of the inspection. There are several screws missing on plate covers throughout the home.

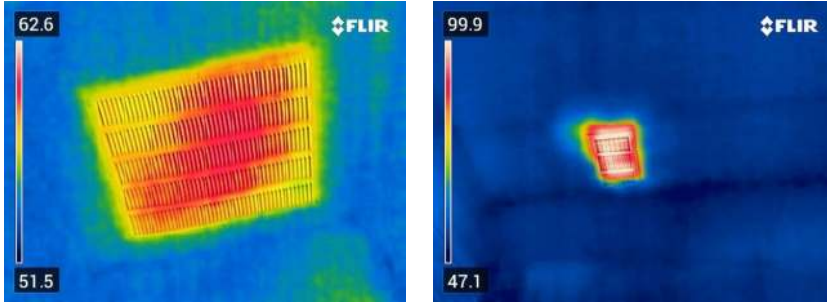
A. Heating Equipment

The gas fired heat unit was performing as intended at the time of the inspection.

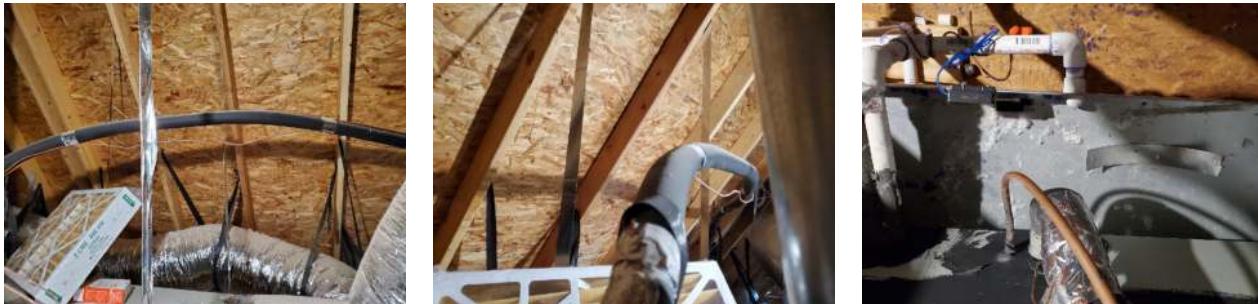
B. Cooling Equipment

The temperature outdoors was too low to test the system without causing possible damage to the unit; a visual inspection was made. The copper lines are not strapped well in the attic space; additional strapping to support the line is recommended. The emergency overflow pan is in need of cleaning out as to not clog the drain when needed.

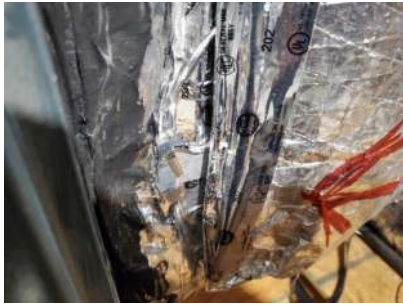
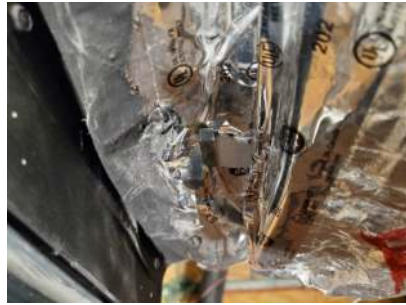
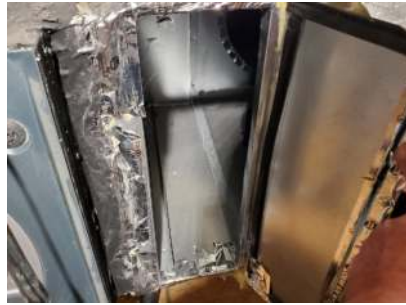
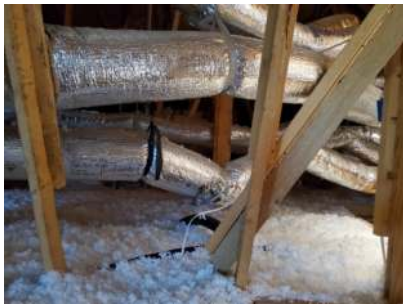
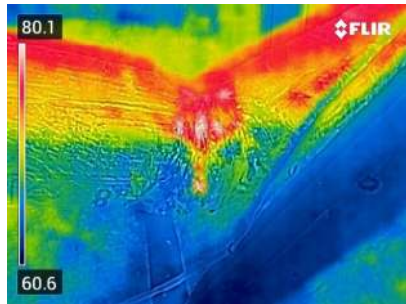
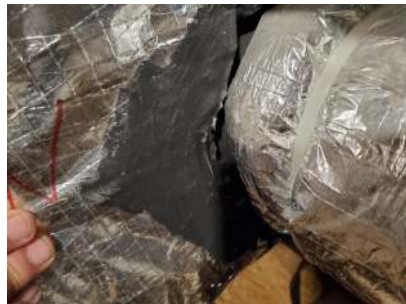
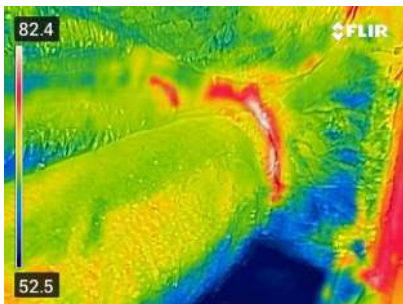
C. Duct Systems, Chases, and Vents

The filter door at the air handler is not sealing well and may allow air from the attic space into the unit. A 1 inch filter was installed in the unit; installing a quality filter at the return air before the unit is recommended. Sealing and suspending/strapping the spliced duct near the air handler is recommended. Sealing areas around the plenum boxes is recommended.

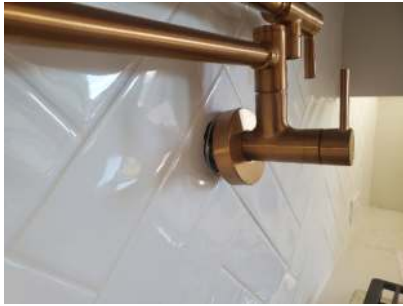
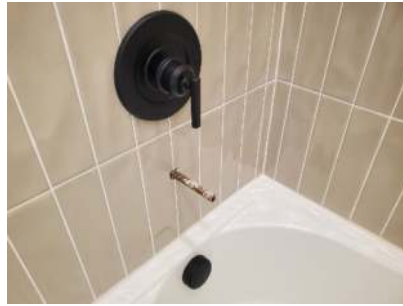
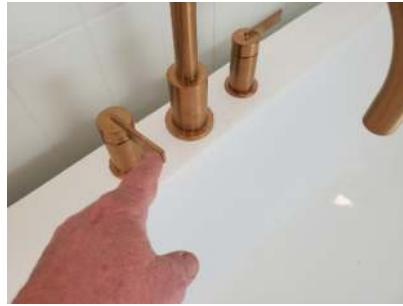
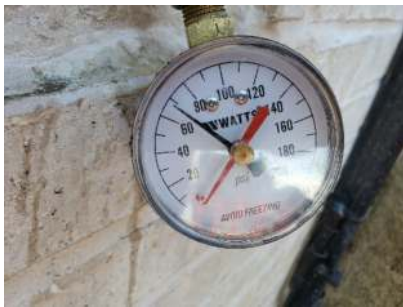
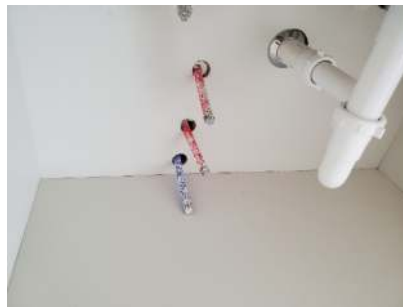
A. Plumbing Supply, Distribution Systems and Fixtures

The water cut off valve is located in one of the closets in the utility room. The escutcheon ring is not set on the pot filler over the cooktop (cosmetic). The tub filler is missing in the shared bath. There is no hot water to the master bath tub. There is some exposed pex piping under one of the cabinets in the master bath; shorting the piping or covering so that the piping is not disturbed is recommended.

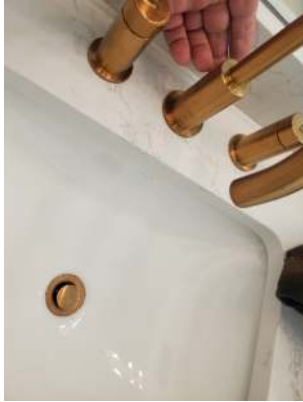
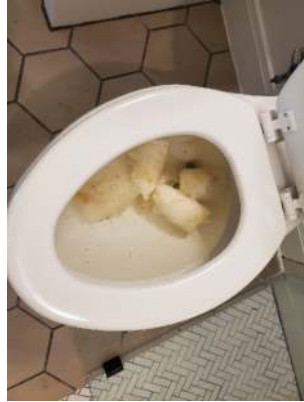
B. Drains, Wastes, and Vents

One of the stoppers is not connected or working properly on the sink in the master bath. One of the toilets is clogged and not flushing at the time of the inspection.

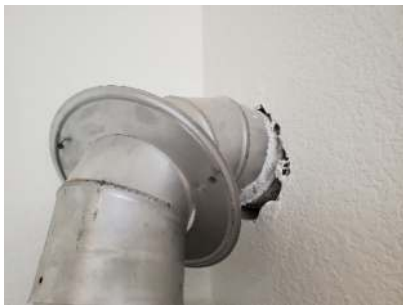
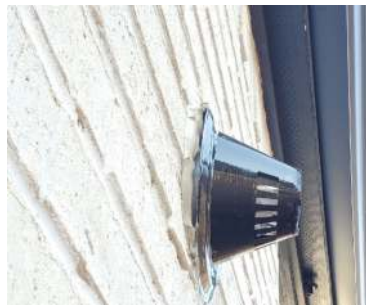
C. Water Heating Equipment

The tankless water heater was performing as intended at the time of the inspection. The heat exhaust piping cover ring was not installed on the interior in the garage. The exterior cover is not flat against the brick wall and not sealed well.

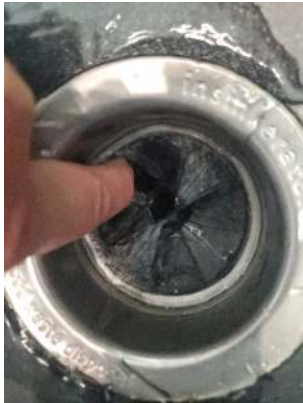
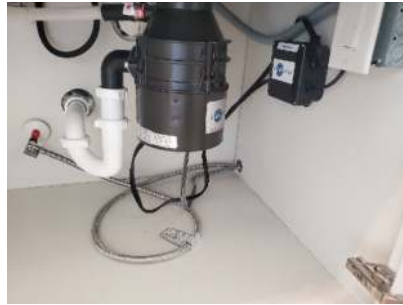
B. Food Waster Disposers

The disposal has something down in it; the stopper was missing. Suspending the power cord off of the cabinet floor is recommended.

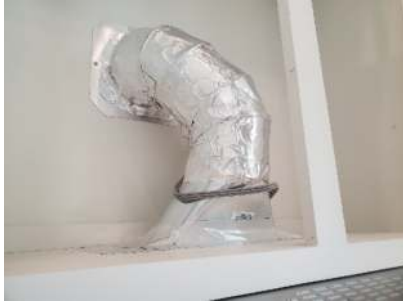
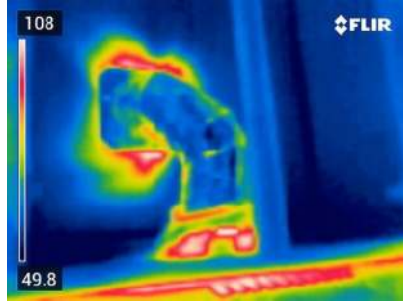
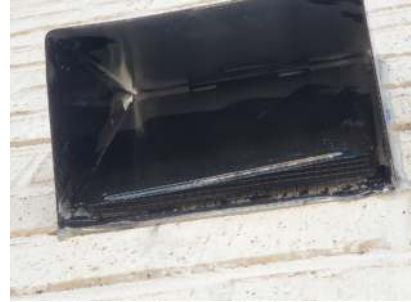
C. Range Hood and Exhaust Systems

The power cord for the vent hood is wrapped around the piping; rerouting of the wire so that it is not in direct contact with the piping is recommended. Sealing the piping at the bottom and at the wall is recommended. The exterior cover does not appear to be closing well; adjustments may be needed avoid drafts during high winds.

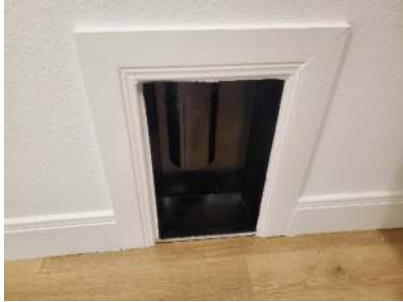
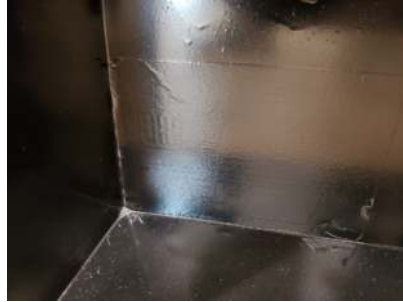
H. Dryer Exhaust Systems

The dryer vent warning label has been painted over. The dryer vent goes through the attic space and may exceed 25 foot. Keeping the dryer vent clear of lint build up is recommended to prevent a fire hazard. The dryer vent termination point confirmation is recommended.
