**ABSOLUTE
INSPECTIONS** LLC

Inspection Report

Property Address:
6300 Trezevant St
Rowlett TX 75089

By: _____
Kevin R. Weiss 7108 10/25/2021

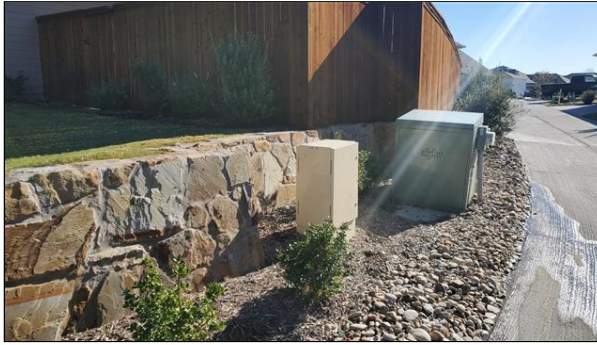
B. Picture 1

(2) Retaining wall present at South side of home. Ownership details unknown, recommend verification of ownership and maintenance responsibilities. Visual inspection only performed. No structural or engineering surveys performed. No warranties, guaranties are made or implied by this inspection.

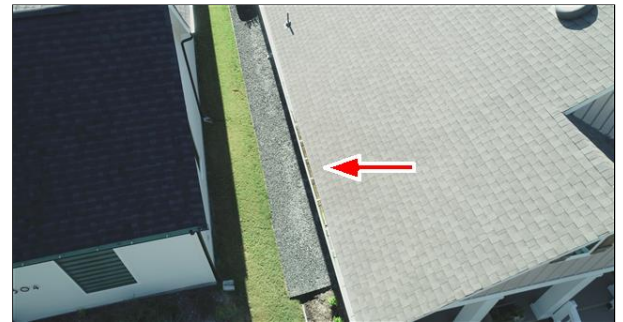
B. Picture 3

(3) Gutter pictured was holding water. Repair or adjustment of the "drop" is recommended to correct this problem. If gutters are not installed properly they may overflow and cause damage. Recommend review and repair as needed by a qualified contractor.

(3) Gutter pictured was holding water. Repair or adjustment of the "drop" is recommended to correct this problem. If gutters are not installed properly they may overflow and cause damage. Recommend review and repair as needed by a qualified contractor.

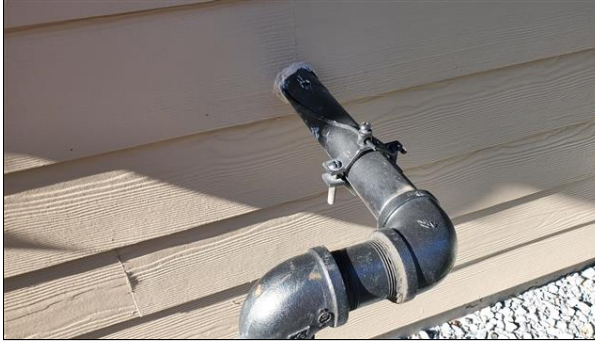
A. Picture 5

(2) Gas pipe bonding wire observed.

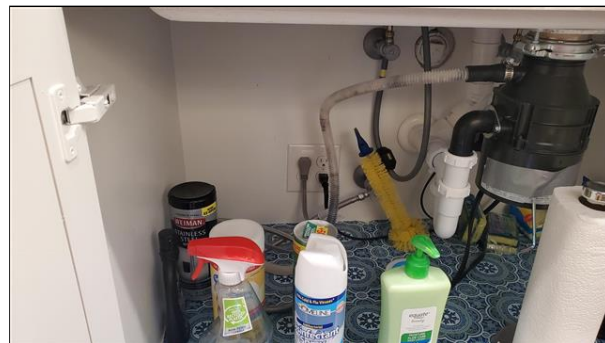
A. Picture 3

(2) A visible backflow device, an air-gap device or properly installed high loop at dishwasher drain line, was not found. The air gap helps to prevent a backflow of contaminated water into the dishwasher. This feature is required by most cities in our area and the absence of such may be considered a health hazard. Recommend review and repair as needed by a qualified contractor.

(2) A visible backflow device, an air-gap device or properly installed high loop at dishwasher drain line, was not found. The air gap helps to prevent a backflow of contaminated water into the dishwasher. This feature is required by most cities in our area and the absence of such may be considered a health hazard. Recommend review and repair as needed by a qualified contractor.
-

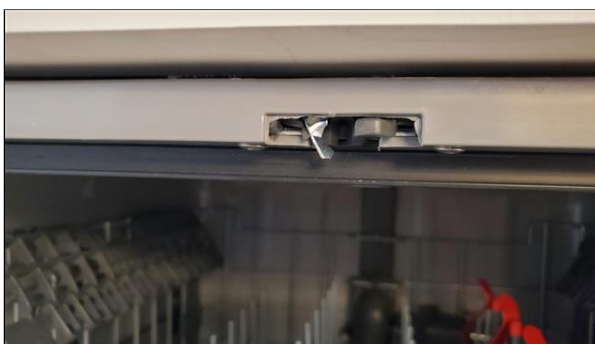
A. Picture 4

(3) Dishwasher door latch mechanism broken. Unit would not operate. Recommend review and repair as needed by a qualified contractor.

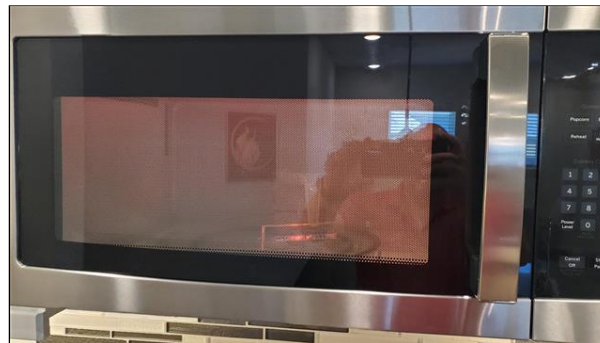
E. Picture 1

The microwave unit was inspected and appeared to be functioning as intended at the time of the inspection. Inspection of the microwave is for heating ability only. No radiation leak testing was completed.
