## RESIDENTIAL HOME INSPECTION

34315 AL-91  
CULLMAN, AL 35055, USA

2/12/2026 9:00AM

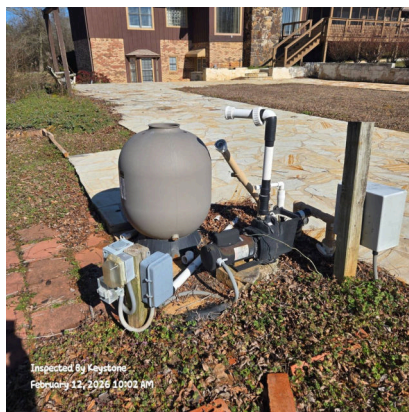
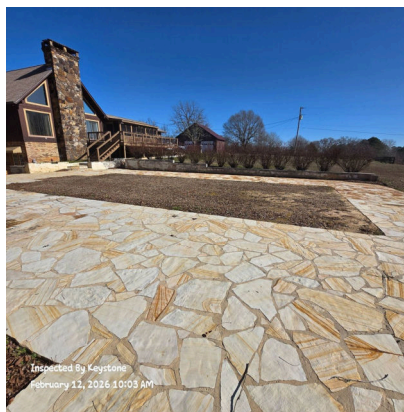
**Location:** Front of House

Inactive pool equipment, including a pump and filter assembly, remains installed at the rear patio area. The system does not appear to be in use and shows signs of age and weather exposure. Recommend removal or proper decommissioning of unused equipment to prevent deterioration, electrical hazards, and trip hazards.

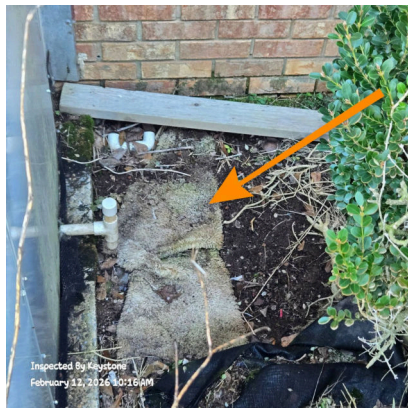
**Location:** Back of House

Carpet material was observed placed around the HVAC unit and within the adjacent flower bed areas. This material retains moisture and promotes moss growth, which may contribute to excess moisture around the equipment and surrounding components. Removal of the carpet and replacement with appropriate landscaping material is recommended to help maintain proper drainage and airflow around the unit.

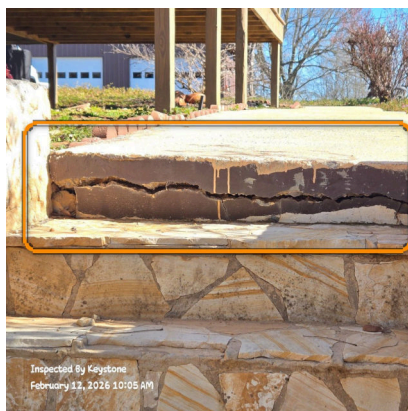
**Location:** Front of House

### 2.5.3 Cracked and Deteriorated Concrete Sidewalk !

The concrete sidewalk shows significant horizontal cracking and separation with visible deterioration along the edge. This condition may affect structural integrity and presents a potential trip hazard during normal use. Further evaluation and repair by a qualified concrete professional is recommended to restore proper support and safe walking conditions.

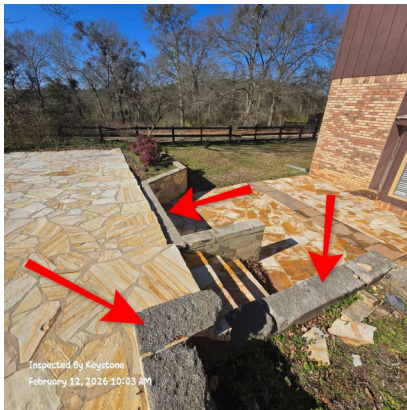
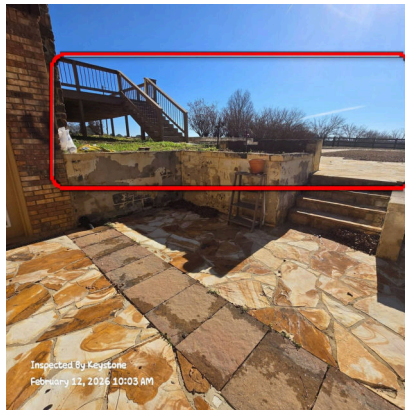
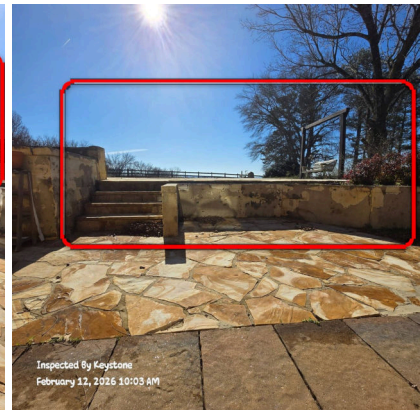
**Location:** Front of House

## 2.6.1 Missing Guardrail at Elevated Patio Edge

A 3–4 foot drop-off is present between the upper pool deck and the lower patio area without a guardrail or protective barrier. The similar surface materials make the edge difficult to distinguish, creating a significant fall hazard. Recommend installation of a secure guardrail or barrier to reduce the risk of injury.

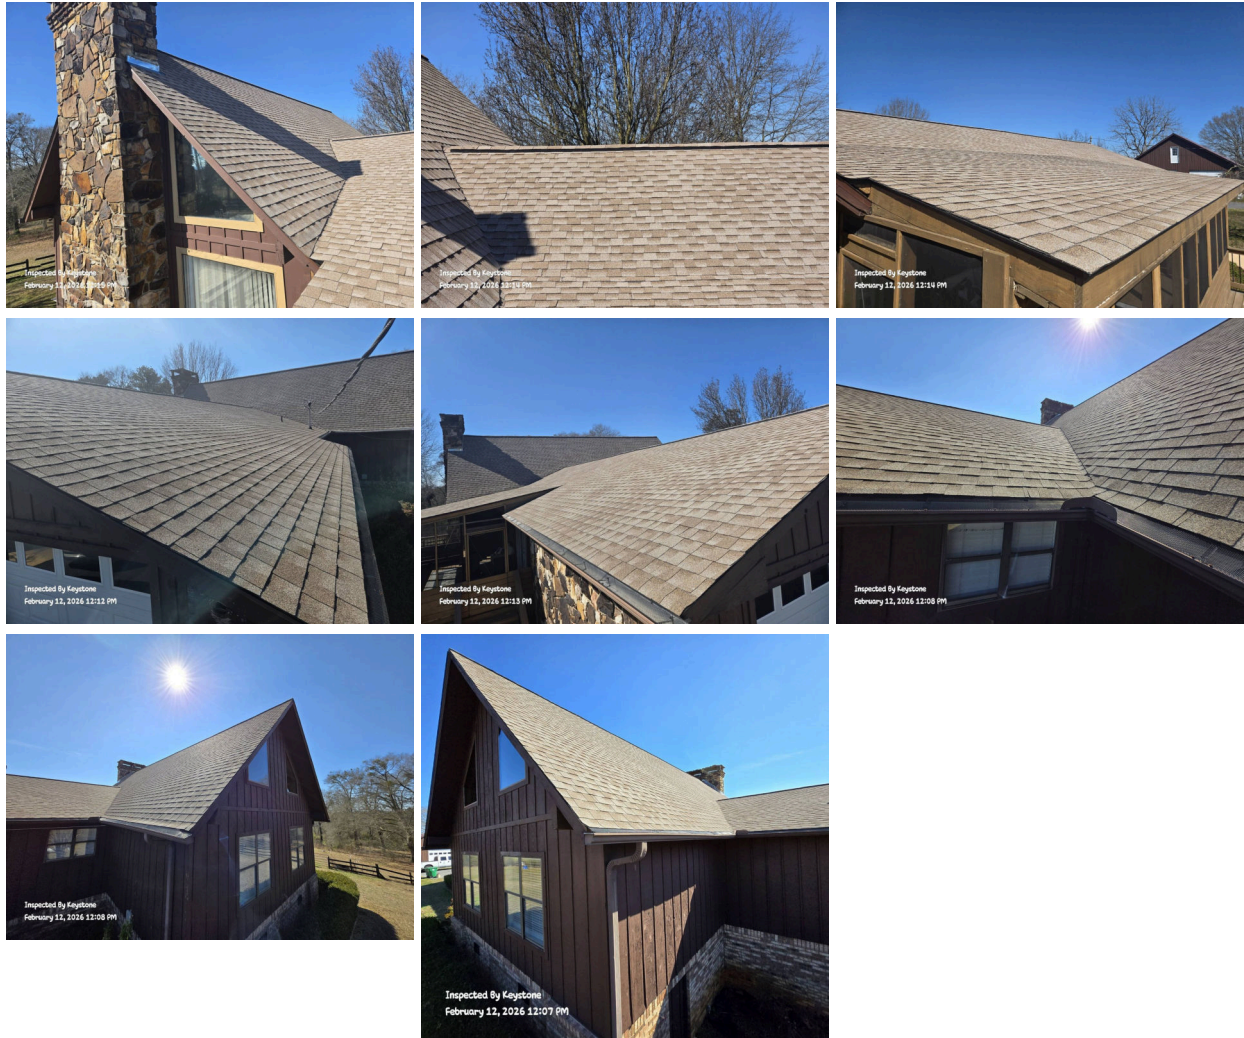
#### 3.2.2 General Roof Pictures

The roof shows typical wear patterns, including granule loss, discoloration, and surface degradation. These signs indicate a natural aging and prolonged exposure to the elements, which gradually diminish the roof's ability to provide adequate protection from water infiltration. If not addressed, these combined issues could lead to leaks or further damage.

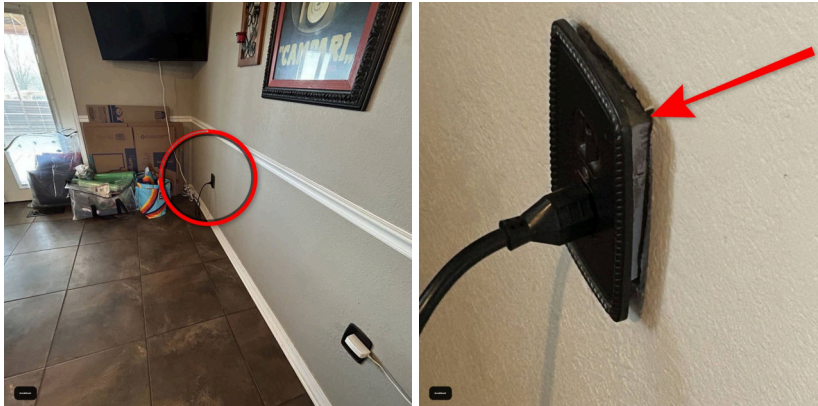
**Location:** See Pictures

#### 6.5.1 Receptacle & Plate Cover is Loose

The receptacle and the plate cover is loose,

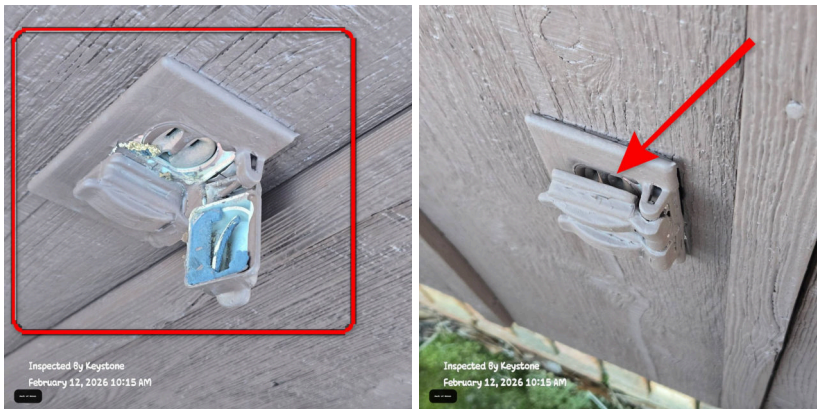
**Location:** See Pictures

### 6.5.2 Exterior Outlet is Damaged

The exterior electrical box is rusted, improperly secured, and has a loose or damaged cover, which may expose wiring to moisture and debris. A licensed electrician should evaluate and repair or replace the box to ensure safety and proper function.

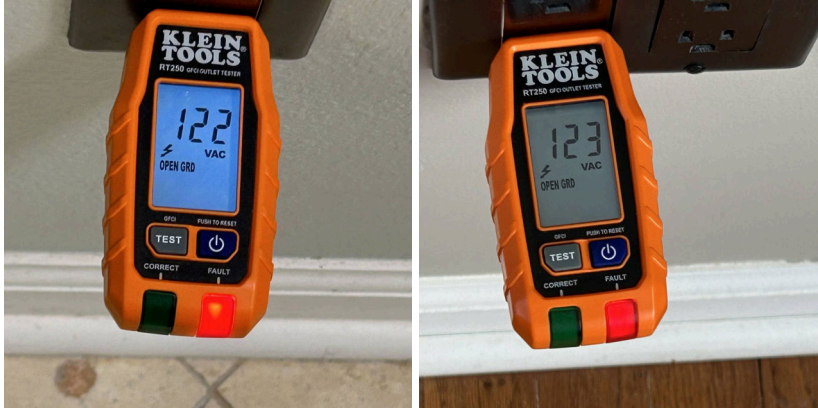
**Location:** Interior Throughout

### 6.5.3 Receptacle Detected Open Ground

The receptacle tested shows an "Open Ground" condition, which means the outlet is not properly grounded. Further evaluation by a qualified electrical professional is recommended to determine the cause and discuss appropriate corrections based on current standards and intended use.

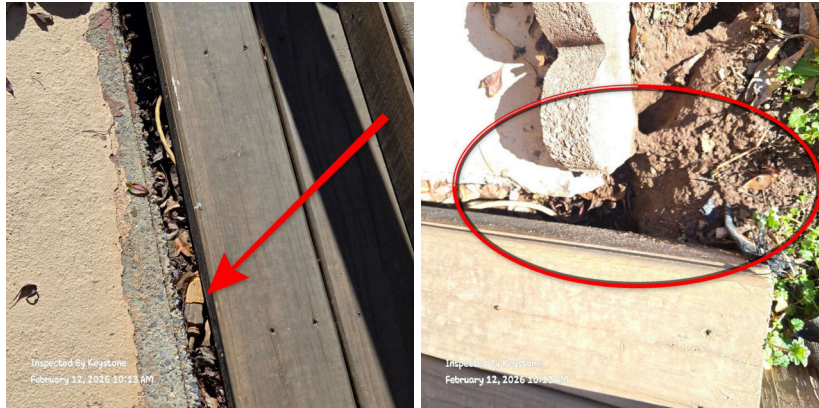
**Location:** Front of House

An extension cord with a connected device was observed routed beneath the walkway area between the concrete and deck, where soil erosion is present. This condition may expose electrical components to moisture and creates a potential electrical hazard. Further evaluation and correction by a qualified electrical professional is recommended to remove the temporary wiring and provide a proper permanent electrical solution.

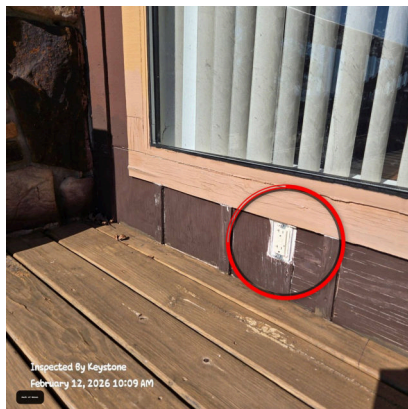
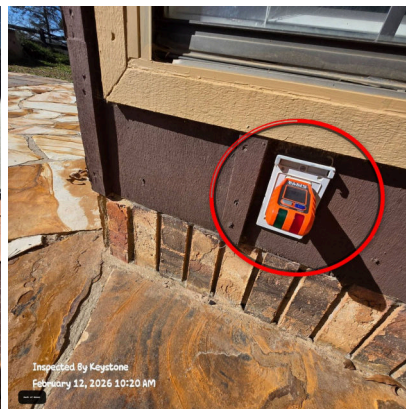
**Location:** See Pictures

The exterior receptacle is missing a proper weatherproof cover and appears exposed to moisture. Exterior outlets are intended to be protected from rain and water intrusion to reduce the risk of electrical hazards. Further evaluation and correction by a qualified electrical professional is recommended to install an appropriate in-use weatherproof cover.

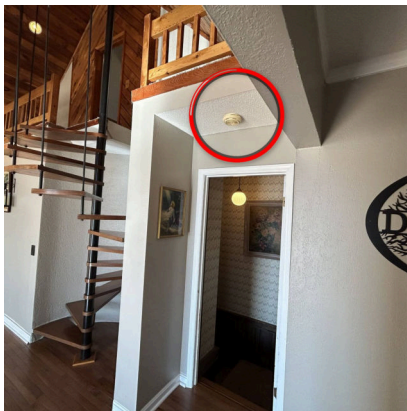
Smoke detector failed to respond when tested. Recommend replacing the battery or installing a new unit for safety reasons.

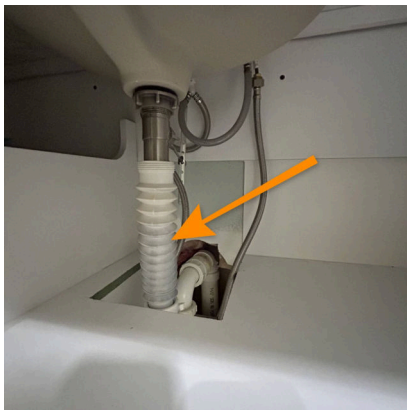
**Location:** Master Bath

The sink drain connection includes a flexible coupling that is not a standard plumbing fitting for this application. This setup may be prone to clogs and leaks overtime. Monitor and repair if needed by a plumbing contractor.

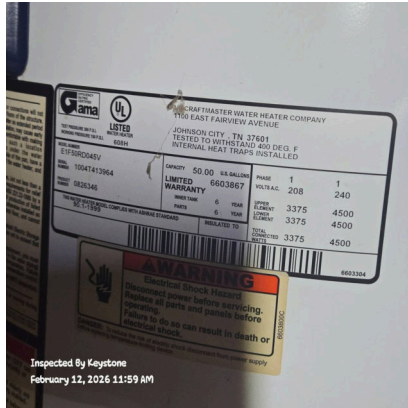
**Location:** Crawlspace

The electric water heater is a Rheem unit manufactured in October 1996. Typical service life for electric water heaters is approximately 10–15 years. This unit is well beyond its expected service life and, while it may have been operational at the time of inspection, there is an increased risk of internal tank failure and leakage due to age. Replacement by a qualified licensed plumbing contractor is recommended, and budgeting for replacement should be considered a priority.

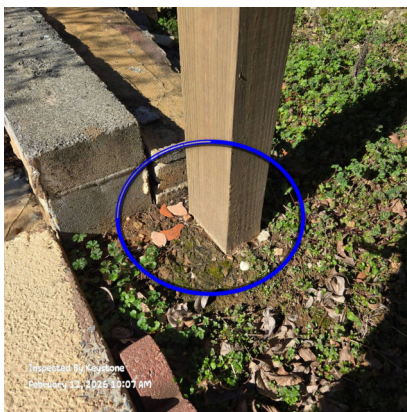
**Location:** Front of House

The deck posts is in direct contact with the soil, which can increase moisture exposure over time. Monitoring this area and maintaining proper drainage is recommended to help reduce long-term deterioration and damage to the wood.

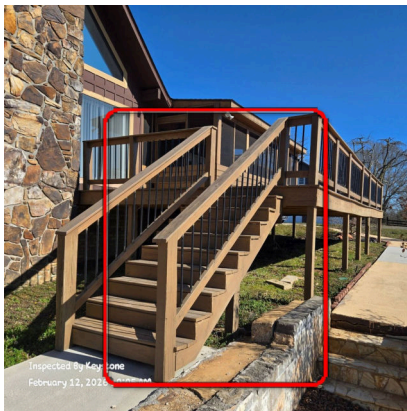
**Location:** Front of House

One or more handrails at the steps are loose and may not provide reliable support. Further evaluation and repair by a qualified professional is recommended to improve safety.

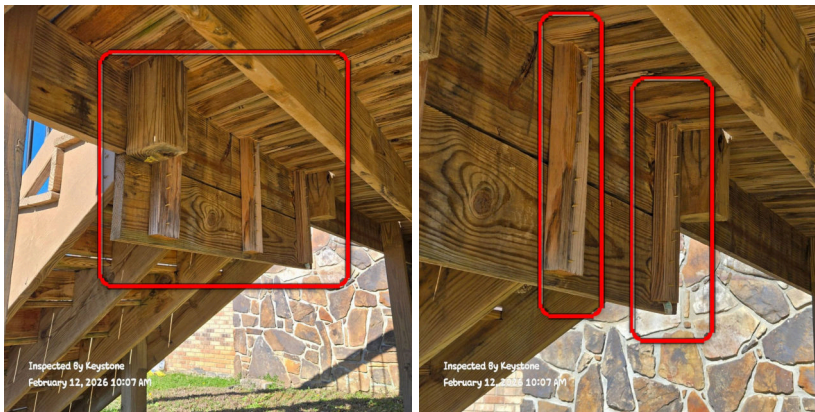
**Location:** Front of House

Multiple fastener ends were observed protruding from the stair framing members at a height accessible to occupants. These exposed points may present a risk of head or injury contact during normal use of the area below. Further evaluation and correction by a qualified professional is recommended to trim, secure, or otherwise address the exposed fasteners for improved safety.

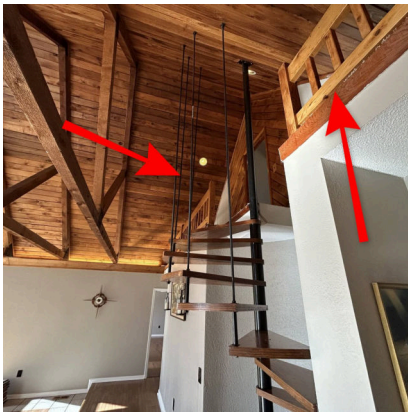
**Location:** Living Room

The spiral staircase and loft area have open guarding with wide spacing that may allow a child to pass through or fall, and the adjacent balcony guard height appears lower than typical safety standards. These conditions present a potential fall hazard during normal use. Further evaluation and modification by a qualified professional is recommended to improve guarding and overall safety.

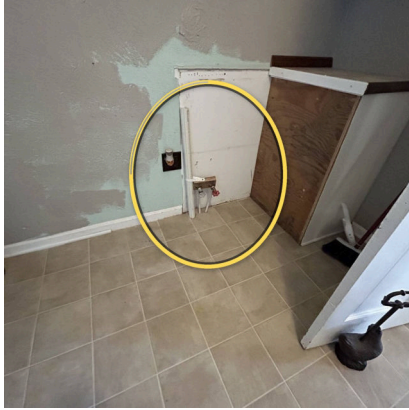
**Location:** Laundry Room

The washer was not installed at the time of the inspection. As a result, the washer supply hoses and drain connection were not tested, as proper operation and leak evaluation require the appliance to be connected and in use. These components are typically verified once the washer is installed and operating.

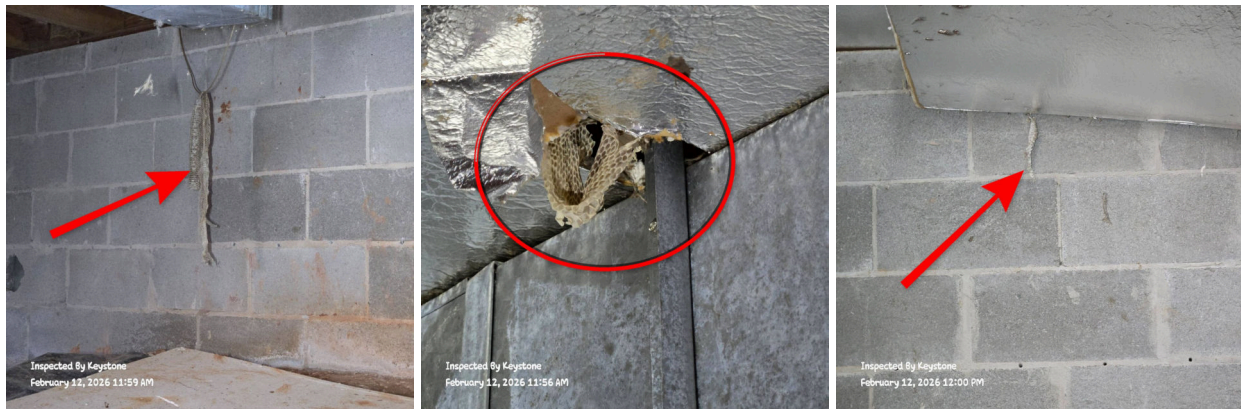
**Location:** Crawlspace

Multiple shed snake skins were observed within the crawl space, including one at the HVAC ductwork and another hanging from an unsecured electrical wire. This indicates prior wildlife activity and suggests possible openings or gaps allowing entry into the crawl space. Further evaluation by a pest control professional is recommended, along with securing loose wiring and sealing accessible entry points to help prevent future intrusion.
