FOUR POINT INSPECTION

333 Turquoise Terrace
Jensen Beach, FL 34957

JUNE 21, 2024

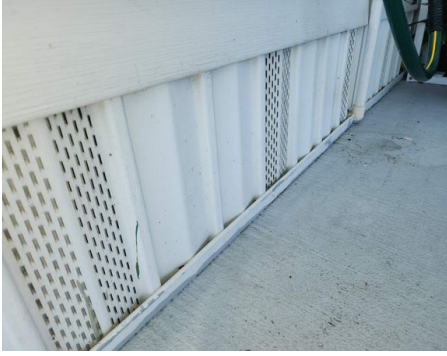
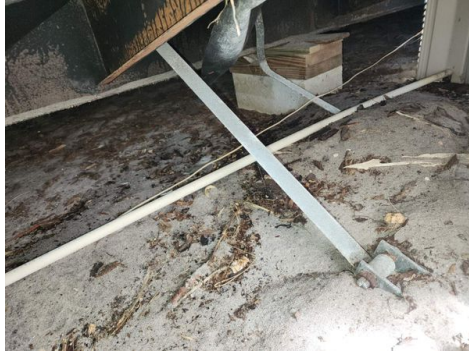
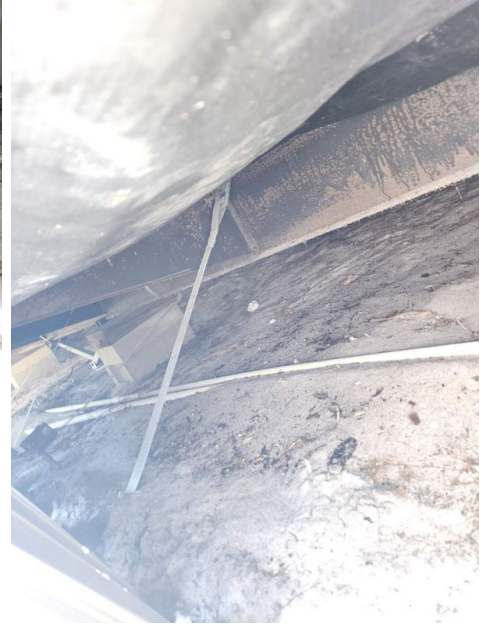
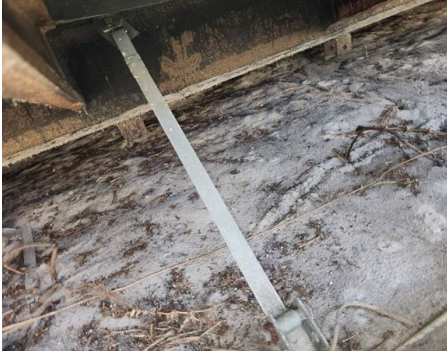
Crawlspace

There was limited access to the crawlspace at the time of inspection. For this reason I was not able to fully evaluate this area.

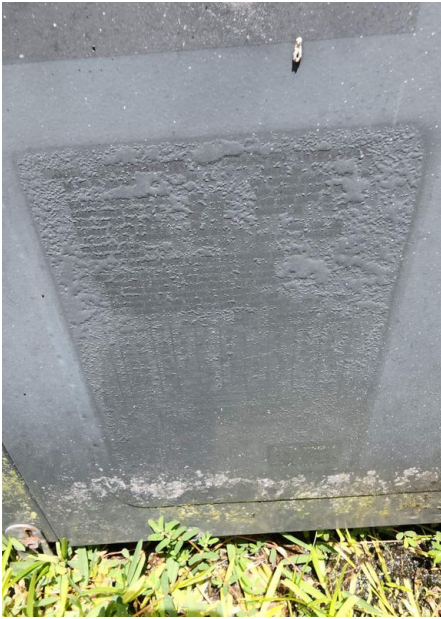
Package Unit Tag

No tag present
