3301 Ricci Ln
Irving, TX 75062
Report ID:20261003-0013301 Ricci Ln

PROPERTY INSPECTION REPORT FORM

Pat Starkey <i>Name of Client</i>	03/10/2026 <i>Date of Inspection</i>
3301 Ricci Ln, Irving, TX 75062 <i>Address of Inspected Property</i>	
William Lee <i>Name of Inspector</i>	6983 <i>TREC License #</i>
<i>Name of Sponsor (if applicable)</i>	<i>TREC License #</i>

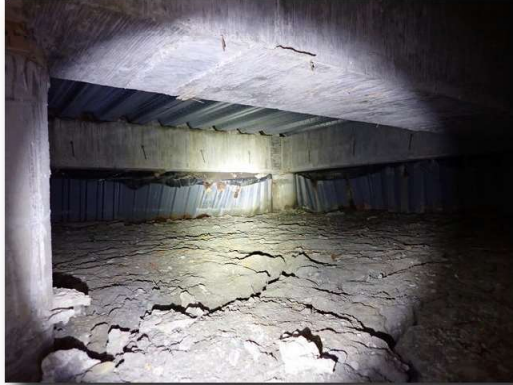
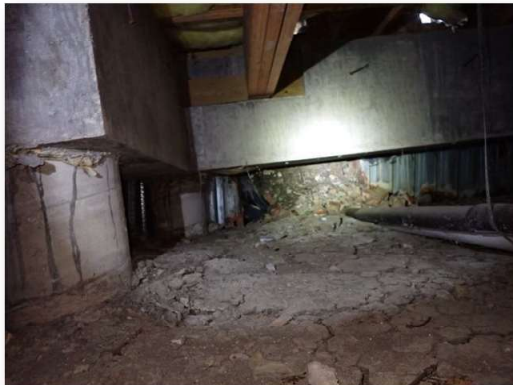
- The skirting has a couple area where it is starting to fail - one under the garage and the other by the front entry

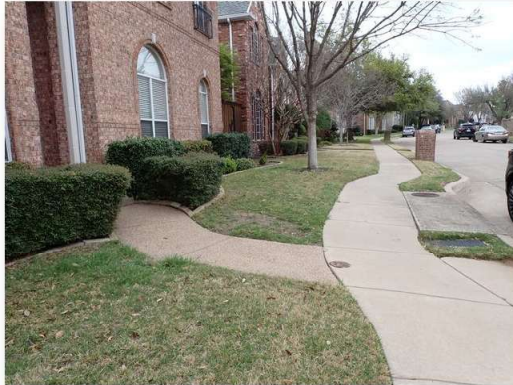
Obvious or ongoing drainage problems were observed around the perimeter of the structure during the inspection at the front flower bed. The IRC states there should be a minimum fall (slope) of 6 inches away from the foundation for the first 10 feet from the house. Monitor site drainage condition over time, especially during rainy weather, and have correction or improvements made if needed. Poor drainage can cause foundation movement, water penetration or attract termites/pest. Avoid landscaping which promotes slow water drainage.

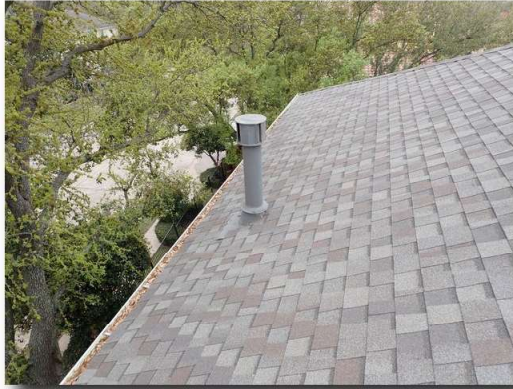
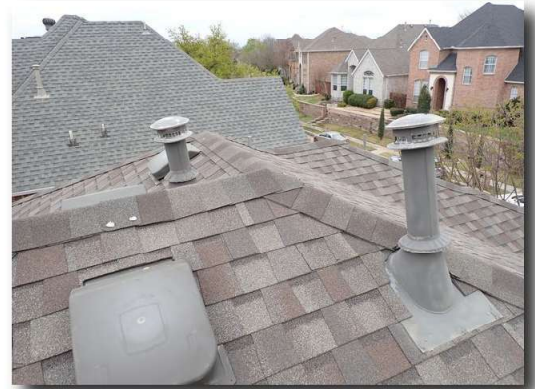
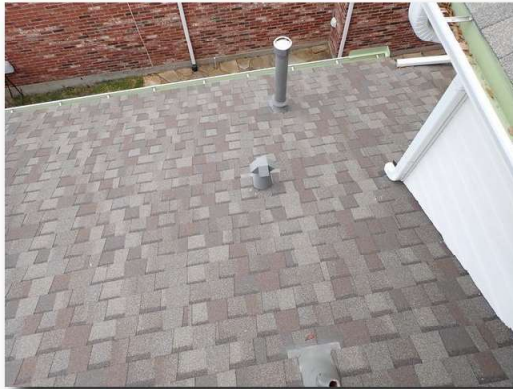
- There is excessive leaves and other debris present on the roof gutters. This material should be removed as soon as possible to prevent any damage.

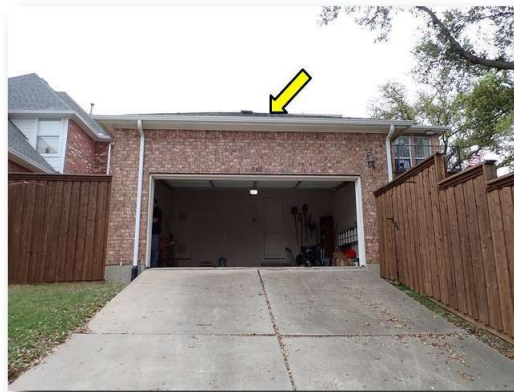
- I speculate there is an attic over the garage that has not been opened.

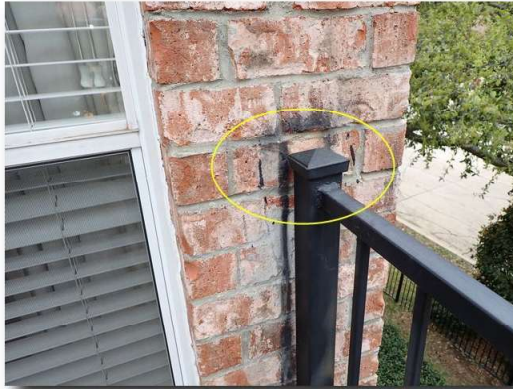
- The brick walls need to be cleared of paint at the upstairs balcony.

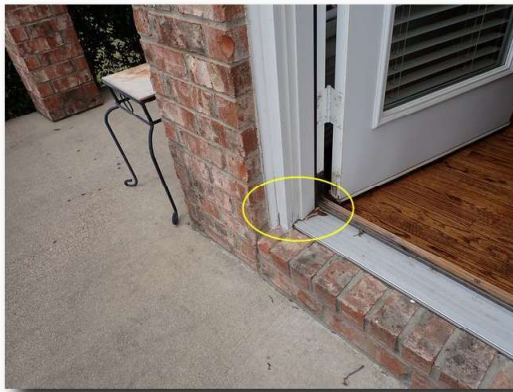
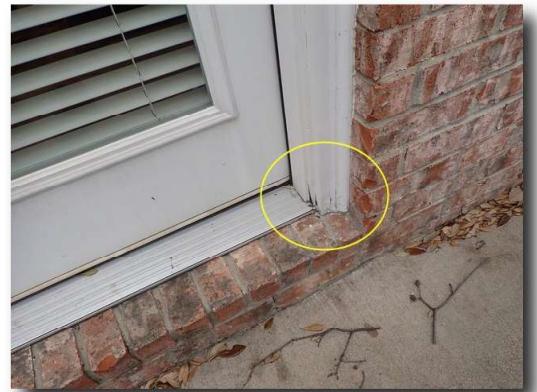
- The door from the garage to the house does appear to be self closing.
- **The family room - door to the patio - the base frame is rotted.**

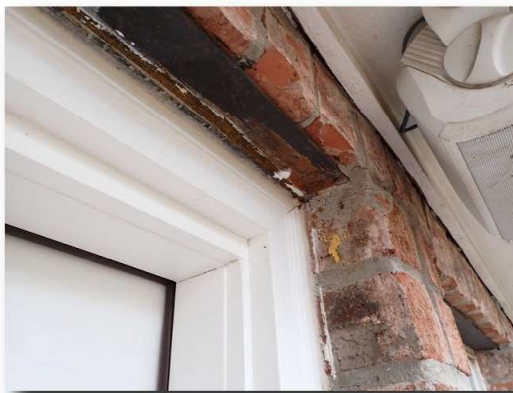
- **The upstairs door to the patio header needs painting.**

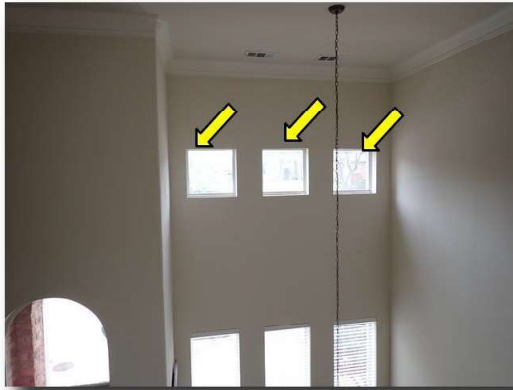
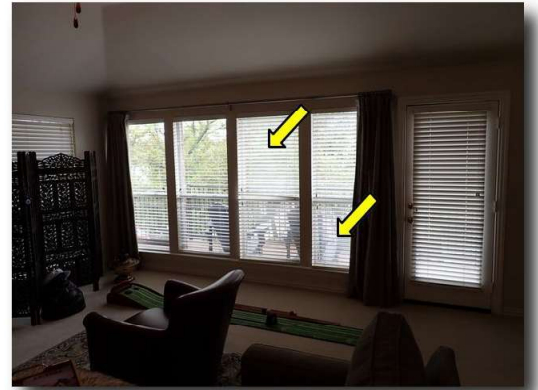
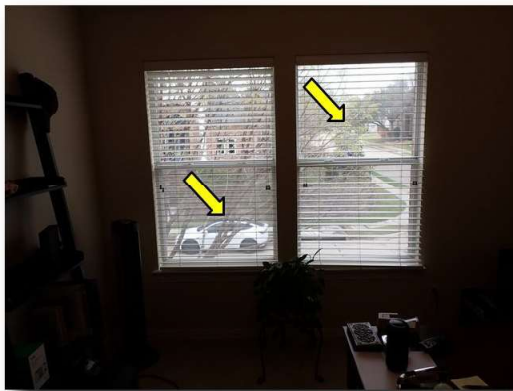
- Some seal failures may not have been discovered due to soiled window conditions, discreet or subtle failures, lighting or window treatments.
- Fog and condensation was noted in the double glazed insulated window panes. This indicates a broken seal which will reduce visibility and the insulating capability of the window. To restore visibility and regain the insulating capability, replacement of the window is required. Suspected failed seal(s) were seen on double pane (multi-pane) windows at:
 - The formal dining - 3
 - The upstairs living room - 2

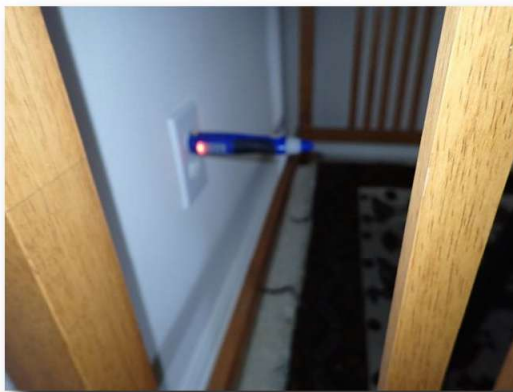
- The upstairs west bedroom - by the bathroom the outlet gives a "not grounded" reading when tested.

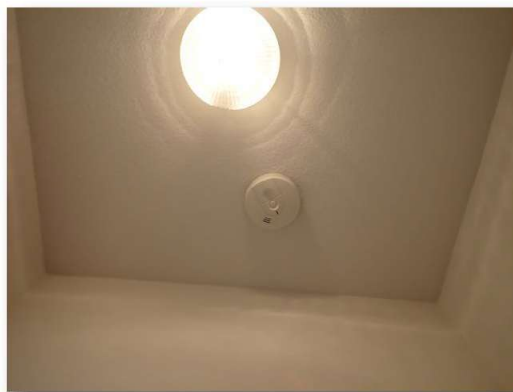
- The smoke alarms appear to be installed at all the proper locations. A manual button was pressed on at least one smoke alarm. All smoke alarms were not physically tested for proper operation or functionality.
- The smoke alarms appear to be installed at all the proper locations.

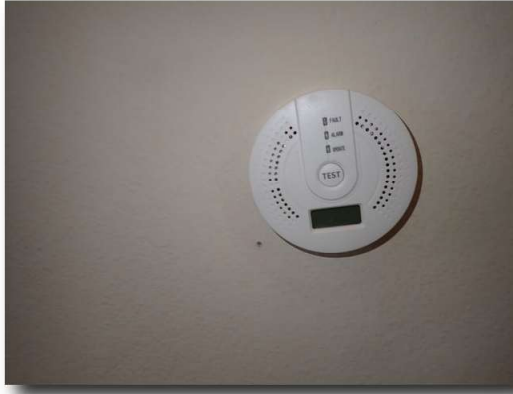
- There is a visible carbon monoxide alarm present.

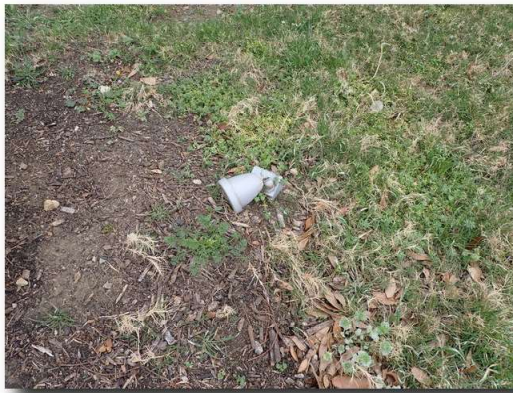
The outside landscape lighting is present, but is not specifically inspected. These systems are considered a plugged in appliance and may have many sensors that turn the system on/off at various time or trigger events.

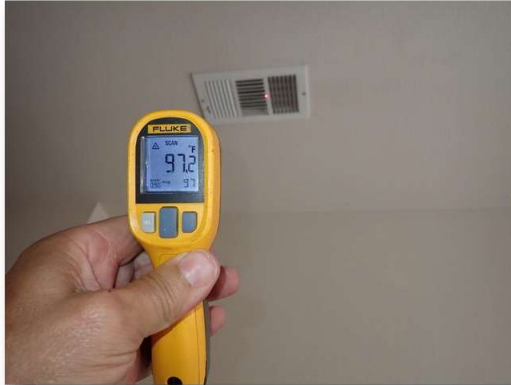
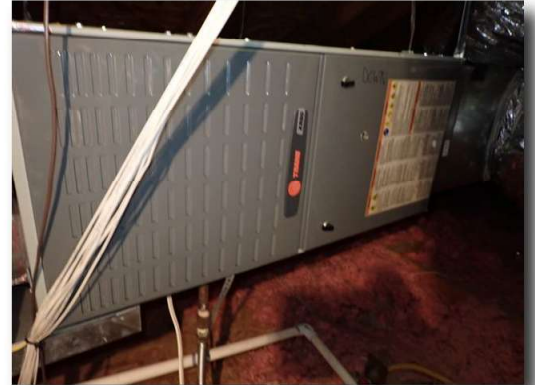
Location of the inside heater unit: Upstairs Hallway Attic
Servicing the: Downstairs
Sediment trap is not present

- The system was operable using normal controls.

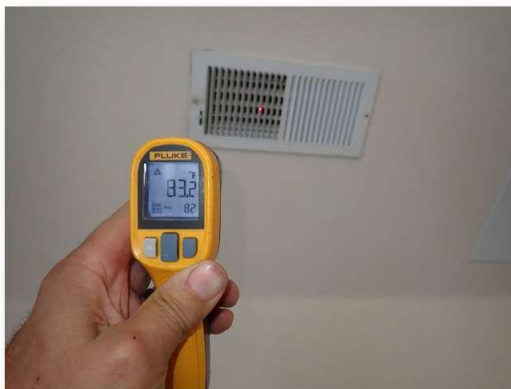
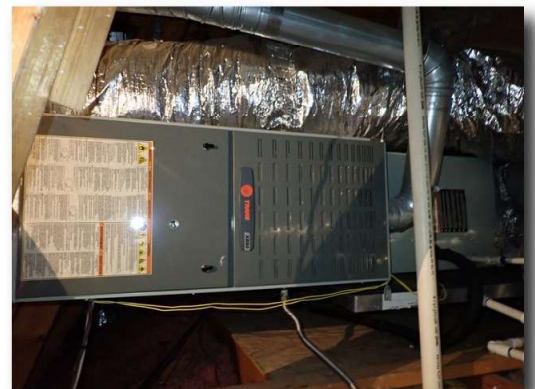
Unit # 2

Location of the inside heater unit: Upstairs Hallway Attic
Servicing the: Upstairs
Sediment trap is not present

- The system was operable using normal controls.

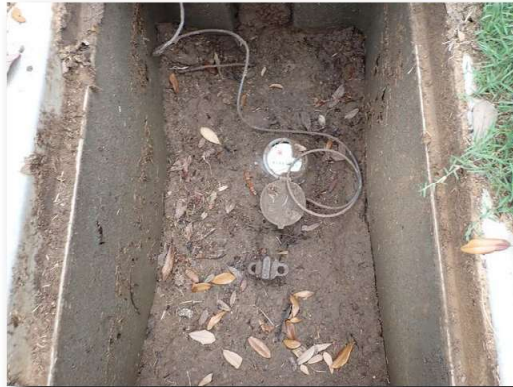
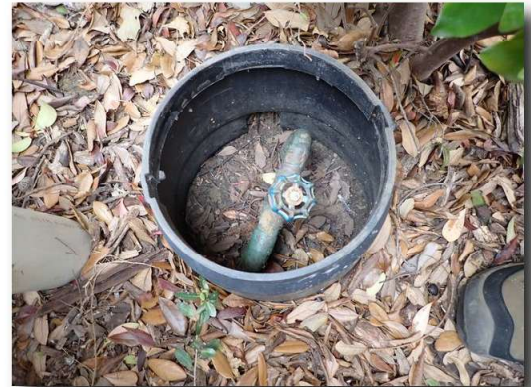
Water Meter

- The water meter was checked and did not indicate a leak at the time of inspection.

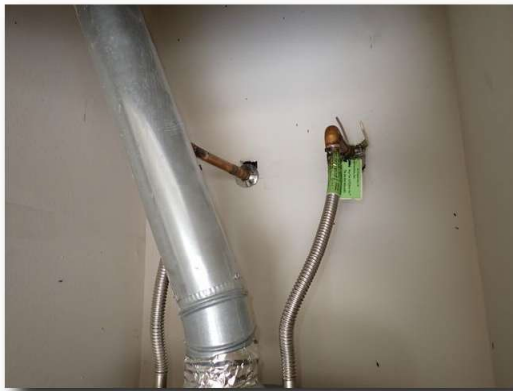
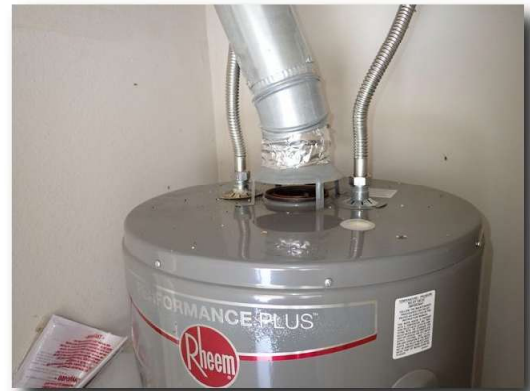
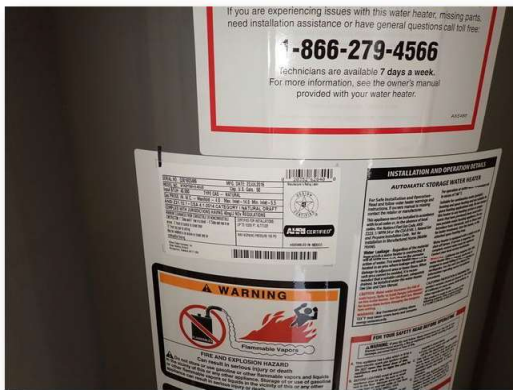
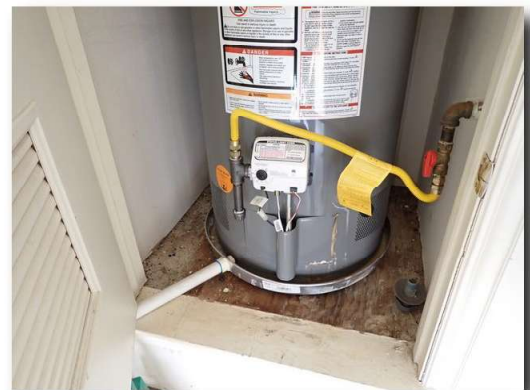
The Garage water heater:

- Brand: Rheem
- Year made: 2015
- Energy Source: Gas
- The temperature and pressure relief valve is present
- Sediment trap is not present
- Cold Water Shutoff: is present
- Pressure Tank Present: No
- Drain pan is present
- Drain pan drain line is present
- Gallon Capacity: 50

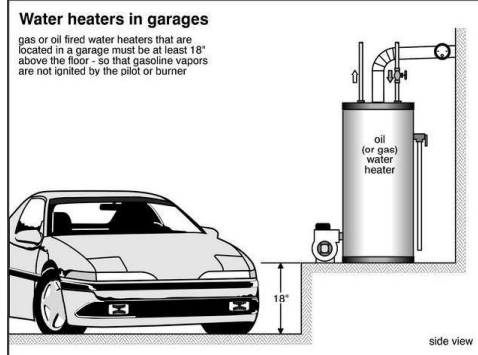
IRC G2408.2 / G2406.2 states gas-fired water heaters installed in garages must be installed so that the ignition source (burner, pilot, or heating element) is at least 18 inches above the garage floor. This requirement is intended to reduce the risk of igniting flammable vapors from gasoline or other chemicals commonly stored in garages.

The TREC Standards of Practice §535.231(b) specifically require inspectors to report as Deficient units where the ignition source *or heating elements* of a water heater in a garage are not a minimum of 18 inches above the lowest garage floor elevation, unless the unit is listed for garage-floor installation (FVIR).

- The unit is not 18 inches above the ground.

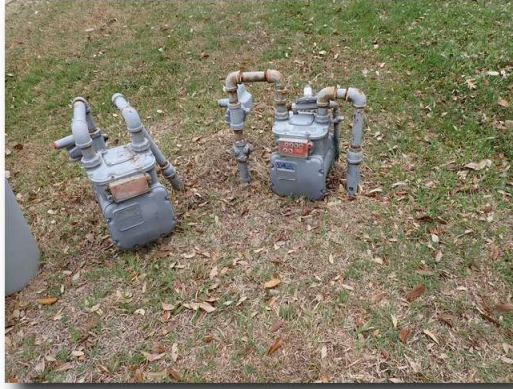
- The gas meter is in proper working order.
- Visible bonding of the gas line present: No

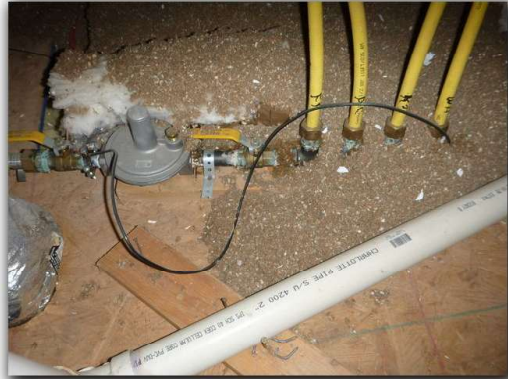
The gas supply piping in the home is Corrugated Stainless Steel Tubing (CSST). This material has a slight risk of developing leaks during lightning storms. CSST is conductive as is copper and it also terminates into the ground as does the grounding system of the electrical system. Should the electrical system become super charged during an indirect lightning strike, there is a possibility that the grounding conductor of the Romex line will arc to the CSST when they are located together.

This arcing is the problem because CSST is so thin, a hole can easily be burned into the pipe. As part of a Class action settlement, a mandatory installation procedure was developed whereas the electrical grounding system and the gas piping system are to be bonded together to prevent arcing.

- There is Corrugated Stainless Steel Tubing present in the attic and there is not visible grounding at the gas manifold.

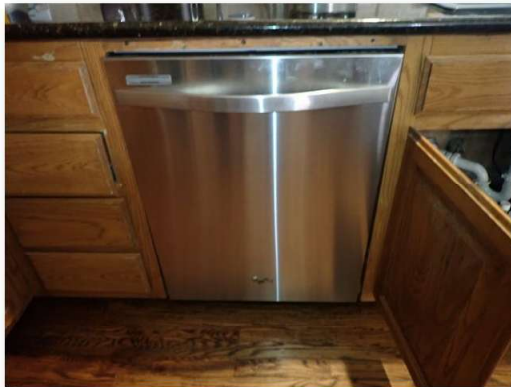
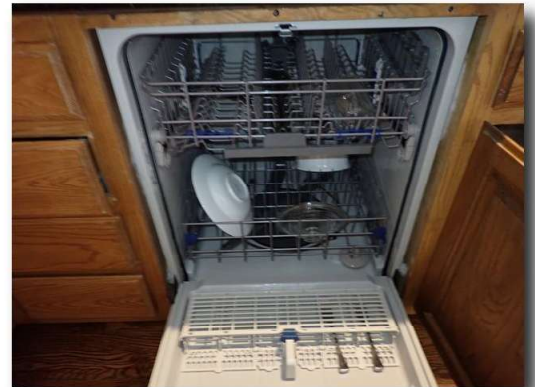
A. Dishwashers

- The dishwasher is present and operates in normal mode.

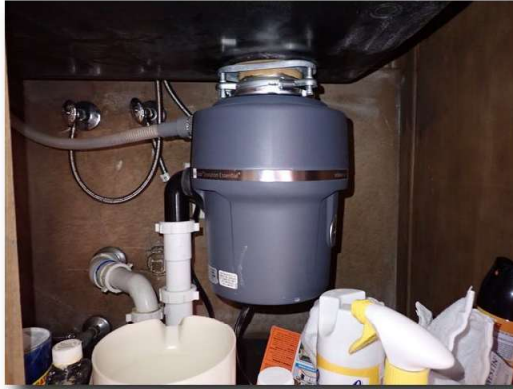
B. Food Waste Disposers

- The waste disposer is present and operates in normal mode.

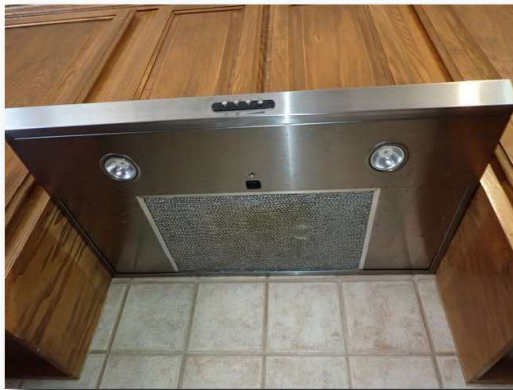
C. Range Hood and Exhaust Systems

- The hood range and light are present and operate in normal mode.
- The hood range is a recirculating type vent.

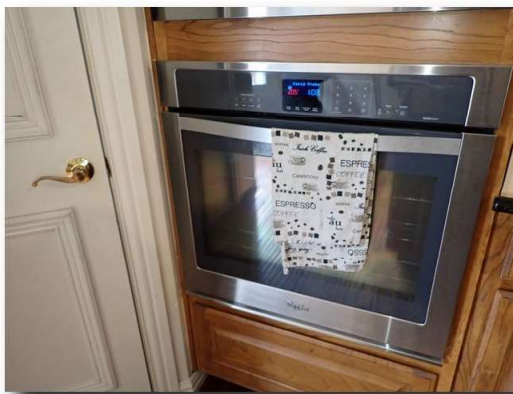
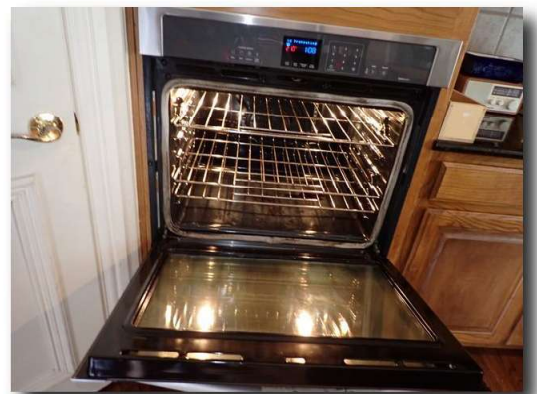
D. Ranges, Cooktops, and Ovens

- The cooktop is gas and all burners are functional.
- The oven was set to 350 degrees and tested within ± 25 degrees.

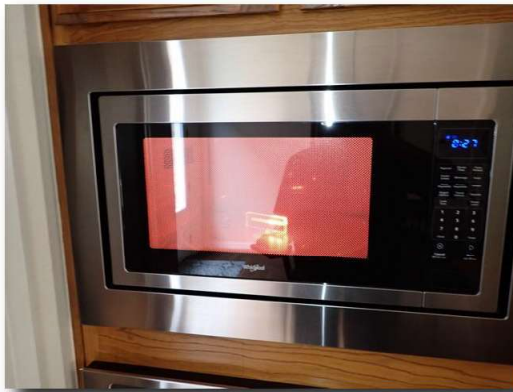
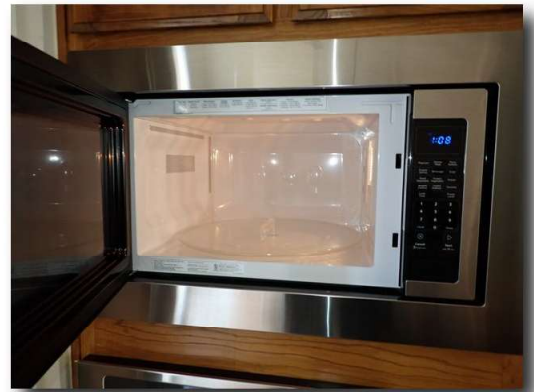
E. Microwave Ovens

- Microwave is present and operates in normal mode.

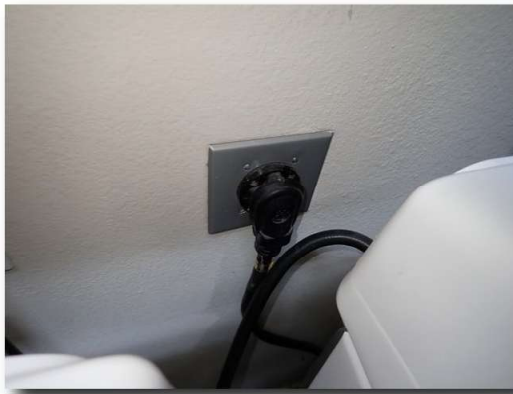
H. Dryer Exhaust Systems

- The dryer has electric service and the electric plug appears to have a 4 prong connection; electric plug does not appear to be GFCI protected.

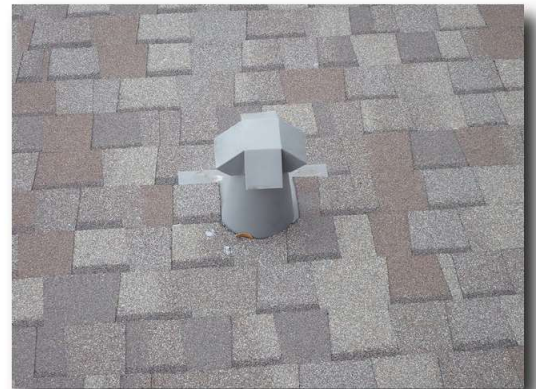
Current

- **The vent for the dryer is an "old" style on the roof.** The roof vent must be accessible for service and has a flap that opens and closes to help keep out pest and debris.
