# Home Inspection Report

720 Third Road, Grand Island, NE 68801

KYH26C27B

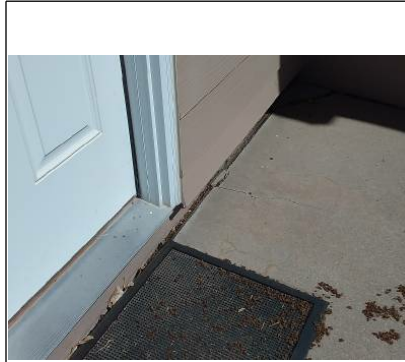
South

**Comments** Exterior North central w alkway cracked and settled and pitched toward the house; recommend repair or replacement of damaged section(s).  
Gaps between walkway and house; recommend sealing to prevent water penetration.  
Other walkways cracked and settled, but usable; recommend filling crack(s) and sealing and repair or replacement of damaged section(s) as needed.

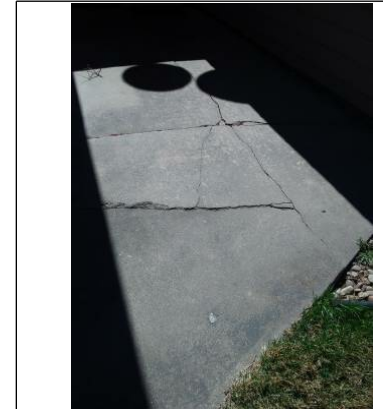
Exterior North central walkway cracked and settled and pitched toward the house; recommend repair or replacement of damaged section(s).

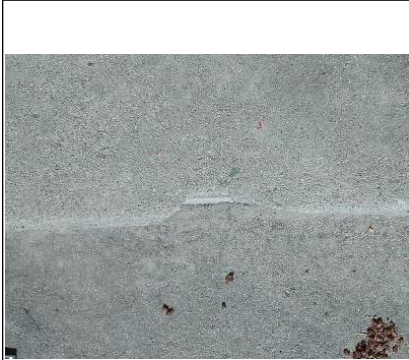
- Material**  Concrete  Flagstone  Wood  Composite  Brick  Concrete Block Other: .
- Condition**  Satisfactory  Marginal  Poor  Typical Cracks  Settled  Peeling Paint/Stain  
 Rotted/Damaged  Pitched Incorrectly  Uneven Risers  Handrail Recommended  
 Railing(s) Recommended  Balusters Recommended  Potential Safety Concern  Safety Hazard
- Comments** South step tread cracked and damaged, but usable; recommend repair as desired and filling crack(s) and sealing to prevent water penetration.

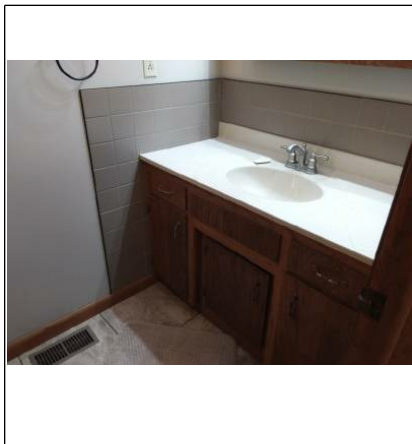
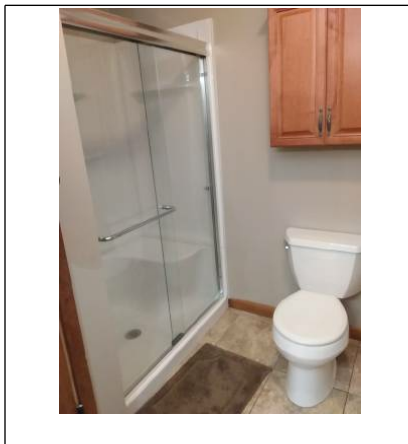
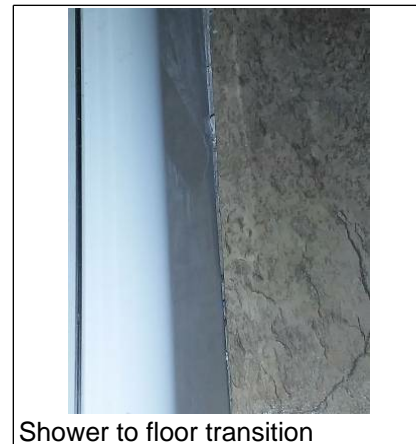
**Comments** Moisture stains on lower wall by the shower; no excess moisture detected during the inspection.  
 As a safety improvement opportunity, recommend installation of GFCI style receptacle(s) or circuit breaker(s) for all locations within 6 feet of water to meet current recommendations.

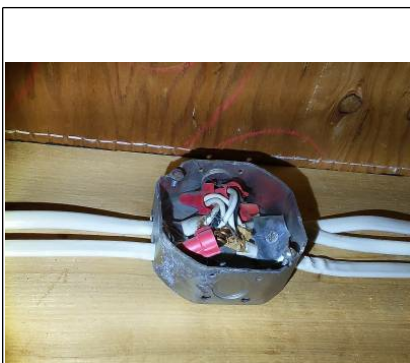
**Comments** Ceiling unfinished. Only wall finished is at South wall West.  
Moisture stains on Southeast lower walls and floor; no excess moisture detected during the inspection.  
Cover not present on electrical junction box at Northwest ceiling; recommend installing for improved safety.

Northwest ceiling

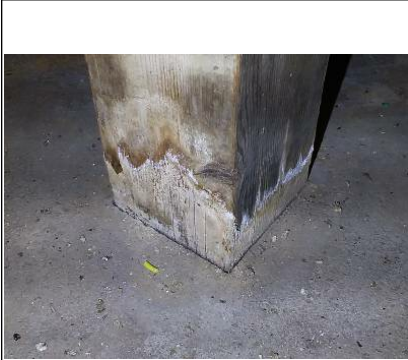
**Comments** Moisturestains on lower walls and floor; no excess moisture detected during the inspection.  
Cover not present on electrical switch box in South central room Southwest ceiling; recommend installing for improved safety.  
Cover not present on electrical outlet box in South central room East ceiling; recommend installing for improved safety.  
Covernot present on electrical junction box in the South central room Northwest ceiling; recommend installing for improved safety.  
As a safety improvement opportunity, recommend installation of GFCI style receptacle(s) or circuit breaker(s) for all locations within 6 feet of water (water softener and sump pump) to meet current recommendations.  
Entry door to the South central room frame loose and displaced; recommend repair or replacement.  
Entry door to the Southeast room does not have knobs installed; recommend installing as desired.

South central room Southwest ceiling

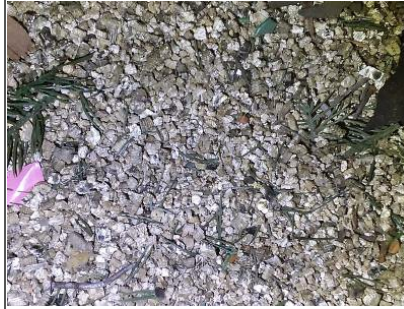
Vermiculite insulation

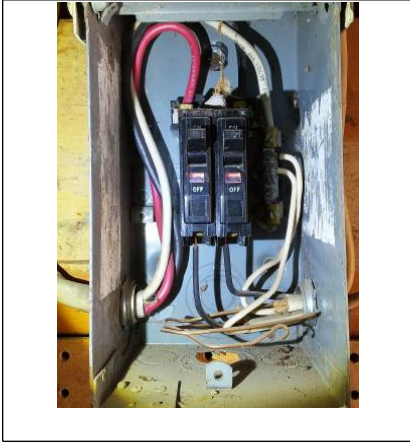
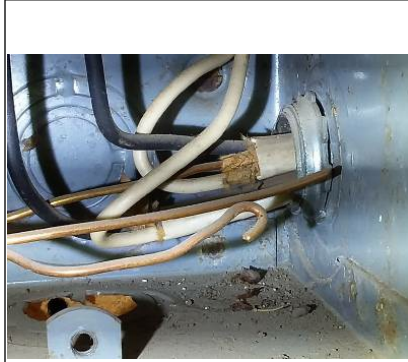
Ground wires

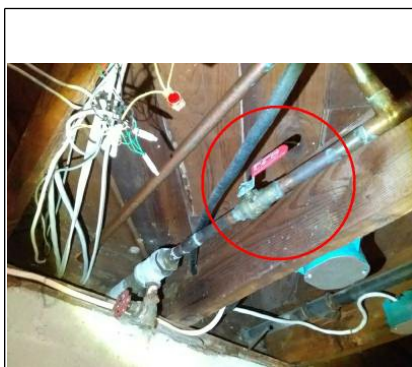
Water main shut off valve

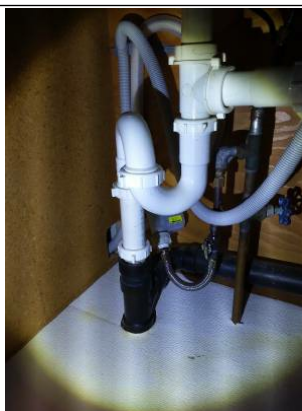
S-style trap(s) present, which are typical for the age of the home; recommend installing P-style trap(s) to prevent siphoning.

Under Kitchen sink

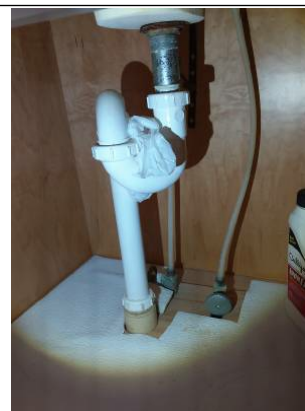
Under first floor hallway Bathroom sink

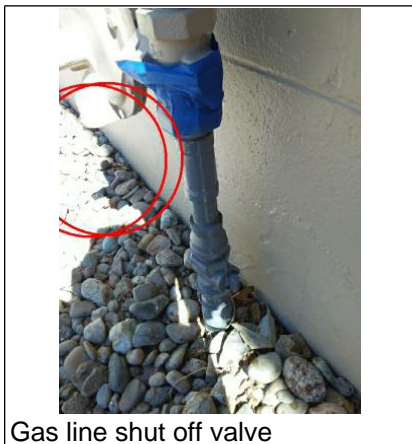
Gas line shut off valve

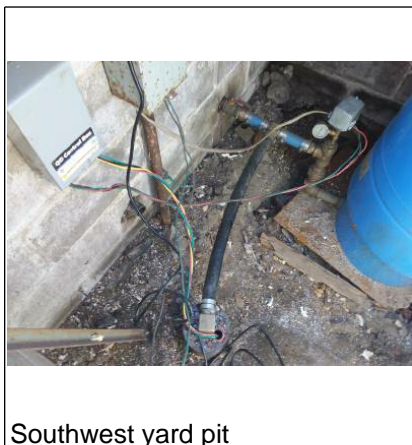
Southwest yard pit

**Comments** Private well pumping from aquifer.  
Well head, gauge, switch, and tank in Southwest yard pit.

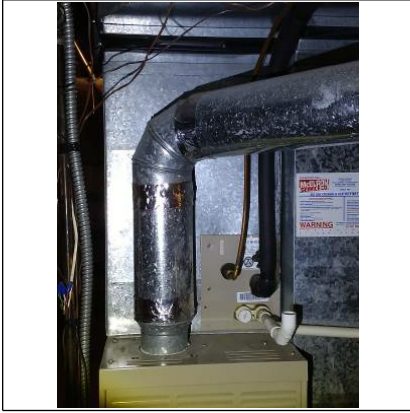
**Comments** Based on age, this item will probably need to be replaced within the next 5 years.

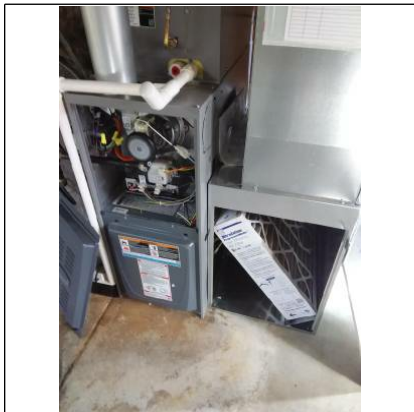
**Comments** Good blue/orange flame observed.

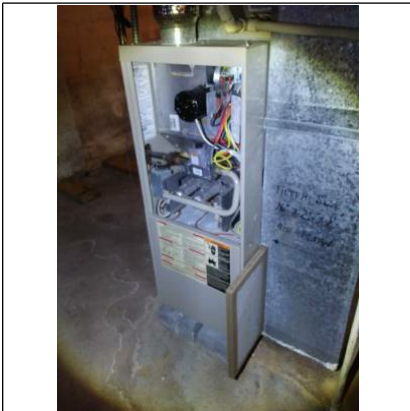
**Comments** Good blue/orange flame observed.  
Based on age, this item will probably need to be replaced within the next 5 years.
