Prepared for: Homes of Riviera Dunes, Palmetto, FL

Floating Dock Assessment Report

Submitted: March 2026

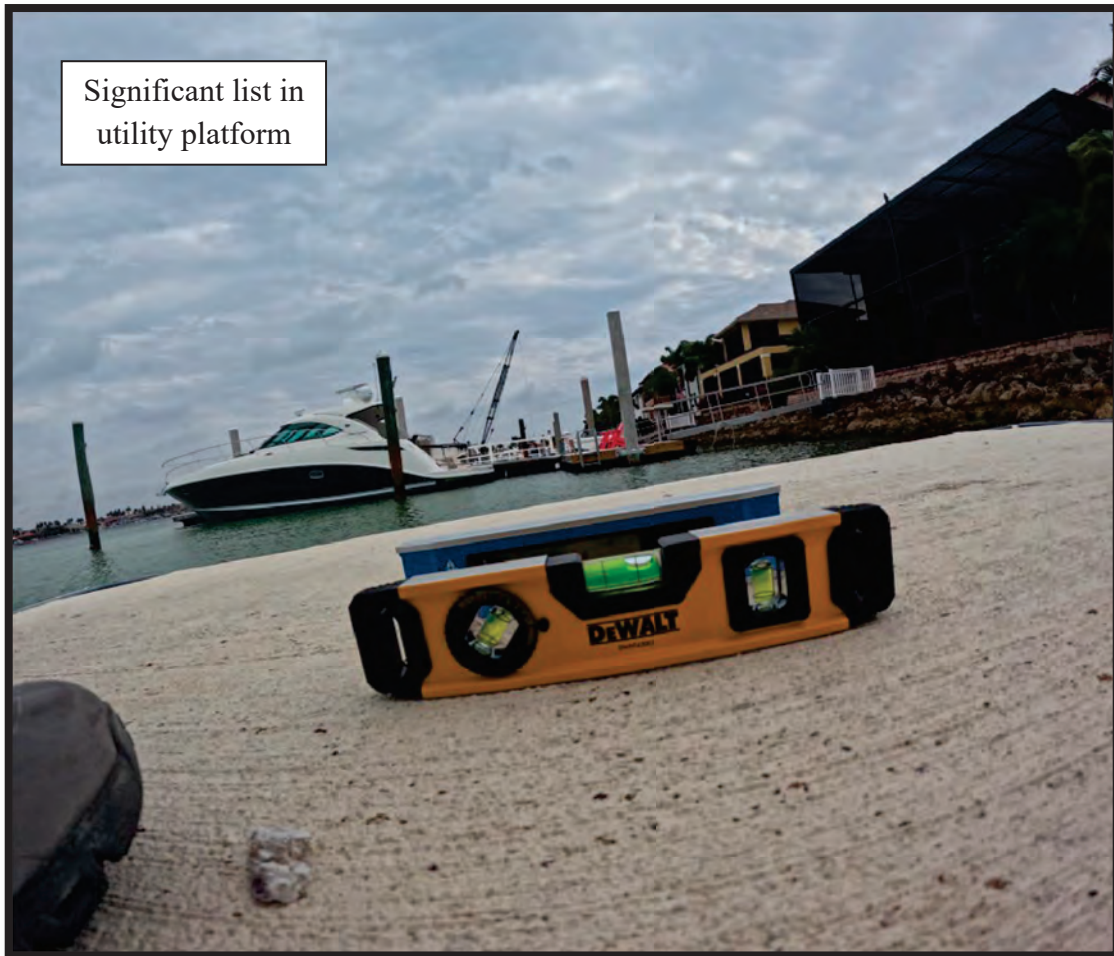
Utility Platforms – Each dock has a utility platform behind the gangway access point. Each of these utility platforms was found to be listing severely. The utility platforms are very well-shielded from wave energy, relative to the rest of the docks; therefore, this list is likely due solely to the weight of the utilities being run through the platform. Additional floatation can be added to help with the listing. The listing of these platforms can lead to stress in the busbars housed inside the panels; therefore, it is recommended that this issue be addressed ASAP.

In the short term, the listing of the utility platforms should be addressed to prevent any potential failure of the busbars housed on the utility platforms.

Phase 1 – 1 year: Install supplemental floats at each utility platform to prevent damage to utility lines/utility housing.
